FE-D Digital Readout Testing and Next Steps

*K. Einsweiler and J. Richardson, LBNL
M. Ackers and M. Keil, Bonn*

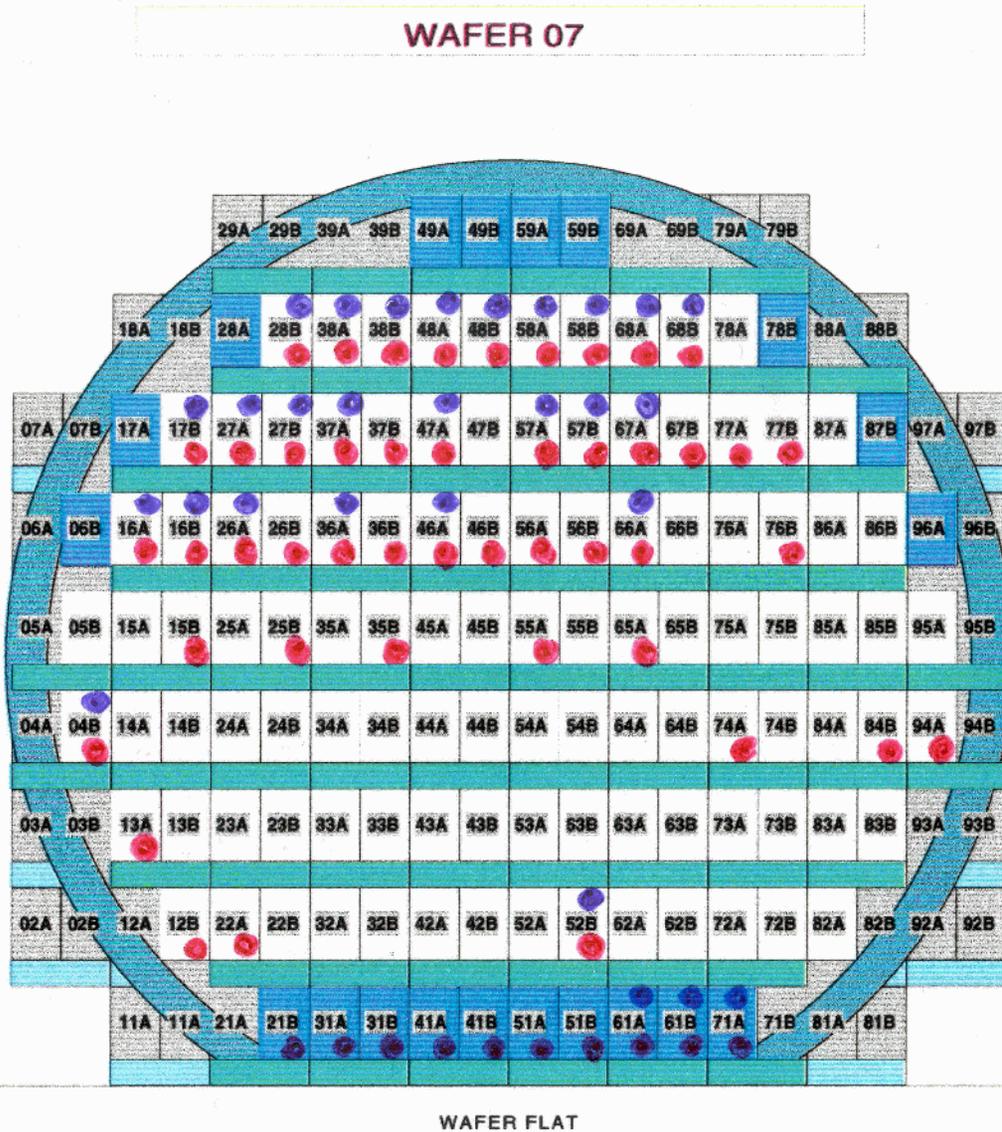
Wafer Maps

- Blue circles represent chips failing Global Register test.
- Red circles represent chips producing corrupt or missing EOE words during digital injection.
- The distribution of failures is heavily biased towards the upper half of the wafer.
- Any die overlapping the exclusion region appear to be bad.

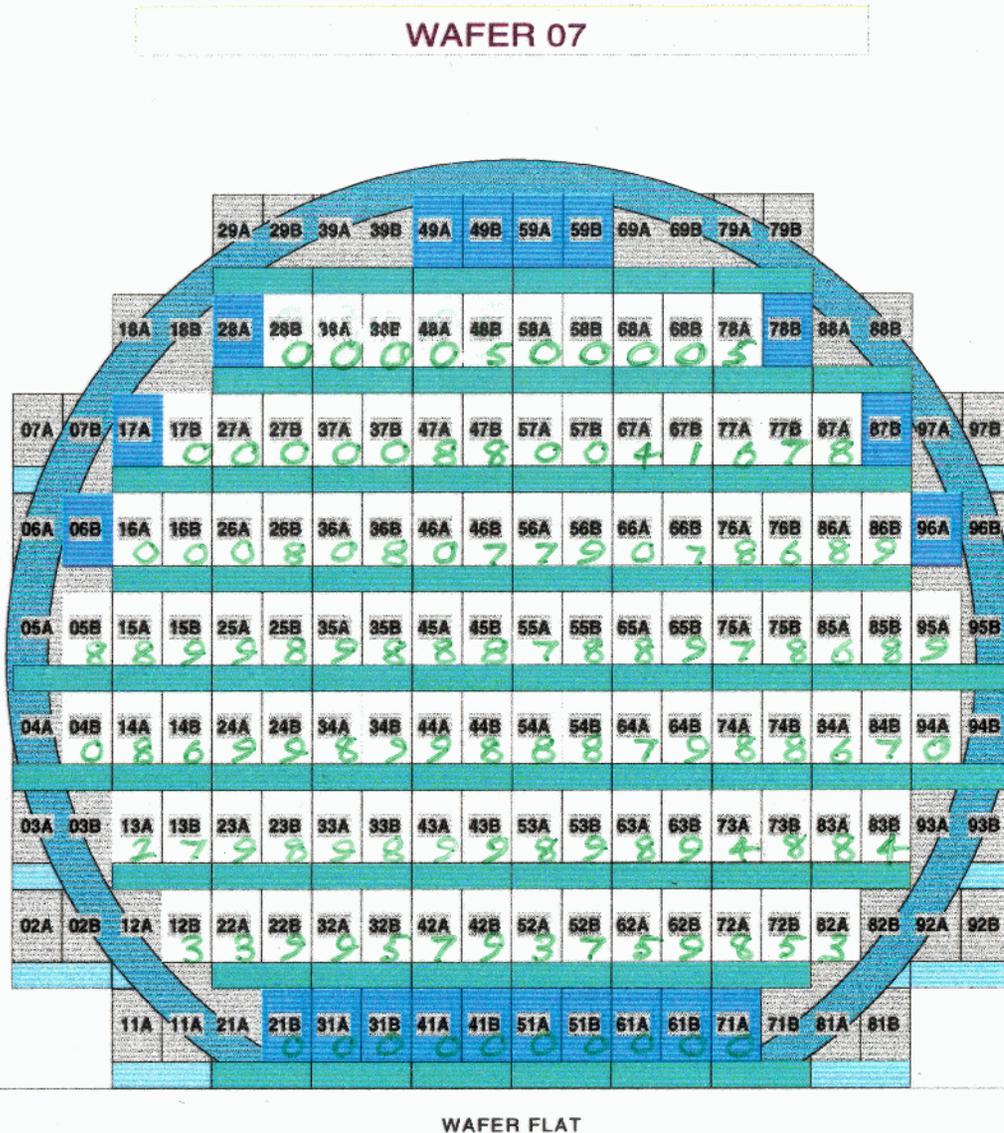
Wafer Maps

- Number of column pairs passing the Pixel Register test.
- Again, the distribution is very non-uniform.
- There were fifteen good die in the lower half of the wafer. This region was selected for dicing.

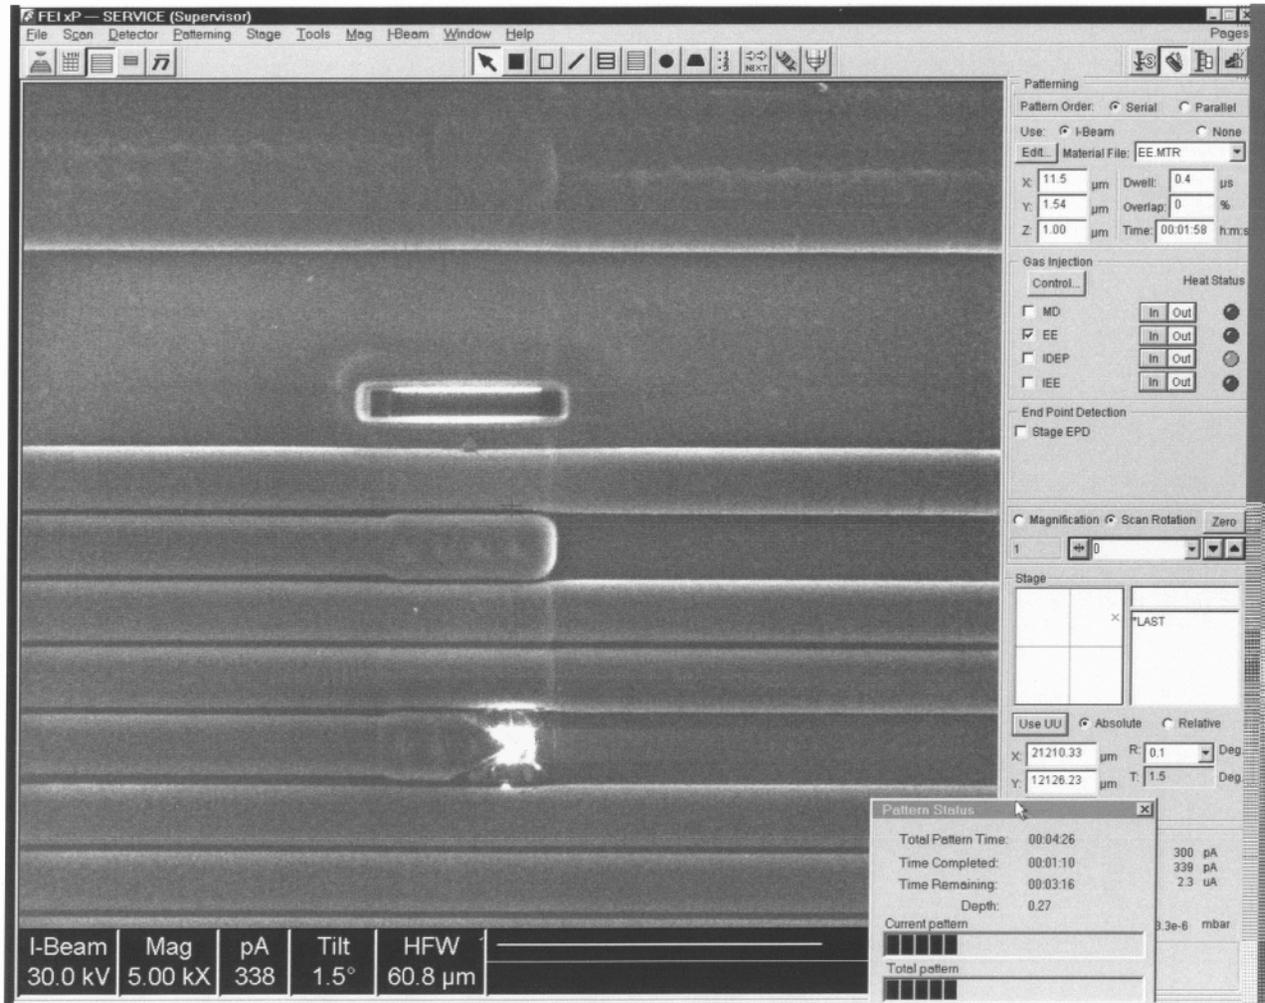
- Cut of approximately 11μ length was made through 9μ wide M1 trace.
- Under SEM, can see the Al remnants of the original trace as bright lines.

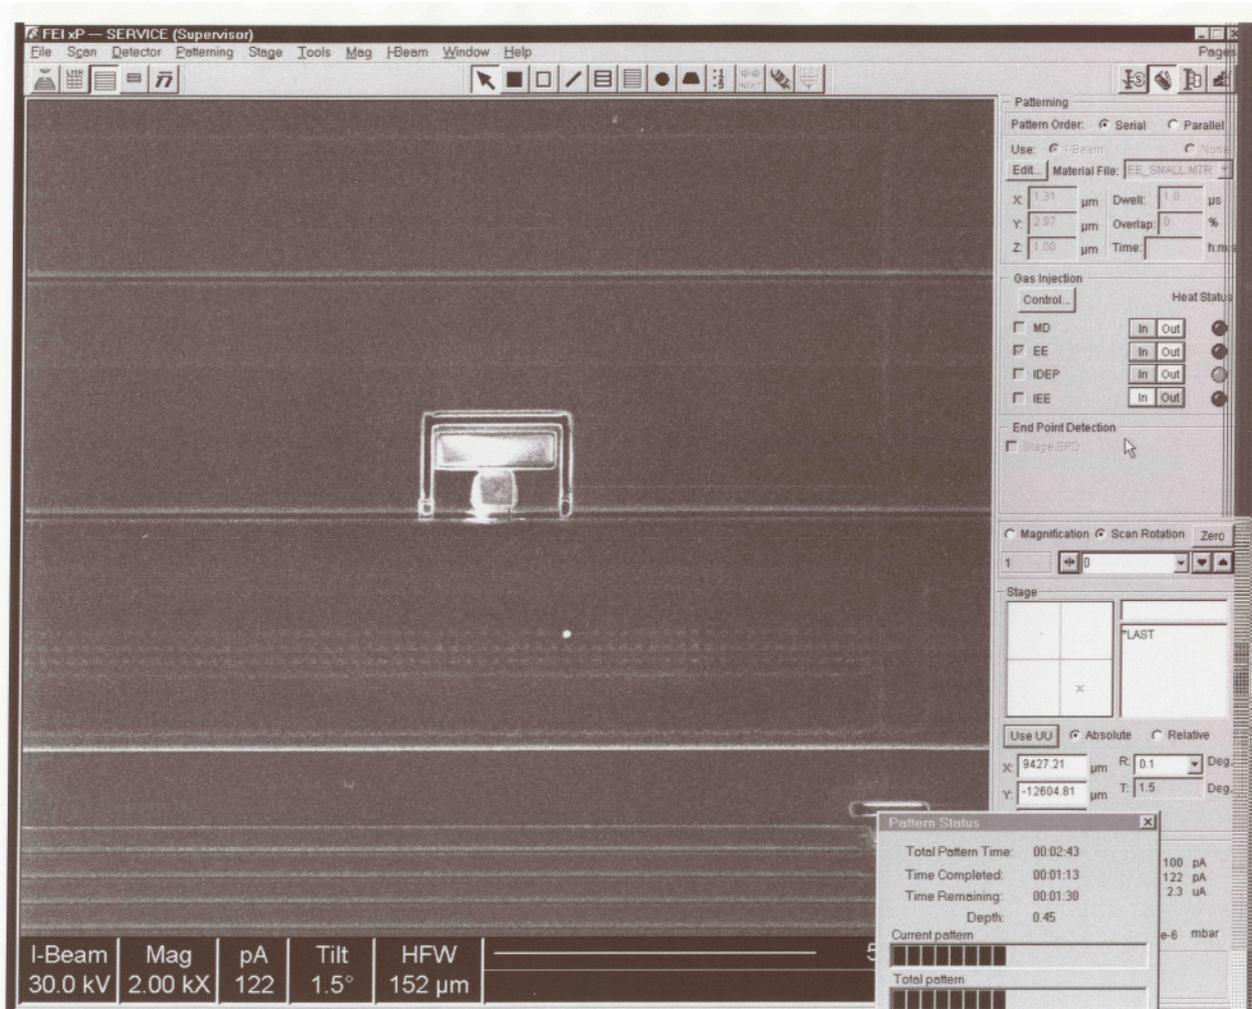
- First step was to cut out a small region of the wide M2 trace shown.
- Second step was to make a small via from this new pad down to the M1 trace underneath, by cutting and then depositing Pt via FIB.
- Finally, the passivation was removed to allow probing.

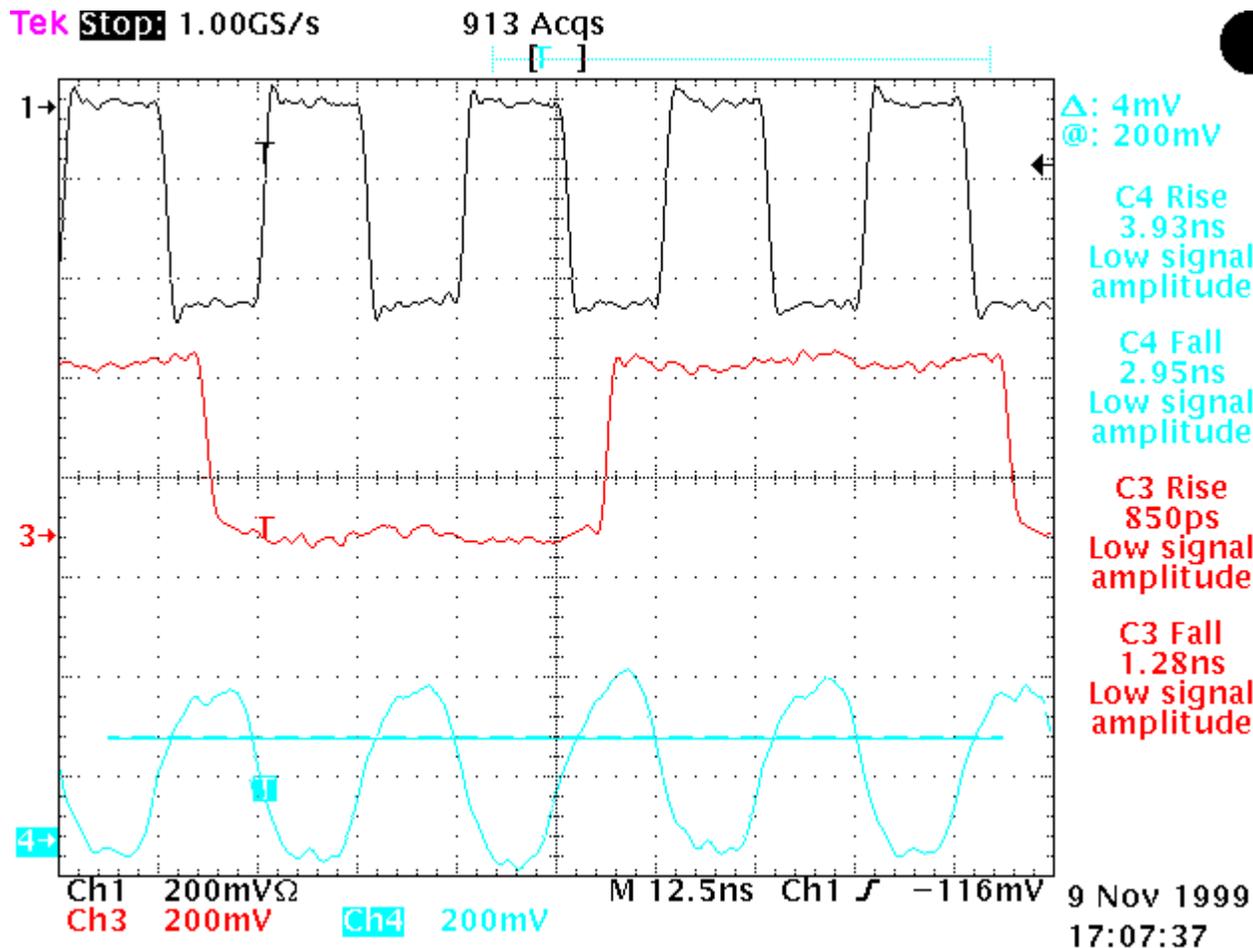
- Realized that there is a serious problem with XCK distribution inside FE-D, with relatively small transistors in LVDS receiver driving a fanout to 72 FF over a large, minimum width, set of busses (perhaps 13mm of busses 1.6 μ wide, giving 8K squares of sheet resistance, or about 300 ohms).

- Observe very poor risetime on internal XCK of about 5ns (10-90%). Duty cycle at VDD/2 is still 50%.
- For reference, TSC0 is also shown. It has a risetime of about 1ns, as expected for the combined Picoprobe and scope bandwidth (500 MHz).

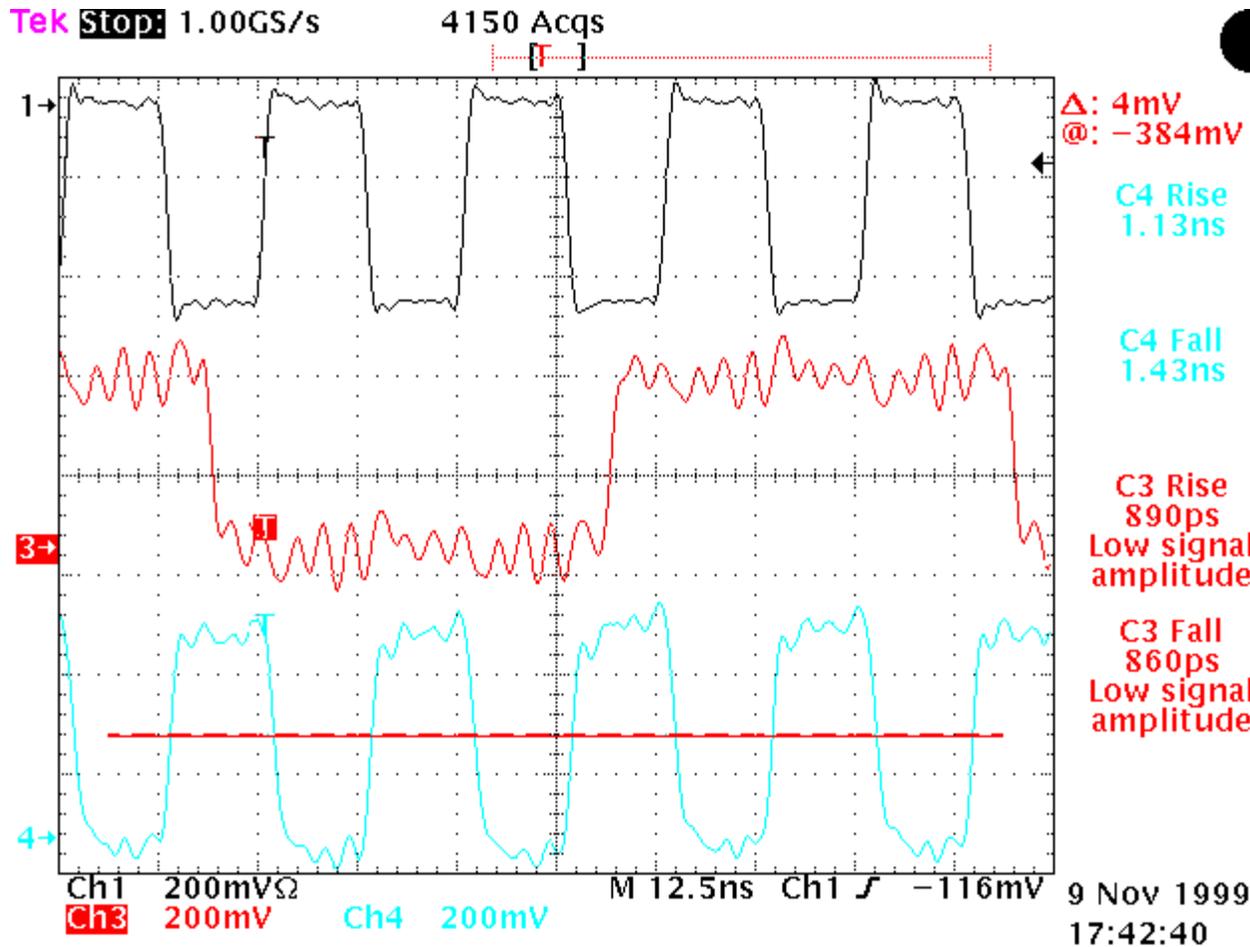
- Externally injected XCK looks good at injection point (but there was a minor ground problem which caused the observed ringing).
- In order to achieve good operation of the chip at VDD of 3.5V, the injected clock amplitude as 5V.
- This suggests internal distribution is also poor.

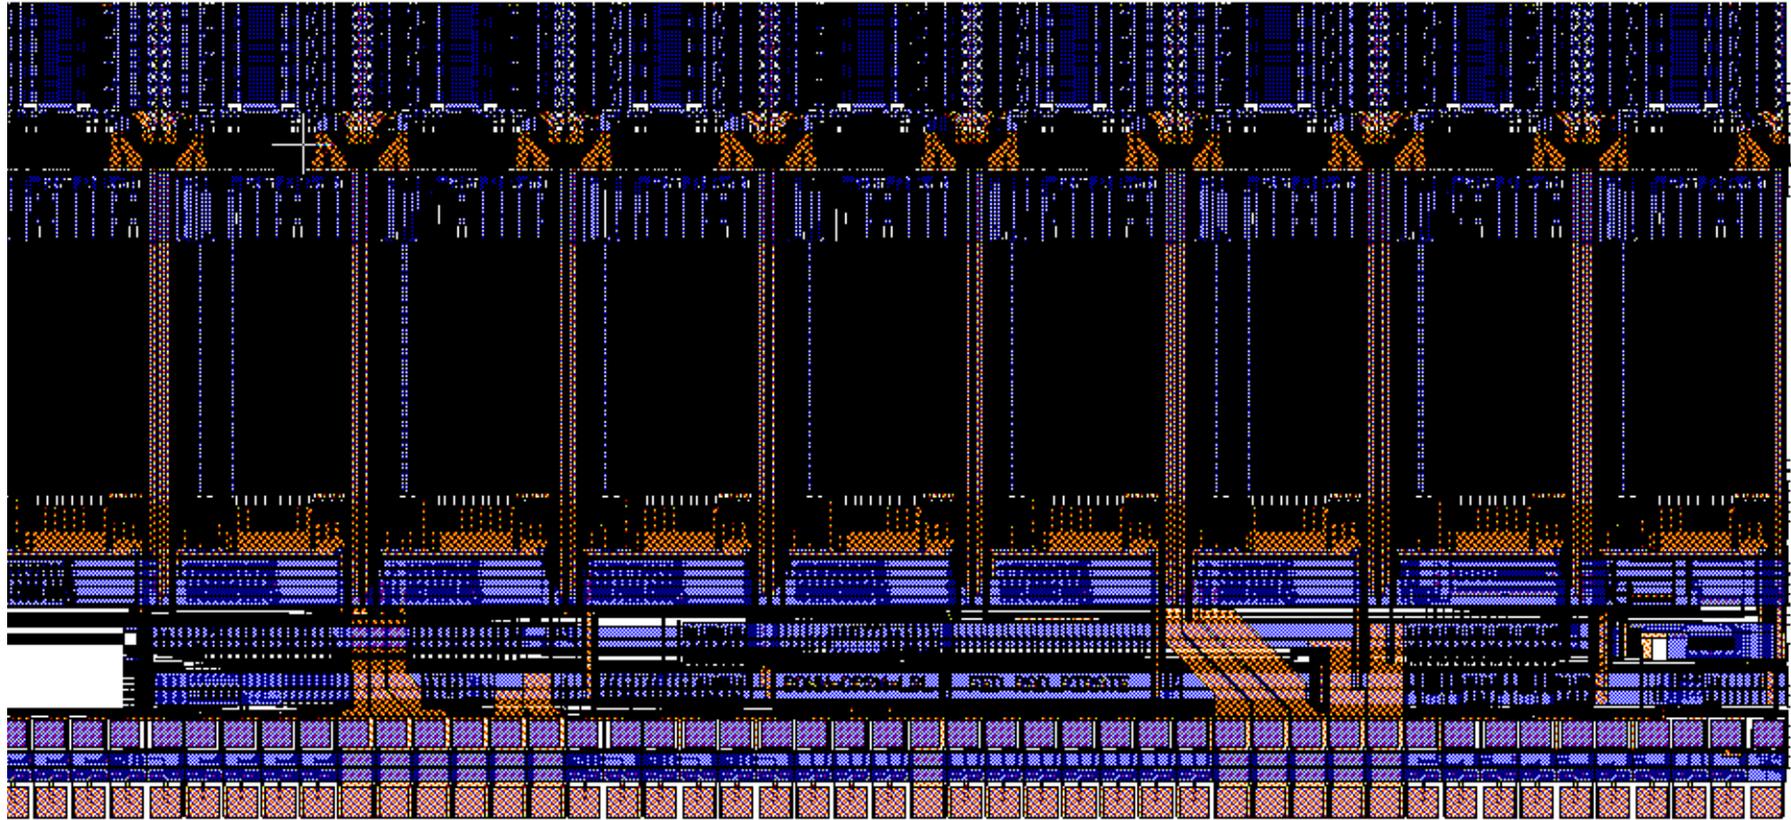
- Layout of bottom of FE-D, where XCK is distributed:

- Present XCK pad does not provide a good point to use when injecting an external XCK. It is far away from much of the circuitry.
- Some internal blocks which we assume are well-synchronized are not that close to each other on the internal bus. They may see rather different clock signals.
- We need to carefully study this whole problem to see how many of the other problems we see can be blamed on this one mistake.

- Extract proper R and C for each segment of the XCK distribution bus, and include this bus as an additional level in the hierarchy. This requires spending some time with the layout.
- In general, we need to create special netlists which are extracted from the layout and include all interconnect parasitics. This requires making special “chopped” layouts, and takes some investment.
- I am willing to do the simulations, Gerrit has extracted the present netlists, but I would like help from Bonn on the layout files and extracted R and C values.

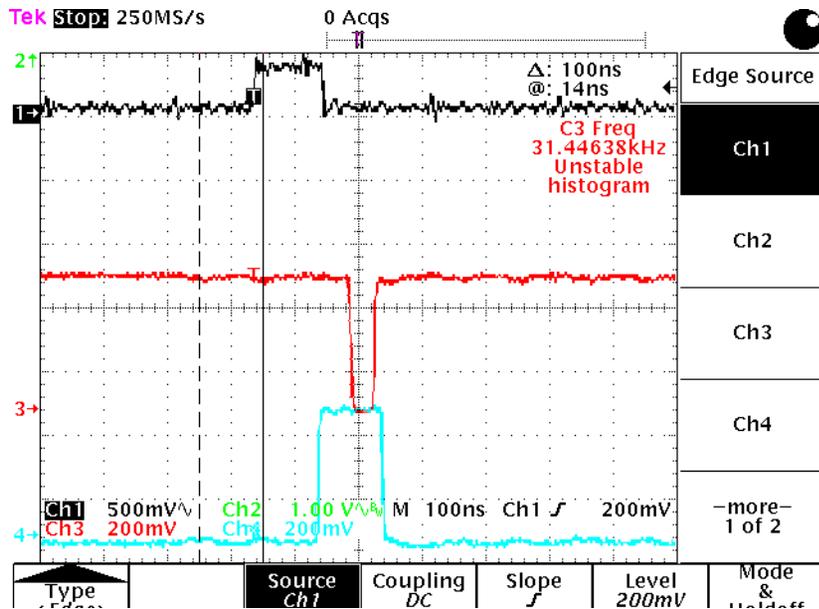
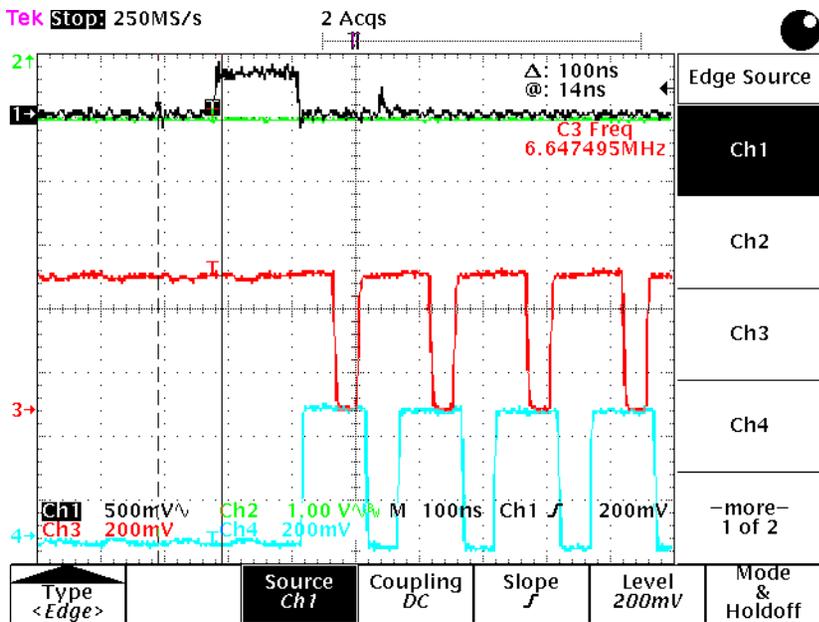
• Example scope pictures of “good” and “bad” pixels:

- Typically see that at a certain point in a scan (at a certain, normally dead, pixel), the CEU seems to go into a loop of sending Freeze/Read/Clear. Presumably no pixel is selected at this time, so this generates empty hits.
- A stuck on pixel cannot produce this effect (Freeze only turns off when no pixel is asserting Pri), so it requires a strange malfunction of the pixel hit logic...

- For good pixel, see Strobe (hit injection), then Freeze and ReadPix (inverted). A single cycle occurs to read out the data from the single hit pixel.
- For bad pixel, see that present of hit creates a continuous sequence of Freeze/Read signals. They occur as quickly as they can be generated by the CEU.
- This is strange because Freeze will only go away if there is no Pri, and Freeze will only come back if there is a Pri. It is very difficult to understand this if the schematic is functioning properly...
- All signals in the column pair look good (good rise/fall and expected timing behavior).

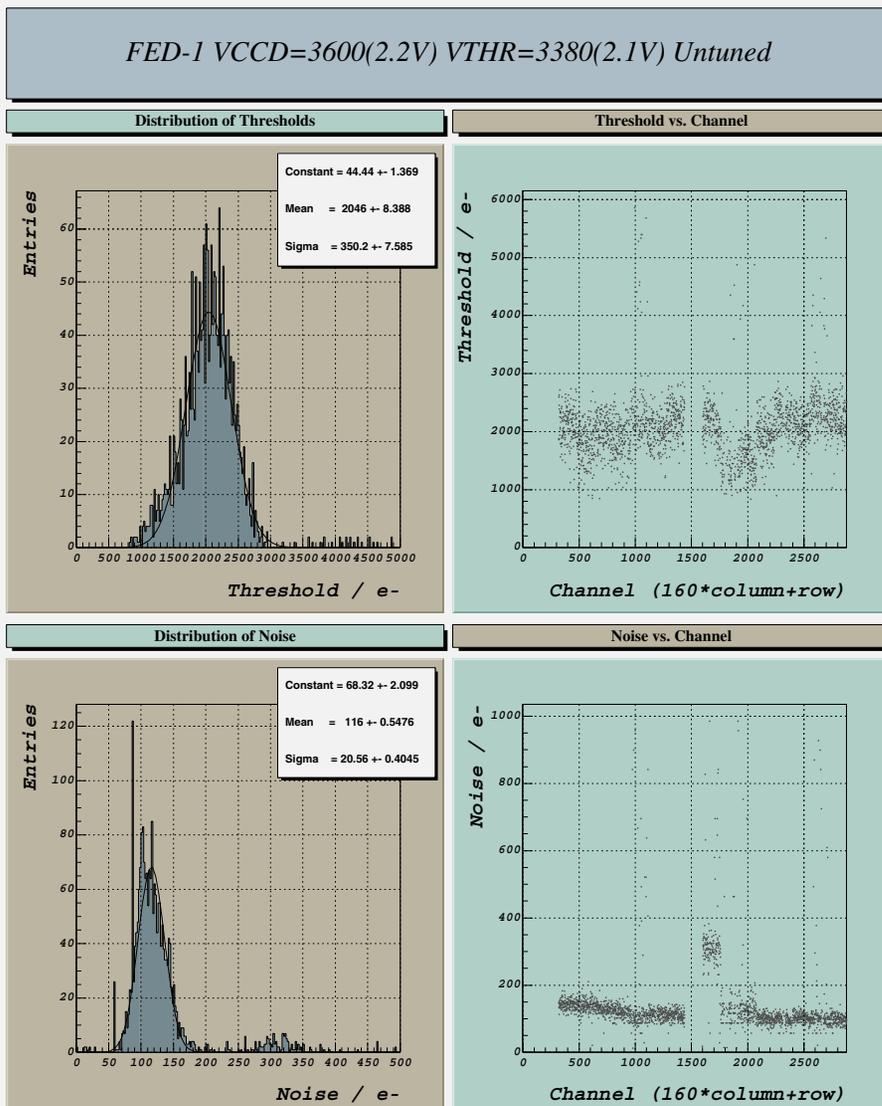
- Initial threshold dispersion is about 350e for a threshold of 2000e.
- Noise is about 120e, with one column which is intermittently “noisy”.

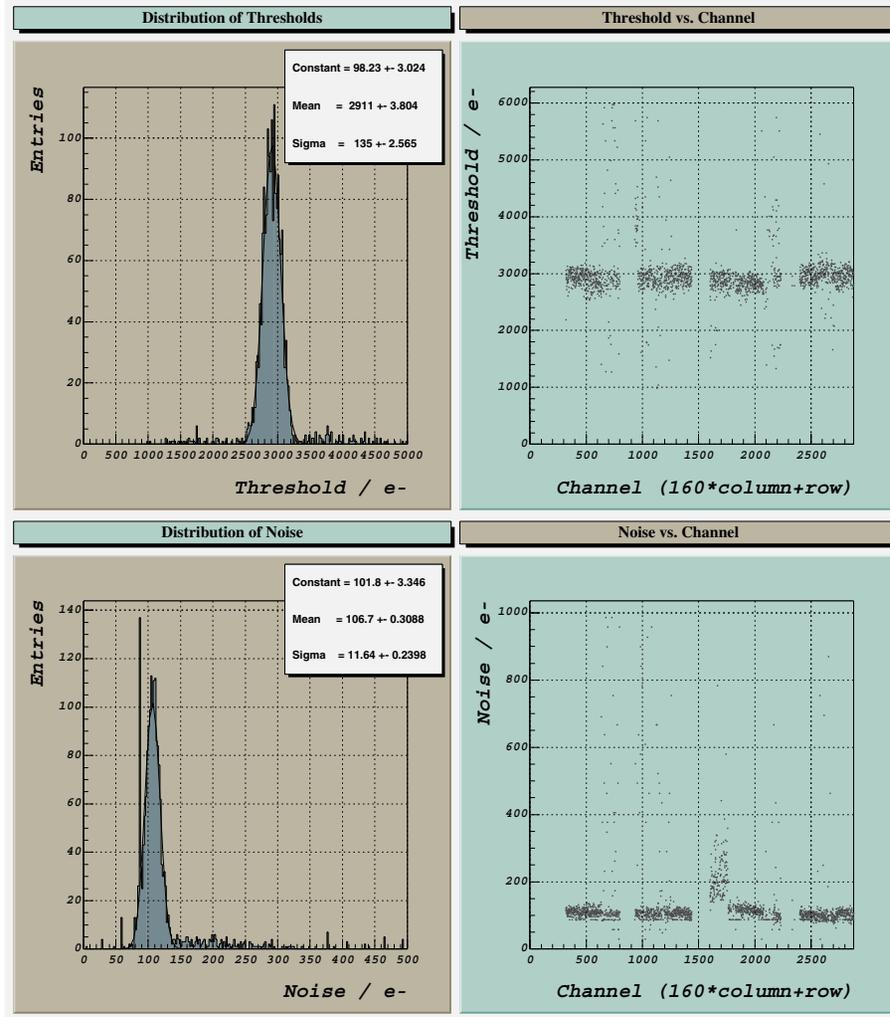
FED-1 VCCD=3600(2.2V) VTHR=3324(2.0V) IF=20 ID=IP=IL=IPS=40

- After tuning, the dispersion is reduced to about 135e.
- The noise is about the same, but this particular chip shows fluctuations in the noise behavior, and is often much noisier.

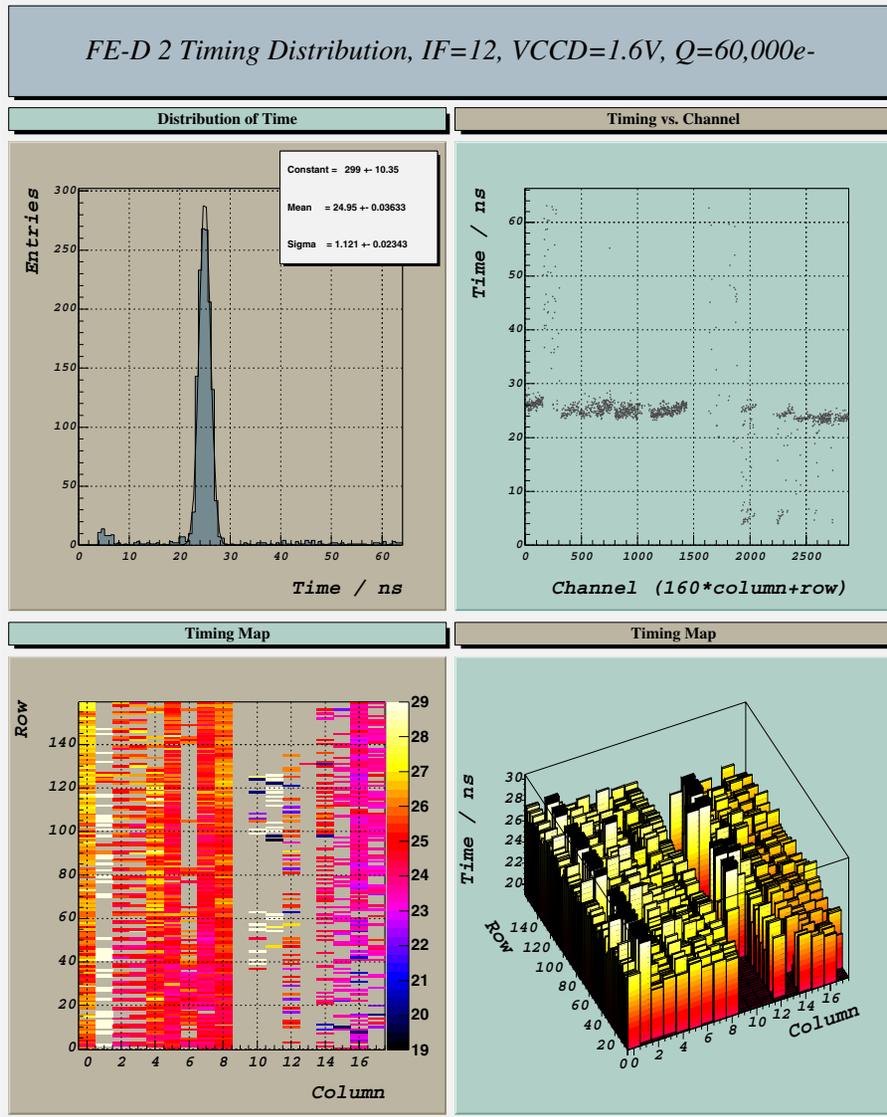
- Scan was done for FE-D #2
- Perhaps some small indications of systematic effects, but chip had many bad/dead channels, so it is hard to tell.
- Taking an RMS over the channels gives 1.1ns, which is similar to the results obtained from FE-B in the past.
