Summary of FE-I2 Measurements

K. Einsweiler, LBNL

Fault Diagnosis for FE-I2

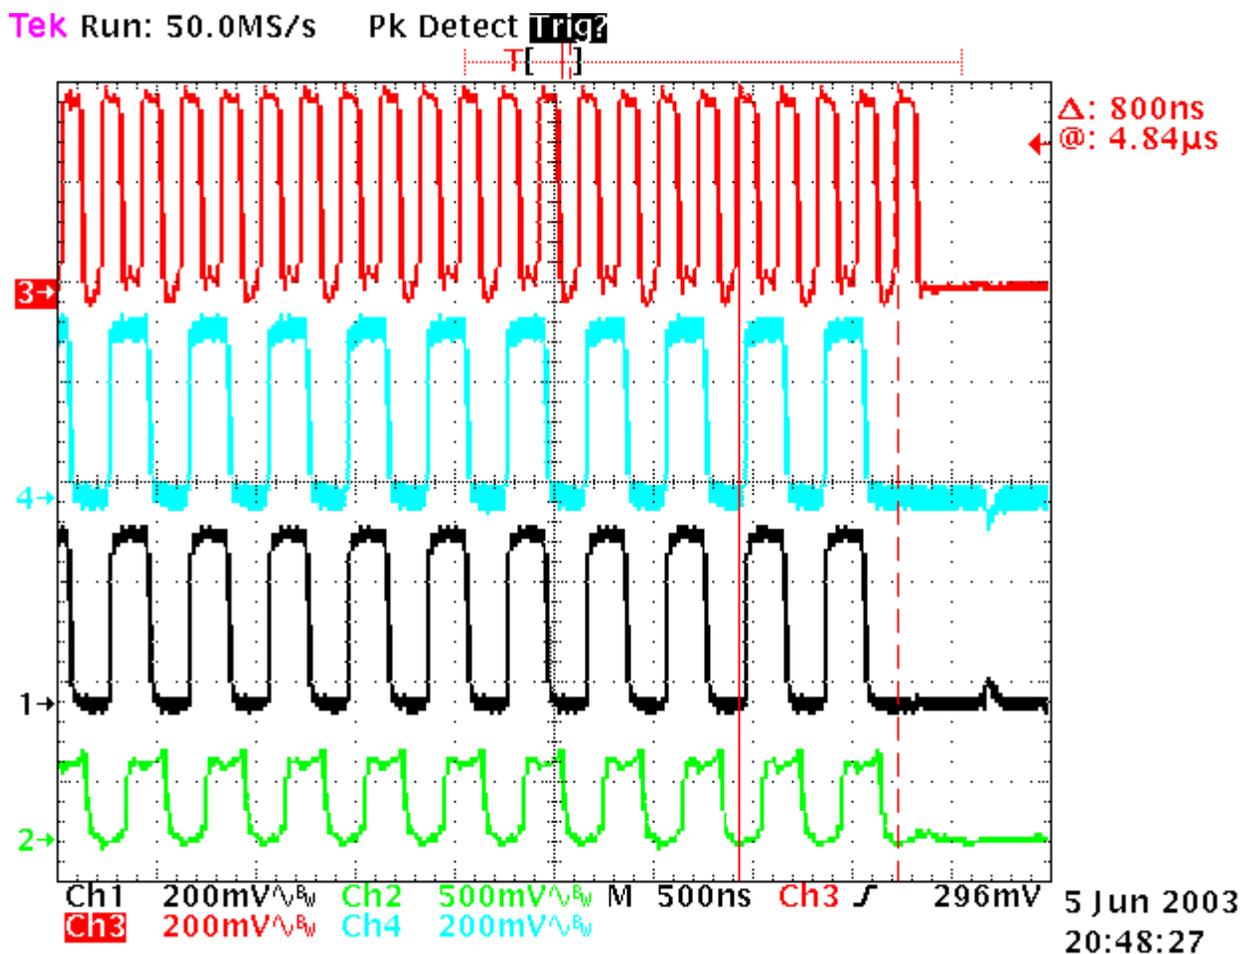
A pattern of '5's was sent with alternating 0's and 1's.

No data has been lost in the shift registers.

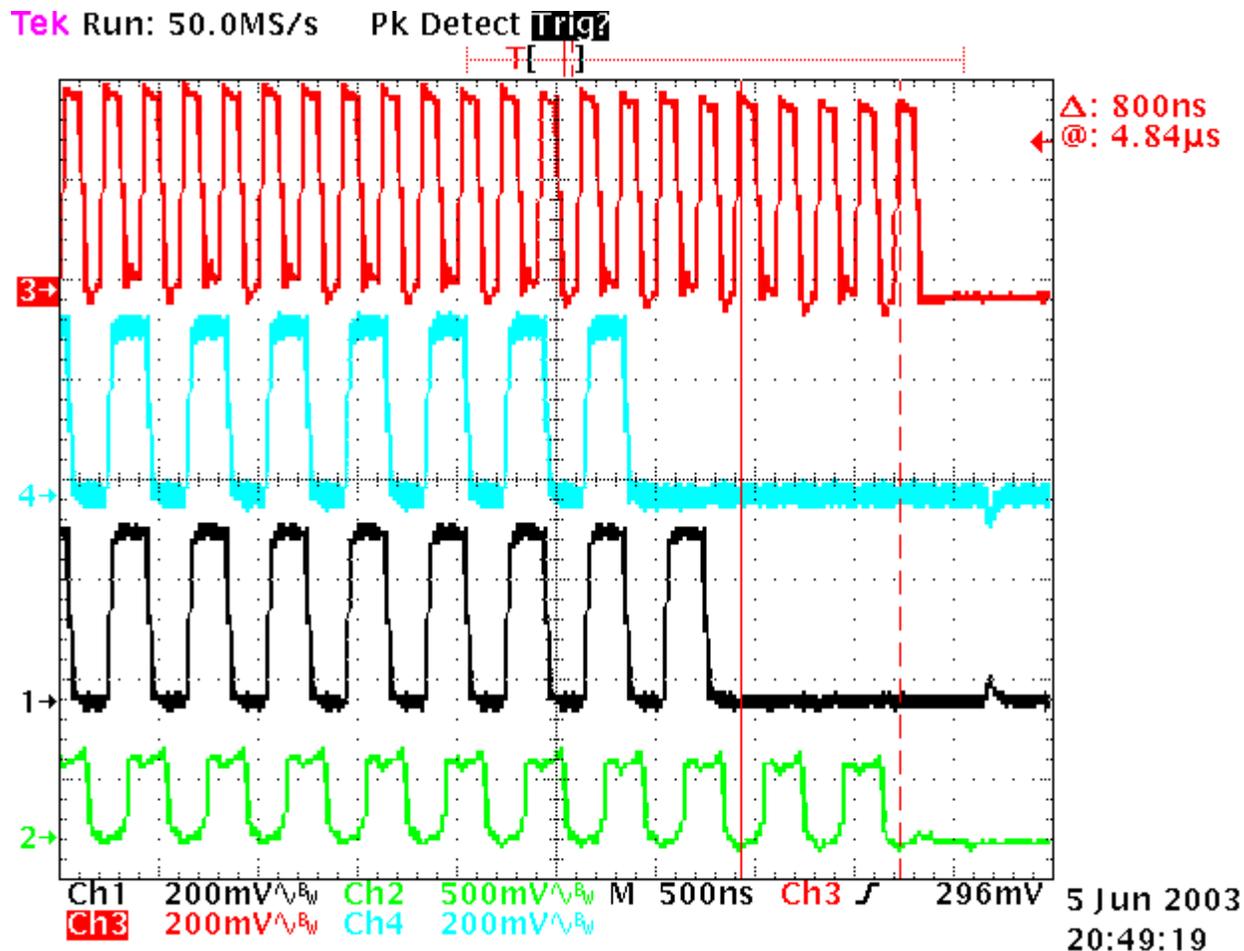
- After pattern was loaded at VDD=1.6V, it is clocked in again at 2.5V. Output data was therefore shifted in at 1.6V and shifted out at 2.5V.

- Observe loss of bits, beginning with 6th bit in Register #1, and 4th bit in Register #2. Clocking in pattern of 'A's indicates losses start in 5th bit. Conclude there is a single point loss between bit 6 and 7 in Register #1 and 5 and 6 in Register #2.

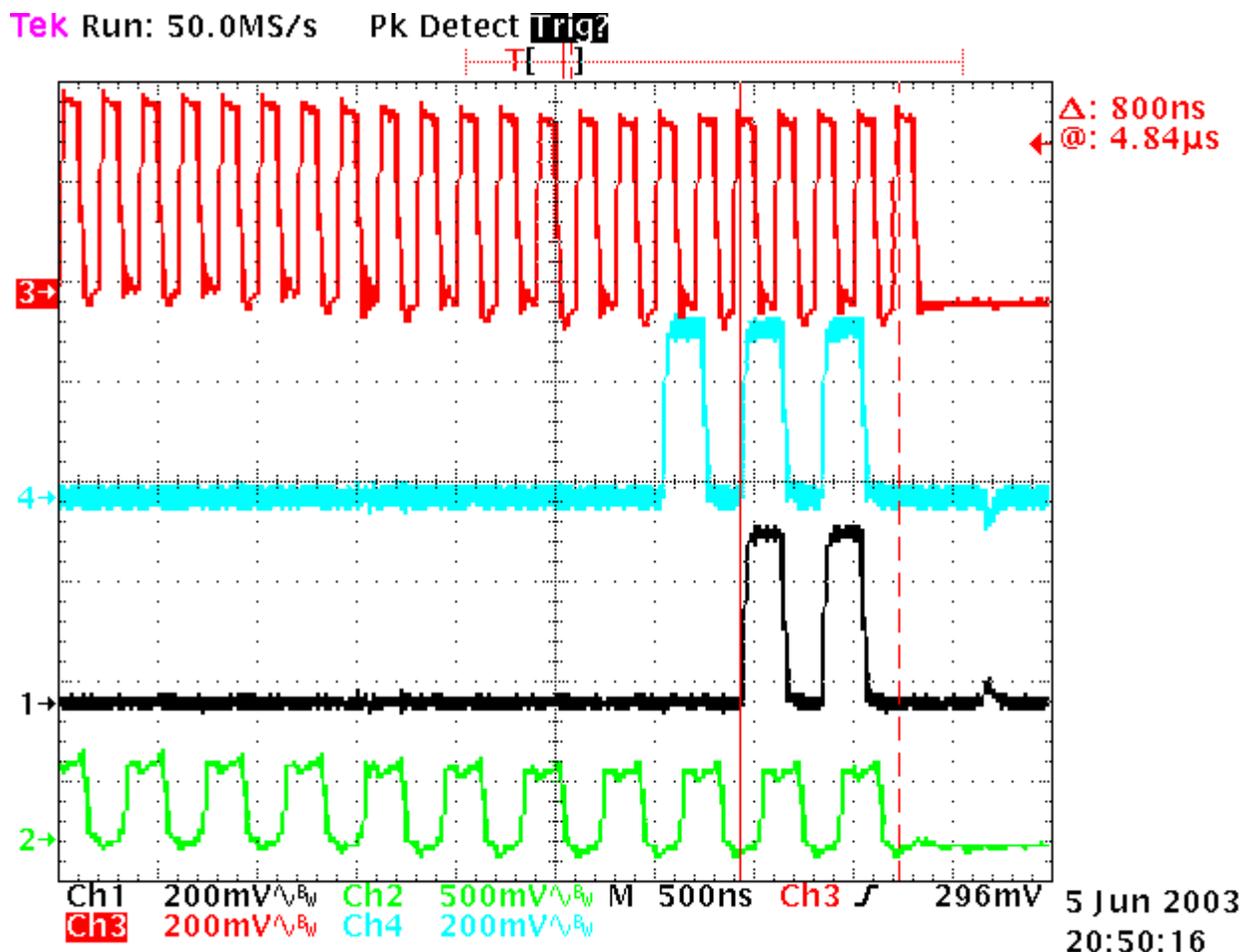
- After pattern was loaded at VDD=1.6V, clocked in again at 2.5V, it is then clocked in again at 1.6V. Output data was therefore shifted in at 2.5V and shifted out at 1.6V.

- Confirm previous single-point defect model, since all bits written at 2.5V after the defect are lost. Bits written before the defect are OK, and are eventually shifted out.

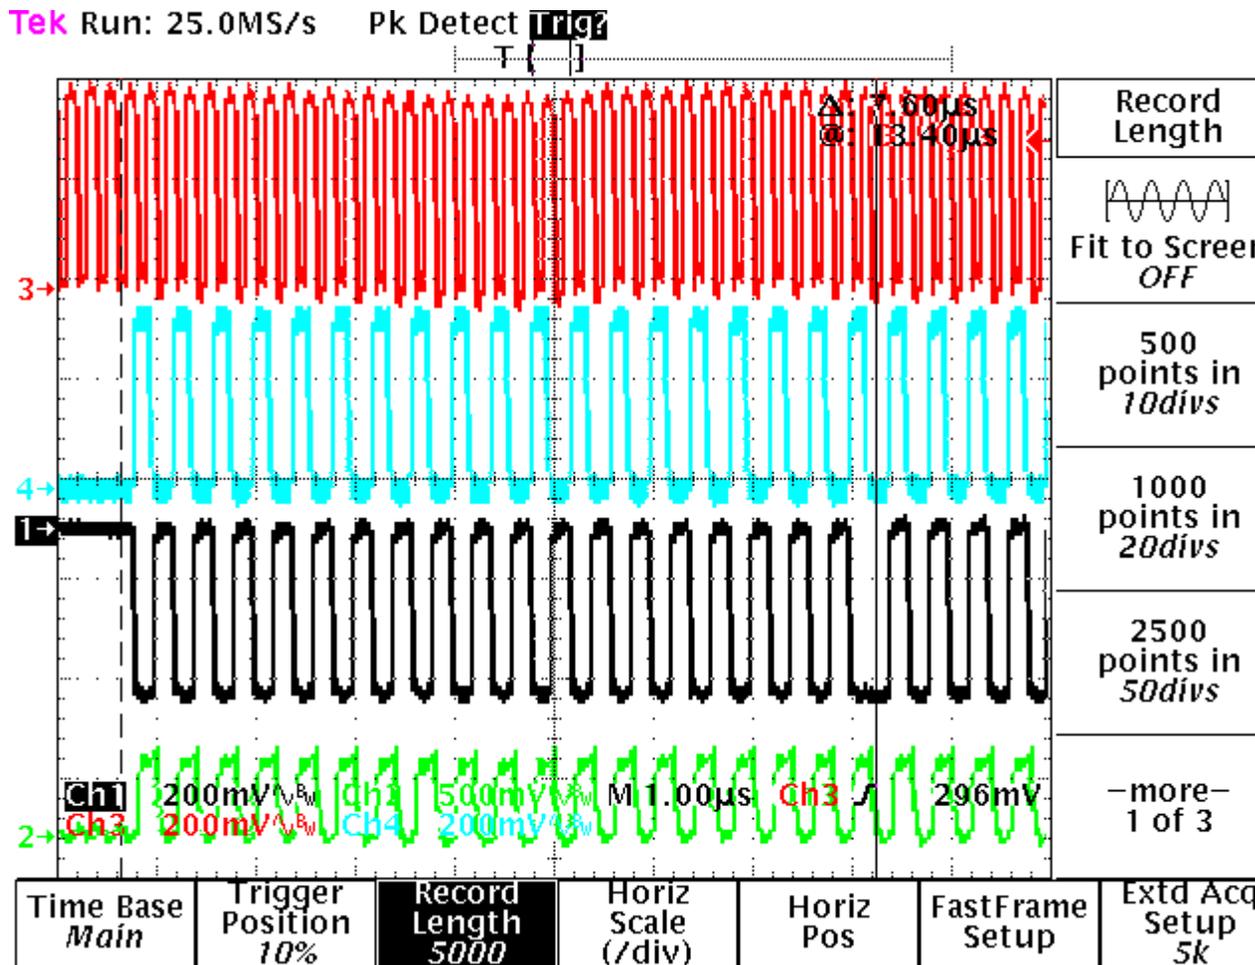
A pattern of '5's was sent with alternating 0's and 1's.

Extra 0 observed as 37th bit in Trace #1 is due to fact that register length is odd and pattern is even.

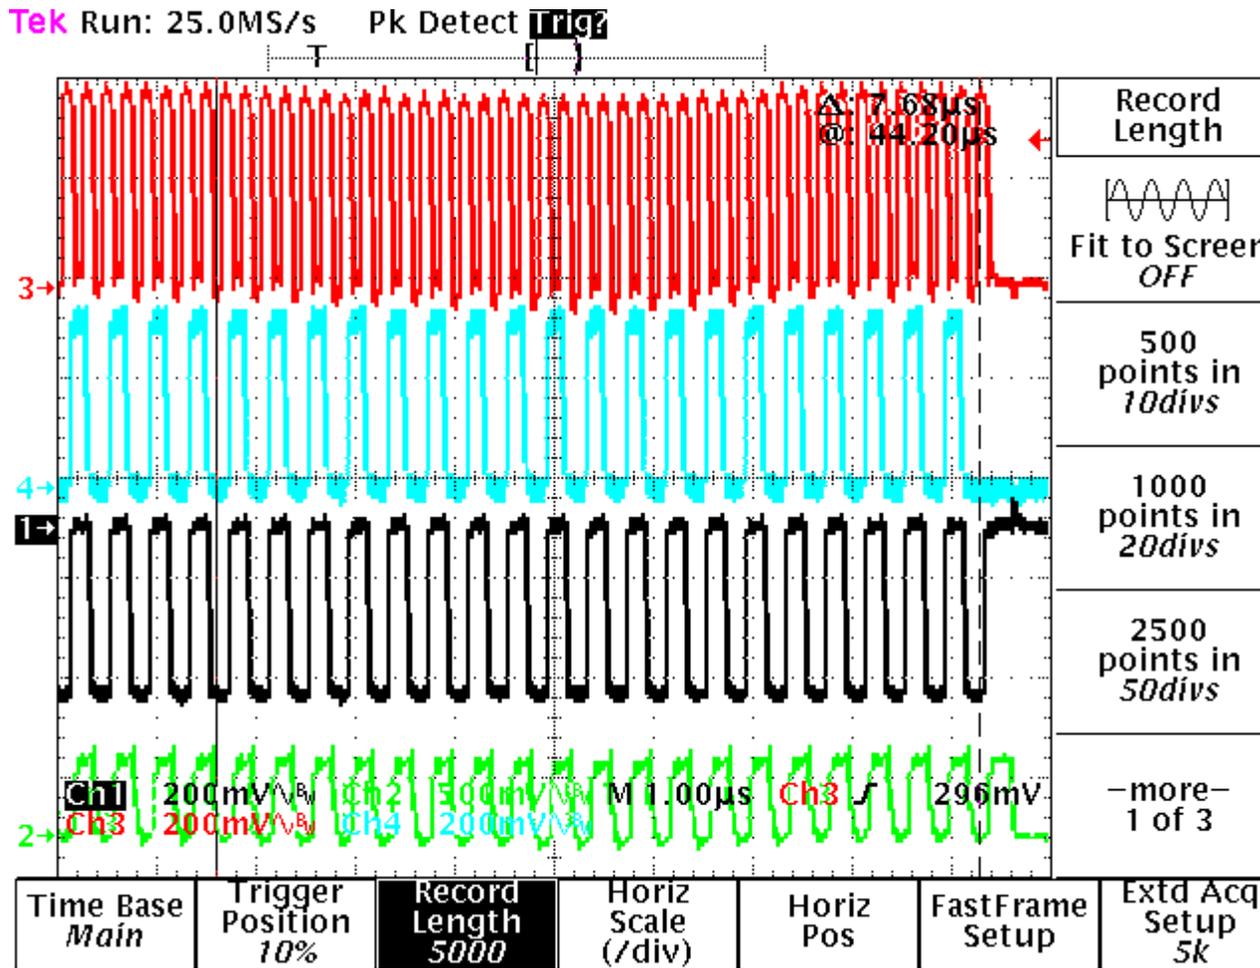
A pattern of '5's was sent with alternating 0's and 1's.

No data loss is observed.

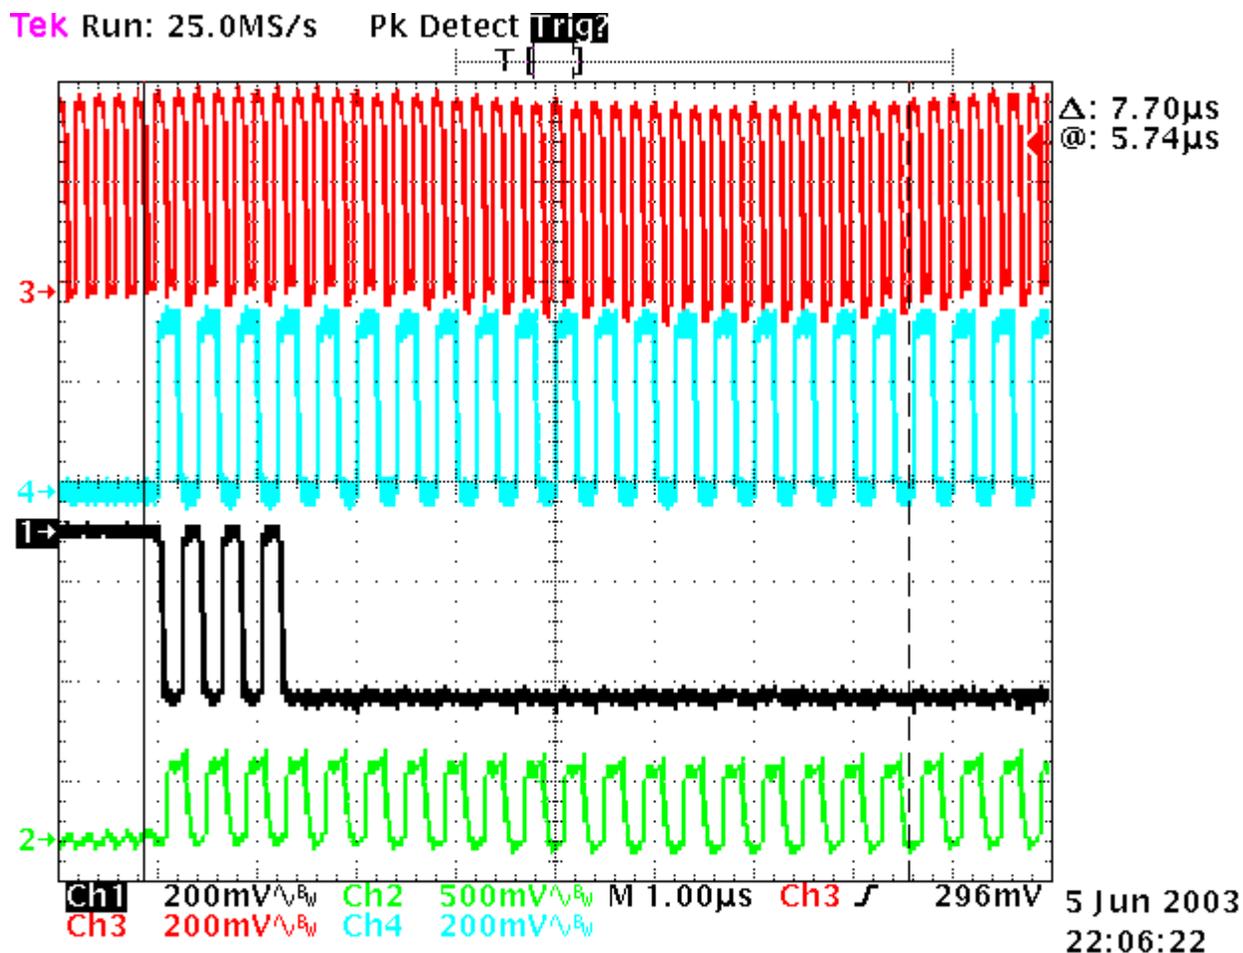
- After pattern clocked in at 1.6V, it is clocked again at 2.5V, and start of string is displayed. Output data was shifted in at 1.6V and shifted out at 2.5V.

- Observe that only the first 8 bits from the 38-bit place and route part survive. These were the 8 bits which were loaded into the Hitbus Scaler at 1.6V, and have now been clocked out at 2.5V. This suggests a single point failure between blocks.

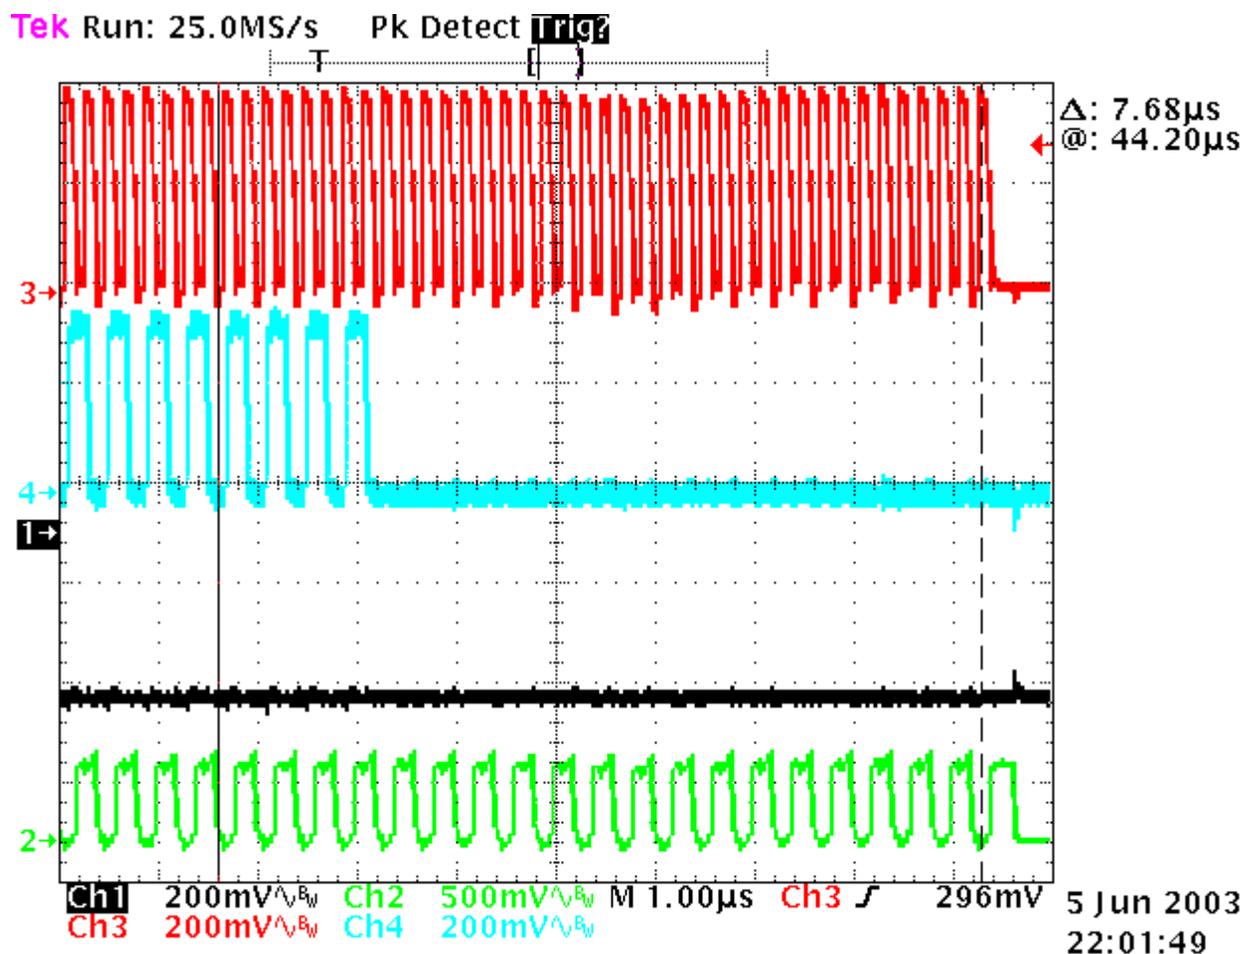
- After pattern clocked in at 1.6V, it is clocked again at 2.5V, and end of string is displayed.

- Observe the loss of the last 30 bits, with 8 bits surviving from the place and route block. This confirms that the single-point defect appears to be between the exit from the first 30-bit ConfigReg and the entrance of the 8-bit Hitbus Scaler.

- Lowering VDD to 1.6V and clocking again confirms the same failure pattern.
- In the test above, bit 30 is lost and bit 32 survives. When testing with a pattern of 'A's, bit 31 survives and bit 29 is lost, confirming that the defect location is between bits 30 and 31.

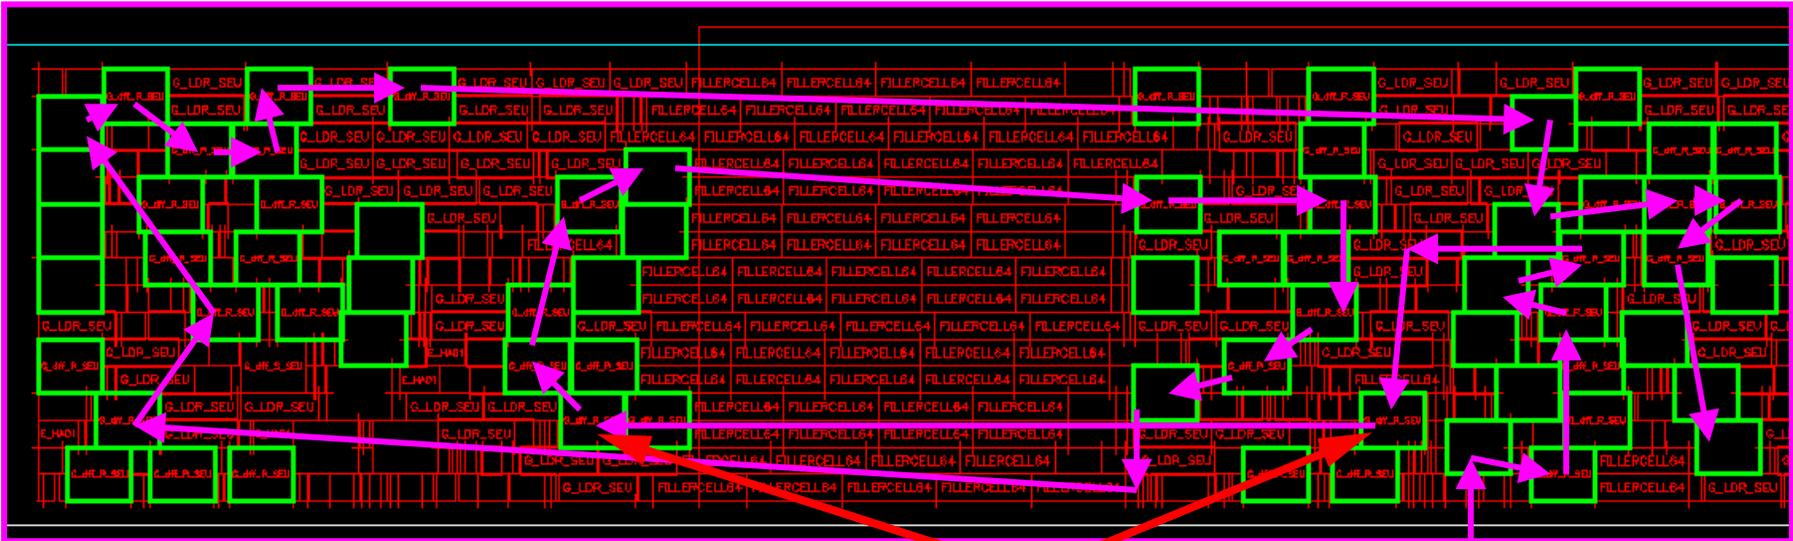
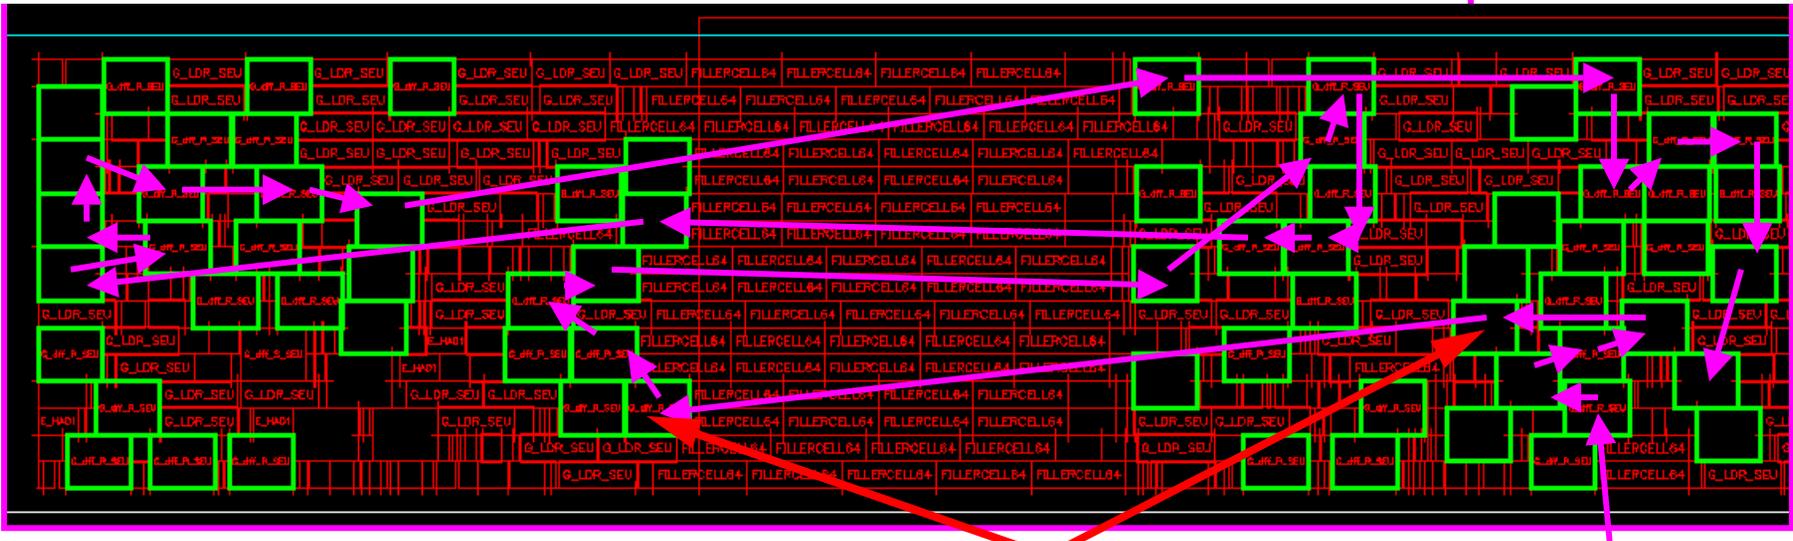
- Data path for Register #1 (upper) and Register #2 (lower). Red arrows = problems:

- Observe that there are long data paths in same direction as clock tree for Bit 6->7 for Register #1, and for Bit 5->6 for Register #2. These are consistent with the observed location of problems.

- However, there is a longer connection from Bit 15->16 in Register #1, and two long connections from Bit 14->15->16 in Register #2, with no observed problems.

- Plan to start on the modified layout for the clock routing for the three registers this week. Estimate that layout modifications and verification could be completed in about one week. It is possible that the critical path for the intermediate step will be getting a new PO in place for IBM. For the moment, we are waiting for the quote.

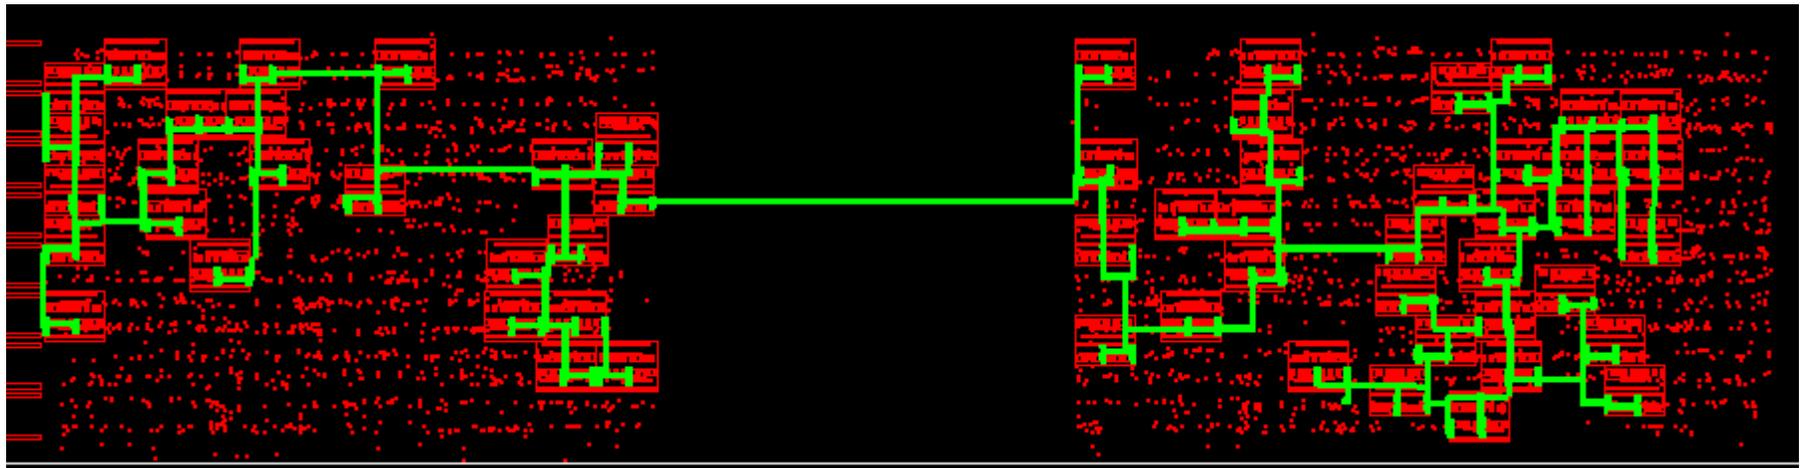
- Clock Tree for the registers (clock enters in lower right of tree):

- Points of concern are cases where there can be a large clock delay compared to the data. Normally, this will happen when the FF are far apart, and the data can follow a direct path, but the clock follows a less direct path. Also, the loading on the data lines is much lower and so their risetimes are much faster (sub-ns versus about 4-5ns), and longer lines become RC transmission lines with delays.

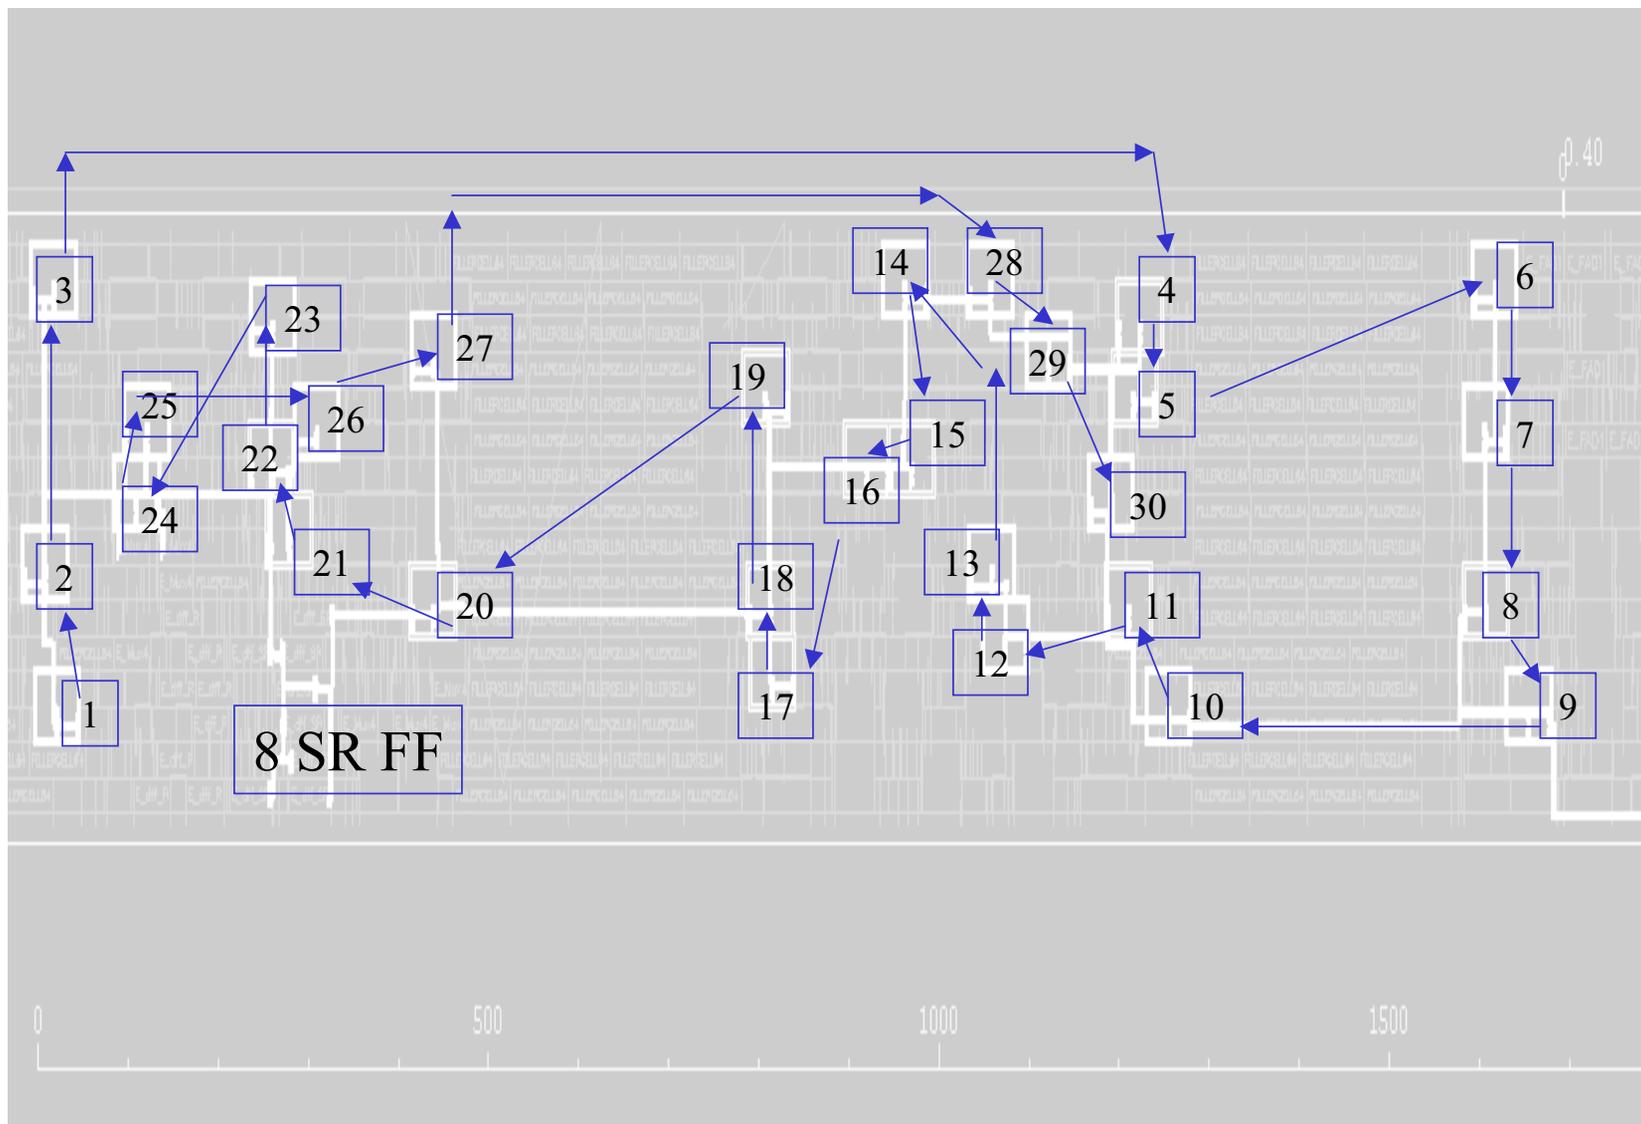
- Data path for Global Register (clock tree is white, clock enters at lower right):

- Eight DFF in lower left are the standard cell DFF for HitBus Readback.

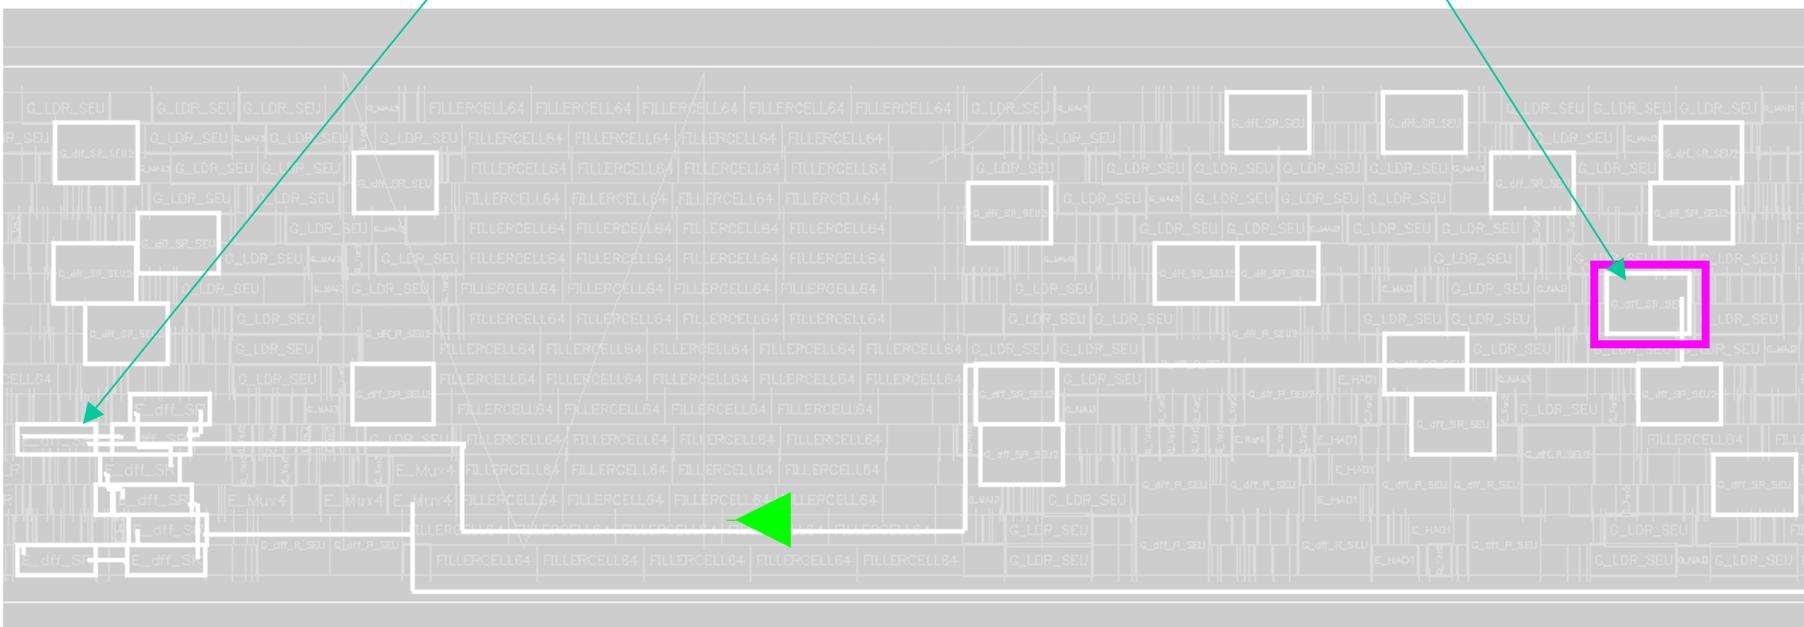
•Connections between ConfigReg (30-bits) and Hitbus Readback (8-bits):

•Once again, the data path is long, but the clock path is longer. This suggests that this location is the weakest point in the 38-bits of place and route Global Register.

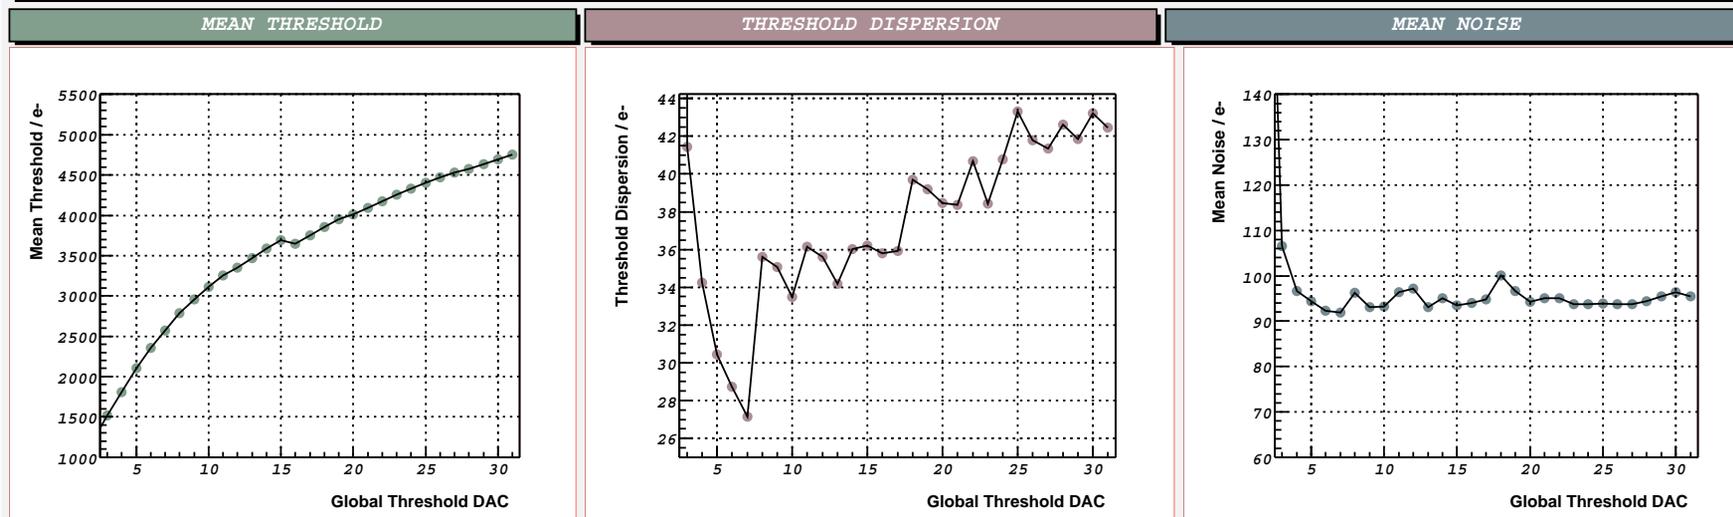
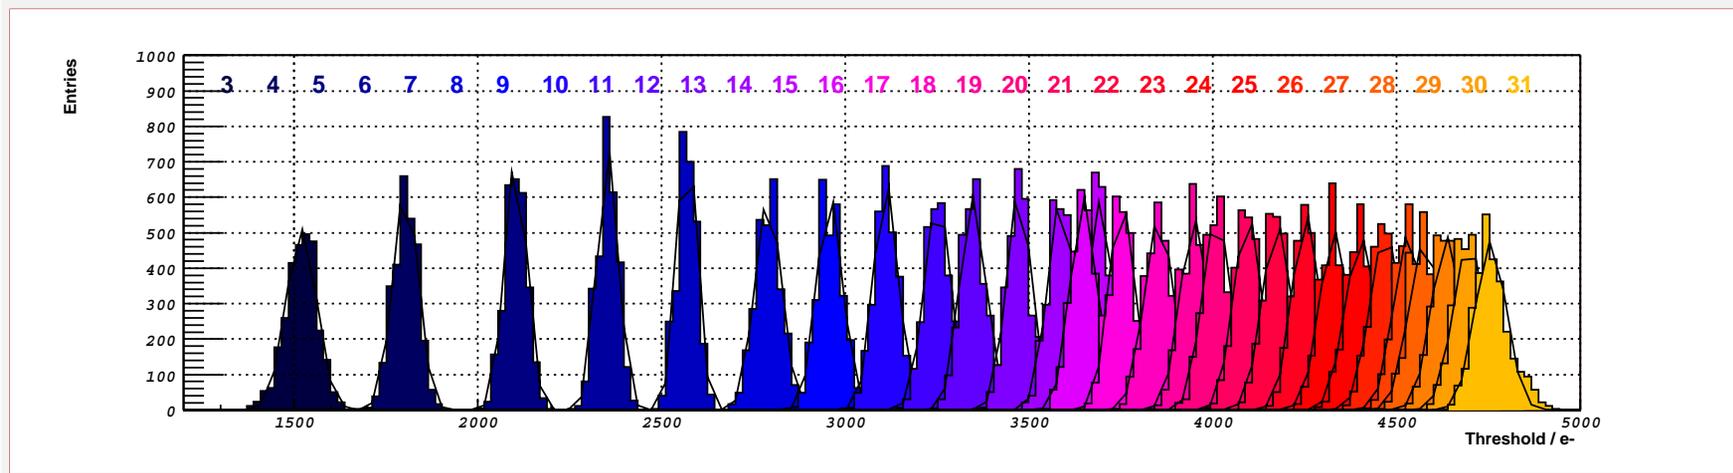
FE-I2 (probed on wafer). Effect of Global Threshold DAC. Tuned at GDAC=7

- Principle observation is that tuned distribution can now be moved without significant dispersion (here, tuned at GDAC=7).
- Problem at MSB transition which makes GDAC=16 lower than GDAC=15.

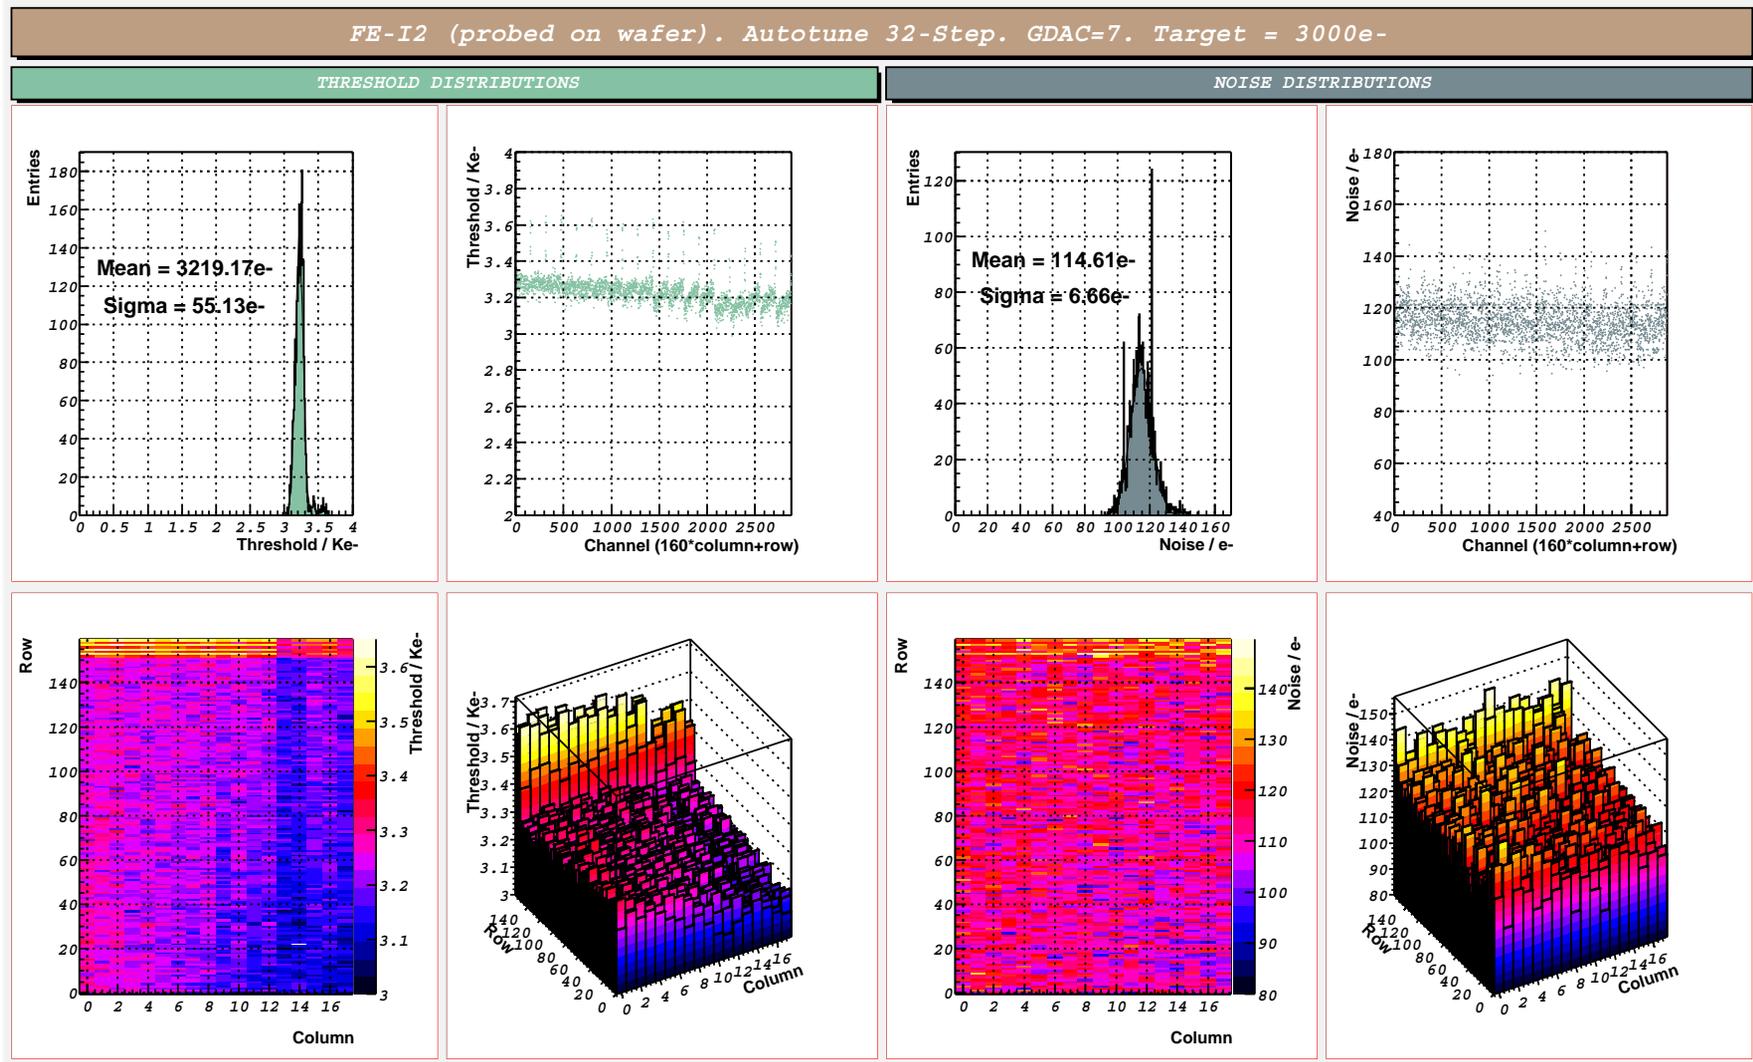
- Plots show results of a verification threshold scan. The tuned dispersion is only 55e, but there are systematics. Ganged and inter-ganged pixels have higher threshold (due to higher noise ?). Some pattern dependence plus non-Gaussian TDACs also

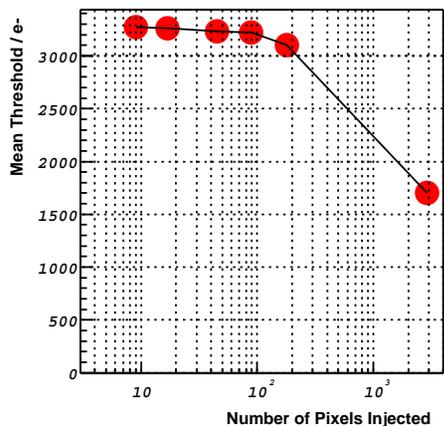
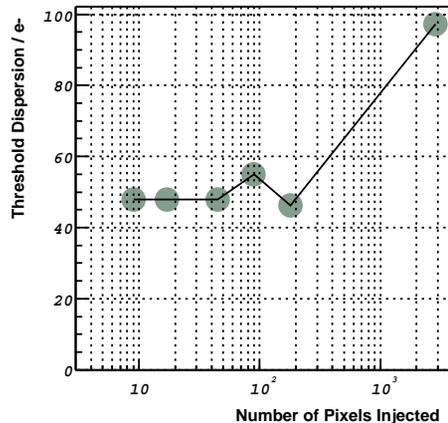
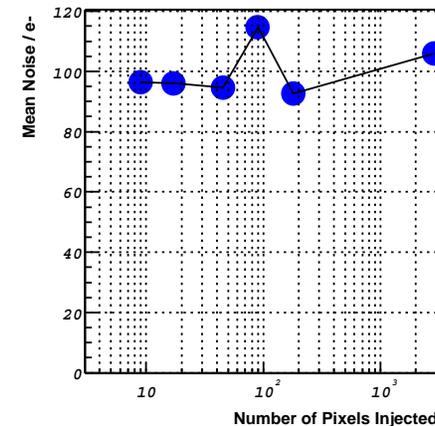
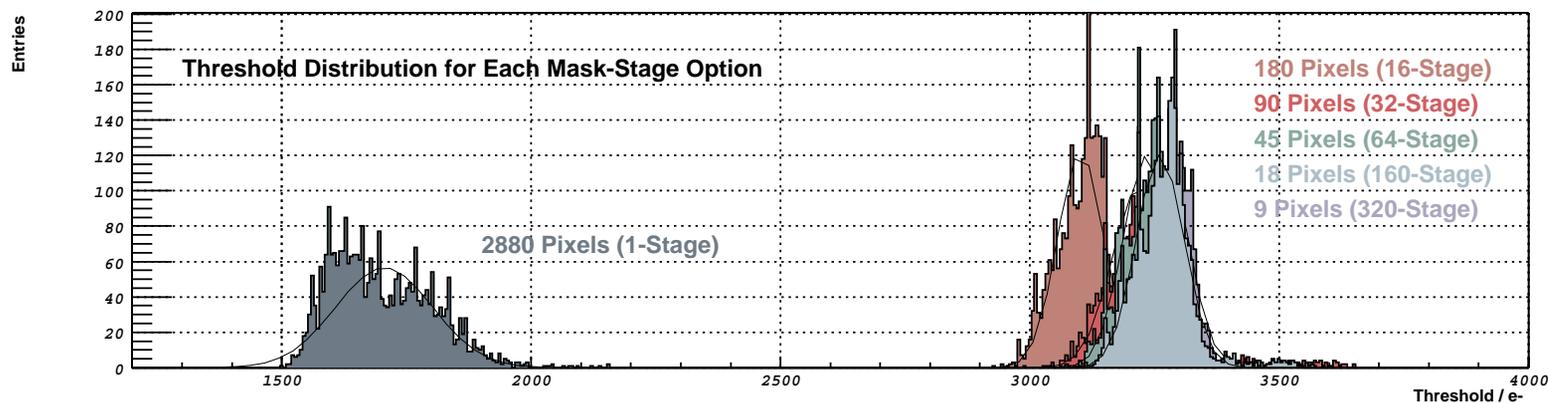
FE-I2 (probed on wafer). Autotune; Effect of Mask Stage Option. GDAC=7. Target = 3000e-

- Observe that 32_step scan is still OK, but 16_step scan shows systematic shift in target threshold (due to loading effects ?). Presently, 32_step scan takes about 30 seconds for a single chip. Suggests module will tune in about 1 minute.

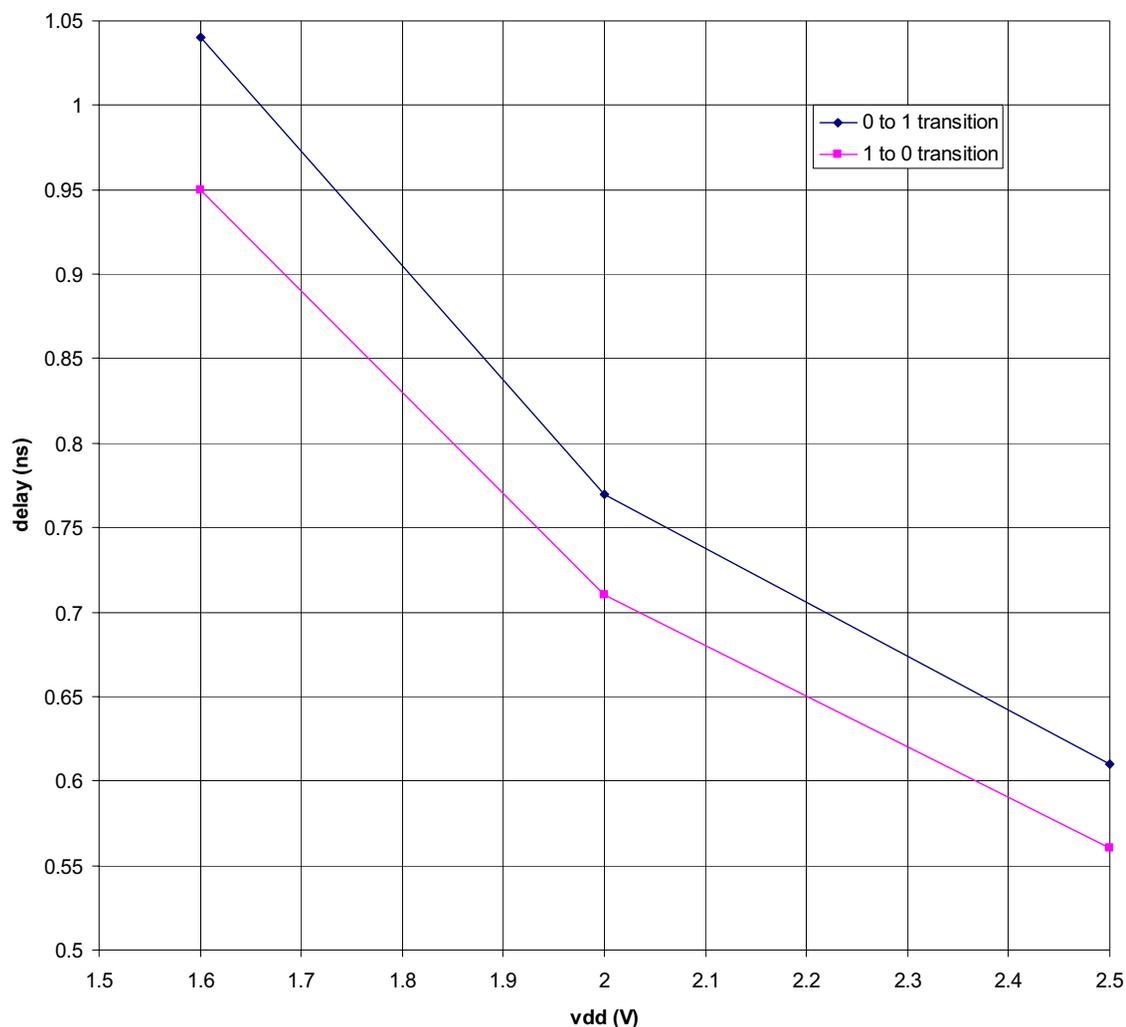
- The first analysis of a shift register made up of SEU-DFF shows very large timing margins, suggesting clock for bit n+1 needs to be later by almost 1ns:

- Do observe that 1->0 transition is faster, which will make the transfer of a one followed by a zero more marginal than the opposite case. This agrees with observations, but difference is not large, and can be compensated by $\Delta V=200\text{mV}$.
