A quick review of the 5 tests run and their findings

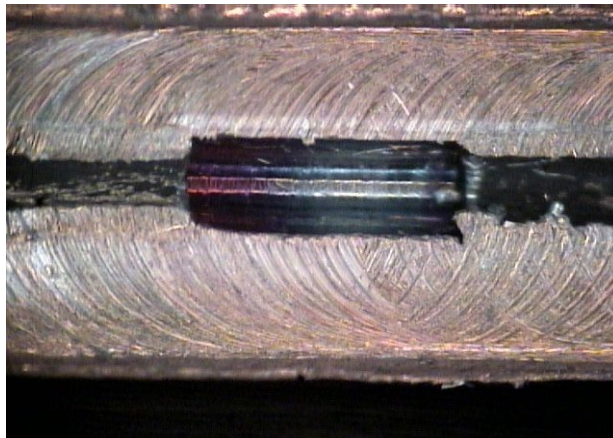
A .880" long .125" dia. Copper rod was bored thru with a .032" and then bored .041" in .400" from both ends leaving a .080" long center section. Short pieces of capillary tubing were, one at a time, placed in while in a vertical position. Hand-feeding common 60/40 flux core solder was used with a pencil iron heating the copper from the side. I had to add a little paste flux to get a good flow. After flycutting I observed what I thought might be blobs of solder in the cavity and flux intrusion into the capillary. See below.

What was learned was a soldering iron was awkward and somewhat ineffective. Paste flux not ideal tho the part did pass pressure/vac tests. Solder amount needs to be controlled.

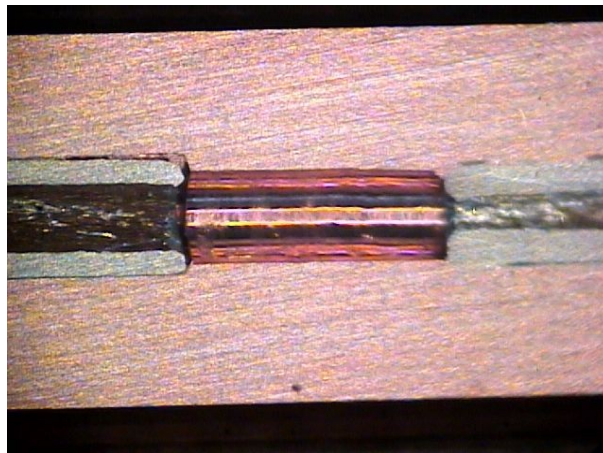
After wet sanding and acid etch, This is what could be seen. Note darkened cap. tube on the left (flux).

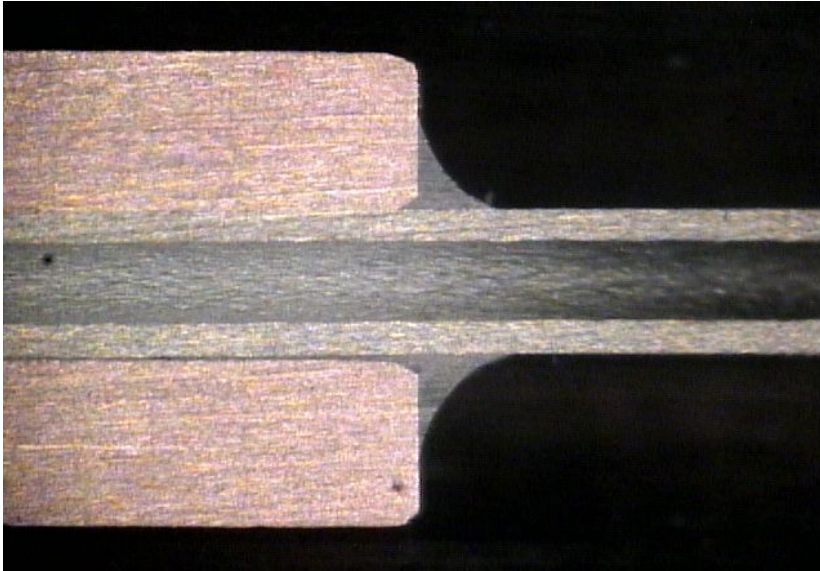
Note nice fillets

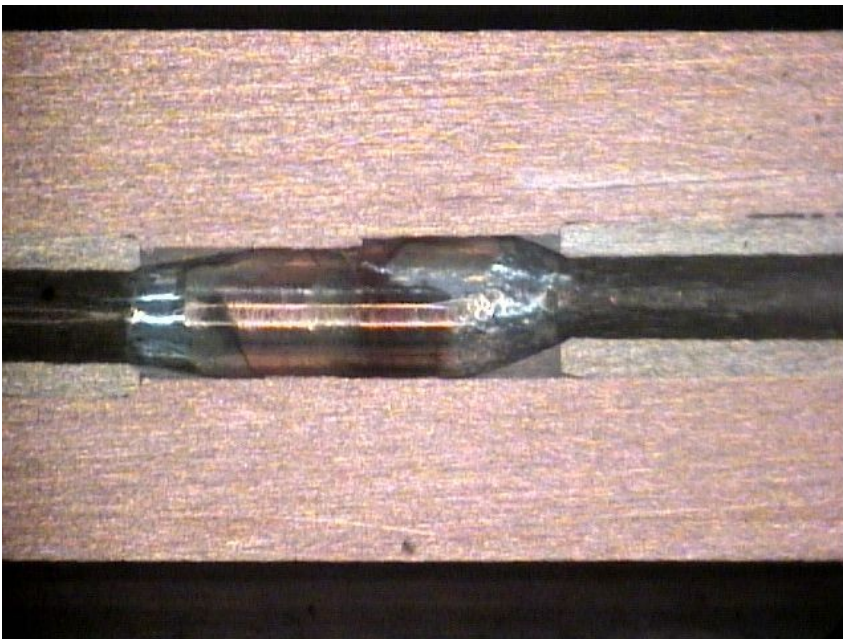
Bore misalignment and aggressive and excessive solder flow, flux intrusion.

Lessons learned, Limit solder to exact amount needed, exact precision at all steps of sleeve manufacture, Address flux intrusion, heat control.

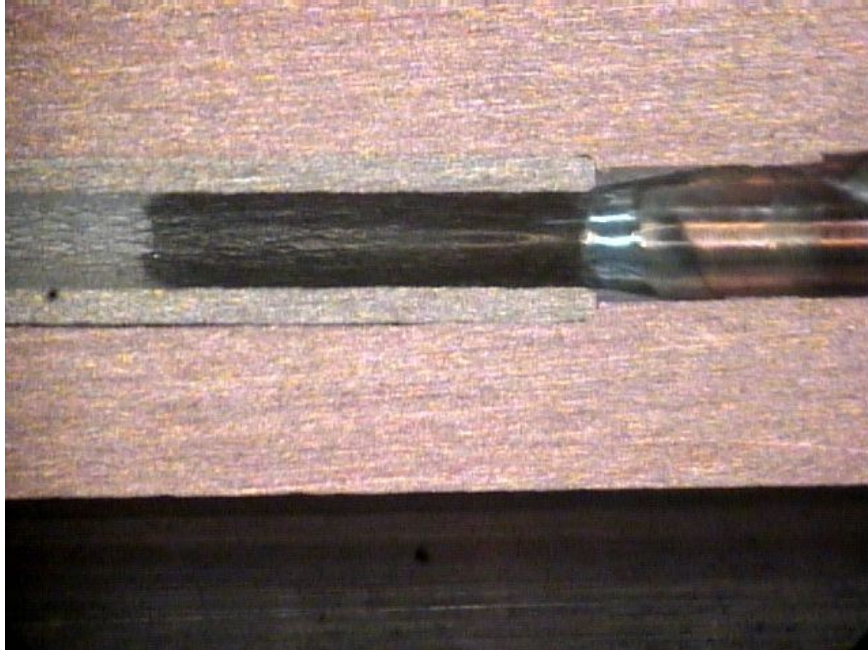
Darkened area is hardened flux

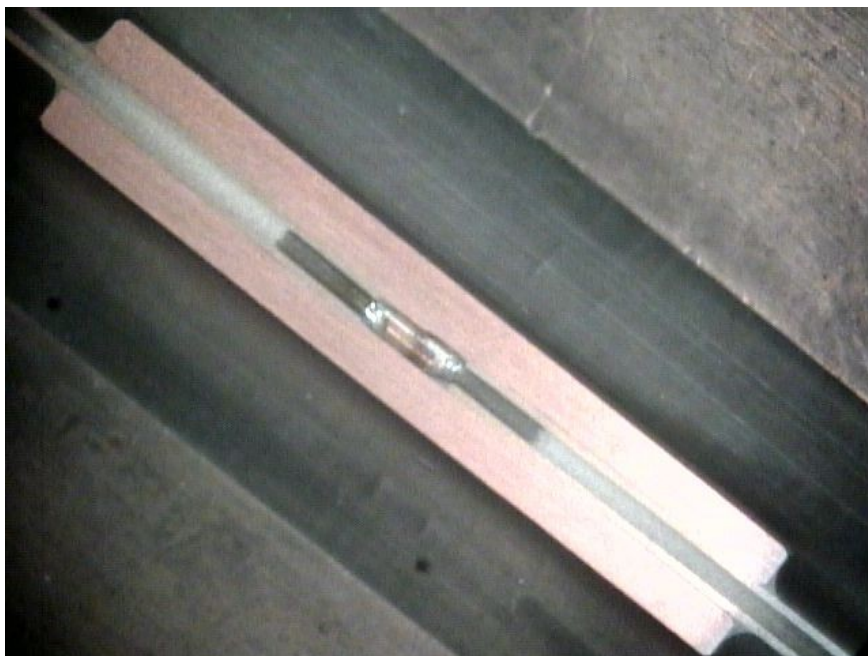
Overall view, again note dark flux intrusion areas

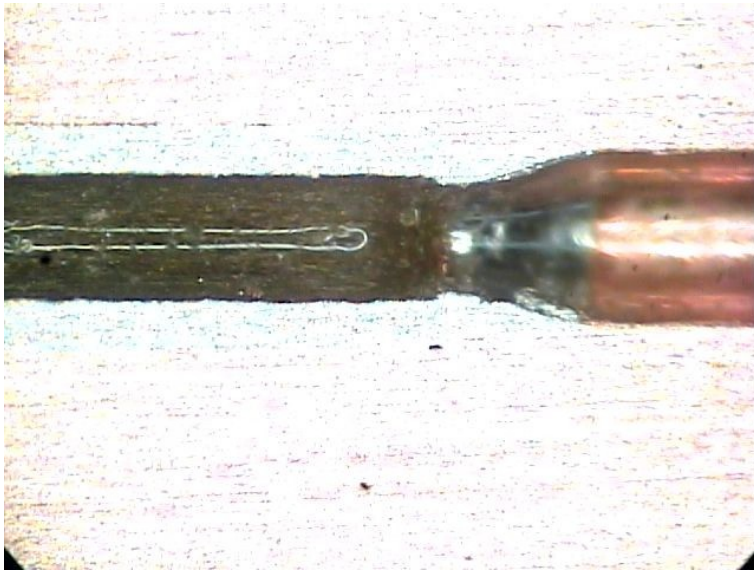
Hardened flux dam (dark area at center)

Lessons learned, Still too much solder, too much or wrong flux

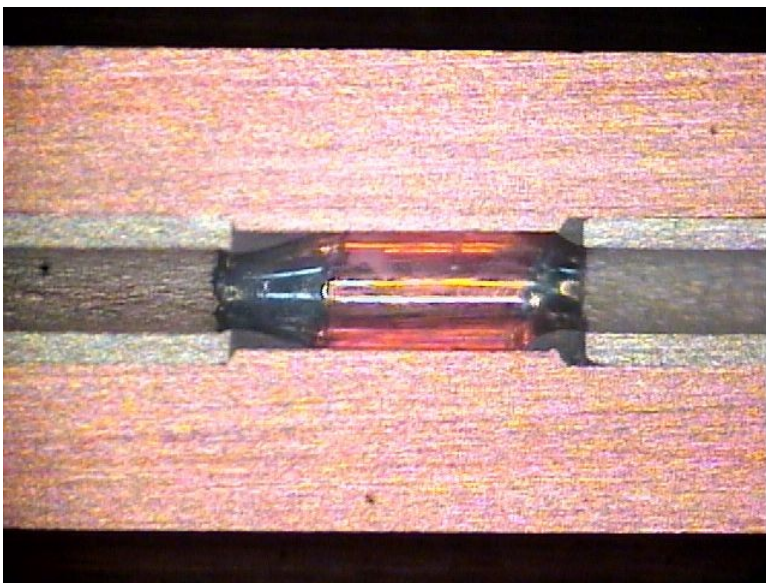
After cleaning with flux solvent

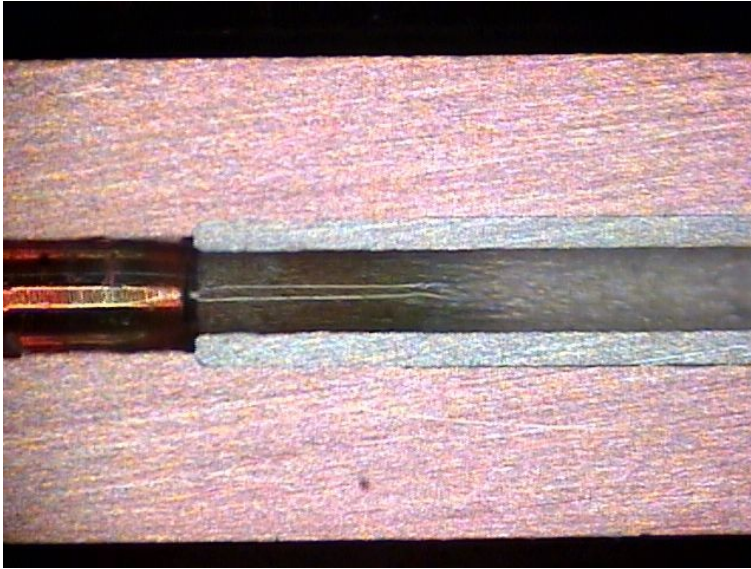
Again the same setup but used $\frac{1}{4}$ wrap solder and just a light swipe with a toothpick tip soaked in flux
Solder under control but still flux inside the cap. tube.

Lesson....The liquid flux is working too well, is too invasive, I think it has to go. Solder amount may now be too little.

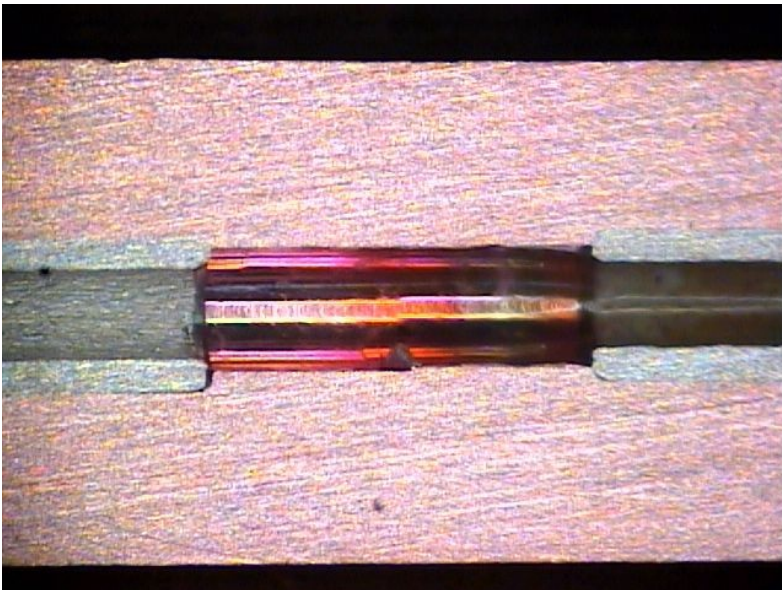
...but only one one side

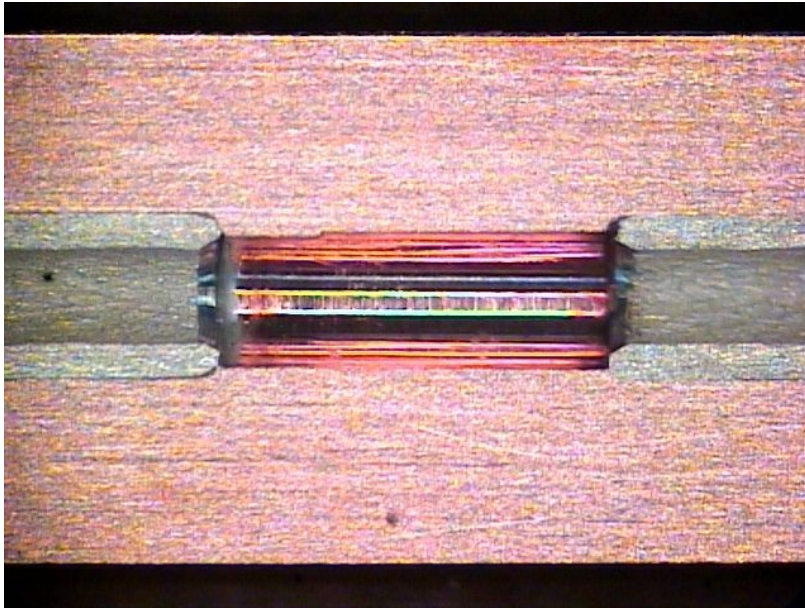
No flux intrusion, a little solder showing on the left

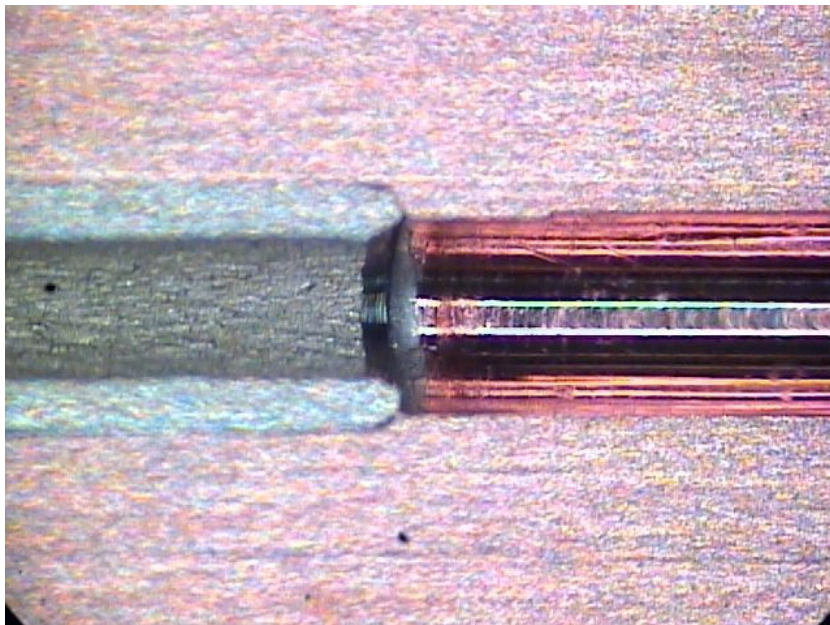
close-up of left side

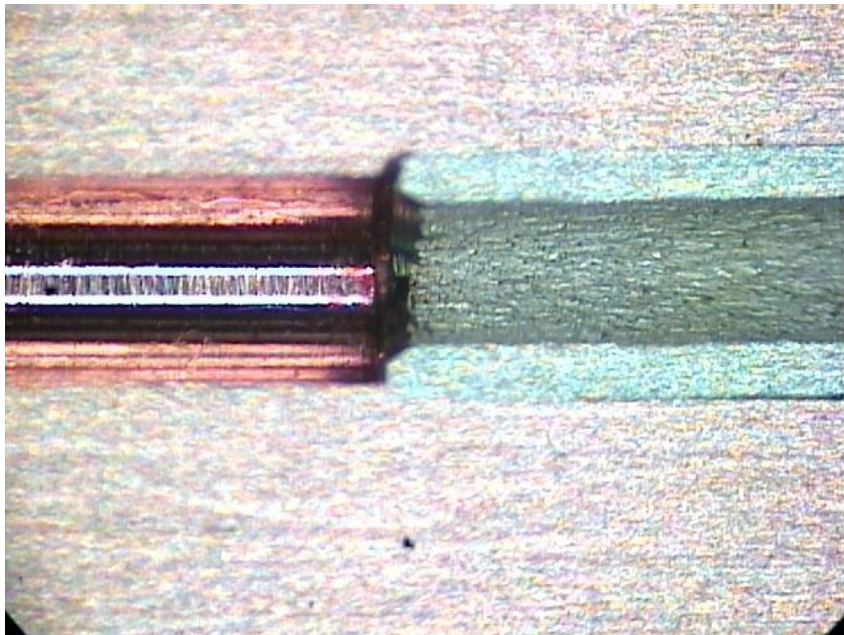
Right side. No solder showing but good fill along length

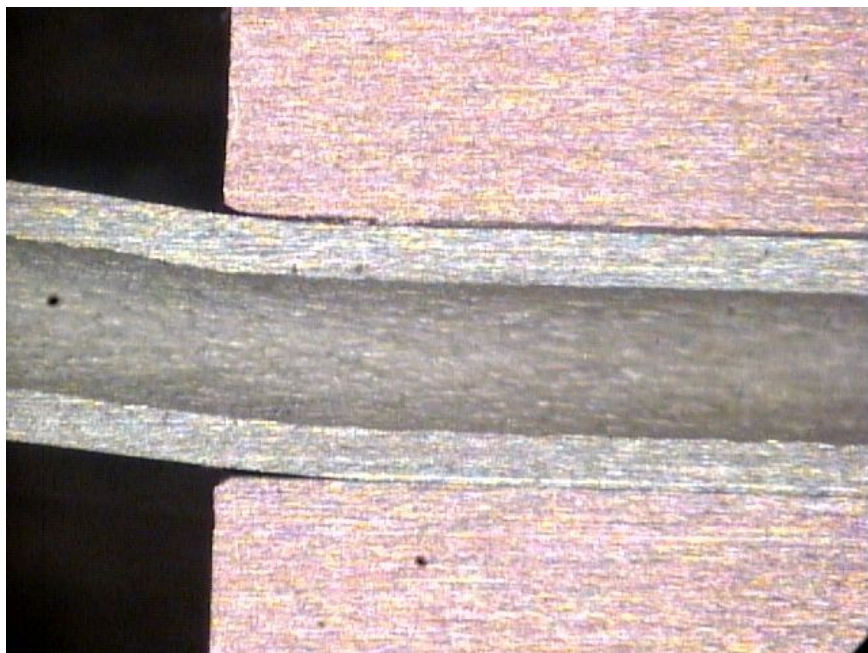
No fillet, but still good fill along length

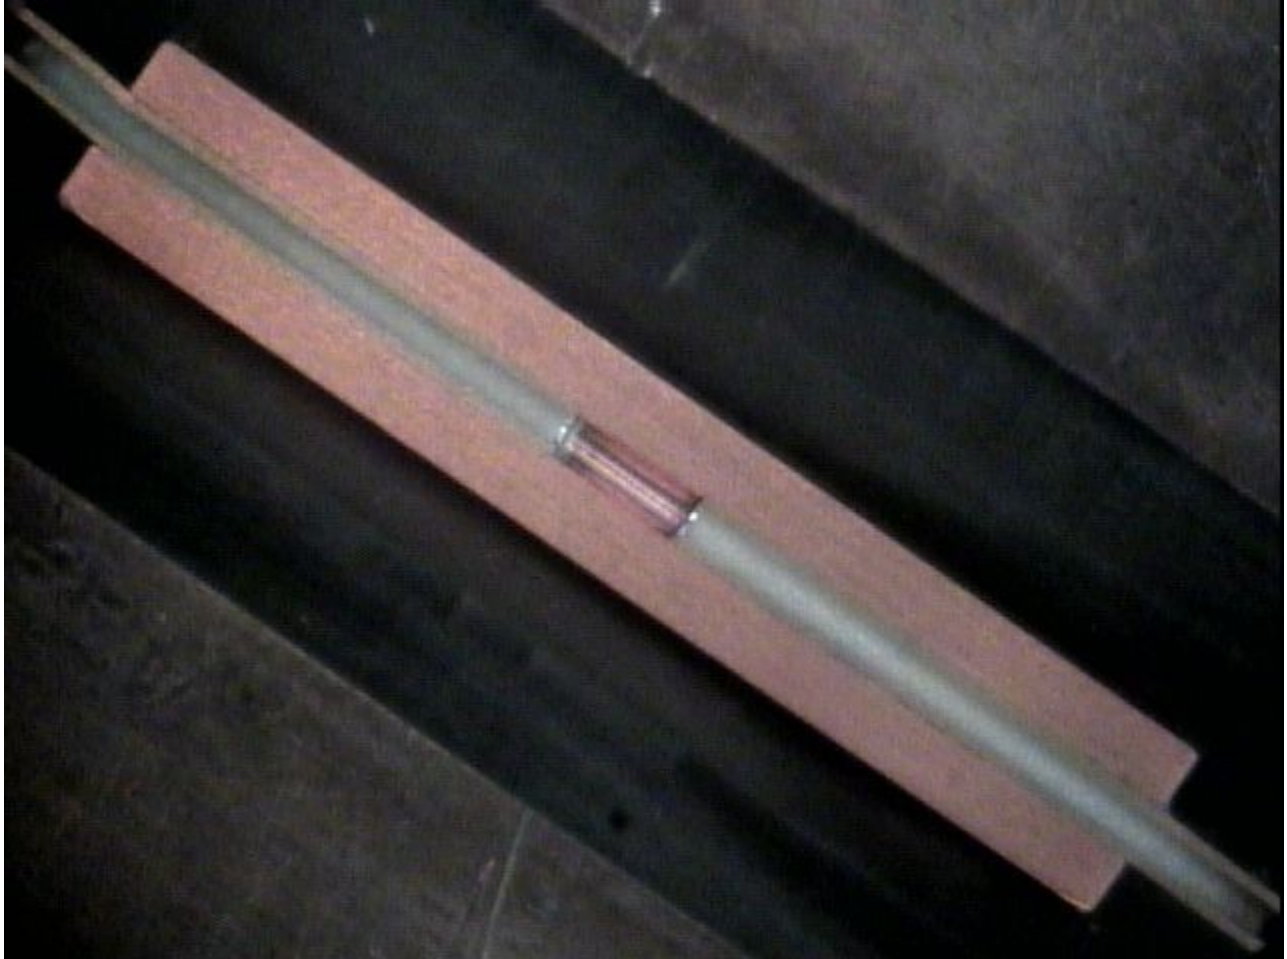
Overall shot

The last 4 tests were not pressure/vac checked as I was addressing the flux and solder amount problems but I believe they would be tight. More complete tests will be run when a proper solder/flux combination is settled on. I will also try a different heating setup using a small butane-catalytic heat gun.
