X-Ray of M2

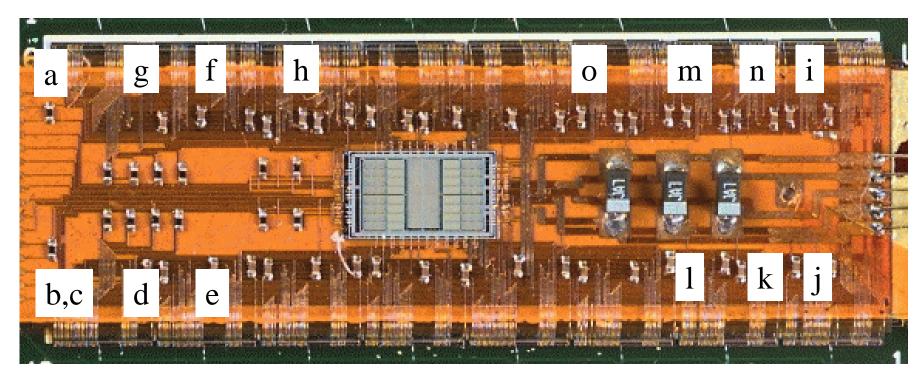
- ICs disconnected last four on both ends. All chips operated OK initial. Later failure.
- Supposition is CTE mismatch from gluing to Al support plate, followed by creep from sufficient shear forces to finally cause joints to break near ends.
- Photos clearly show greater displacement near ends.
