FE-D Digital Readout Testing and Next Steps

*K. Einsweiler and J. Richardson, LBNL
M. Ackers and M. Keil, Bonn*

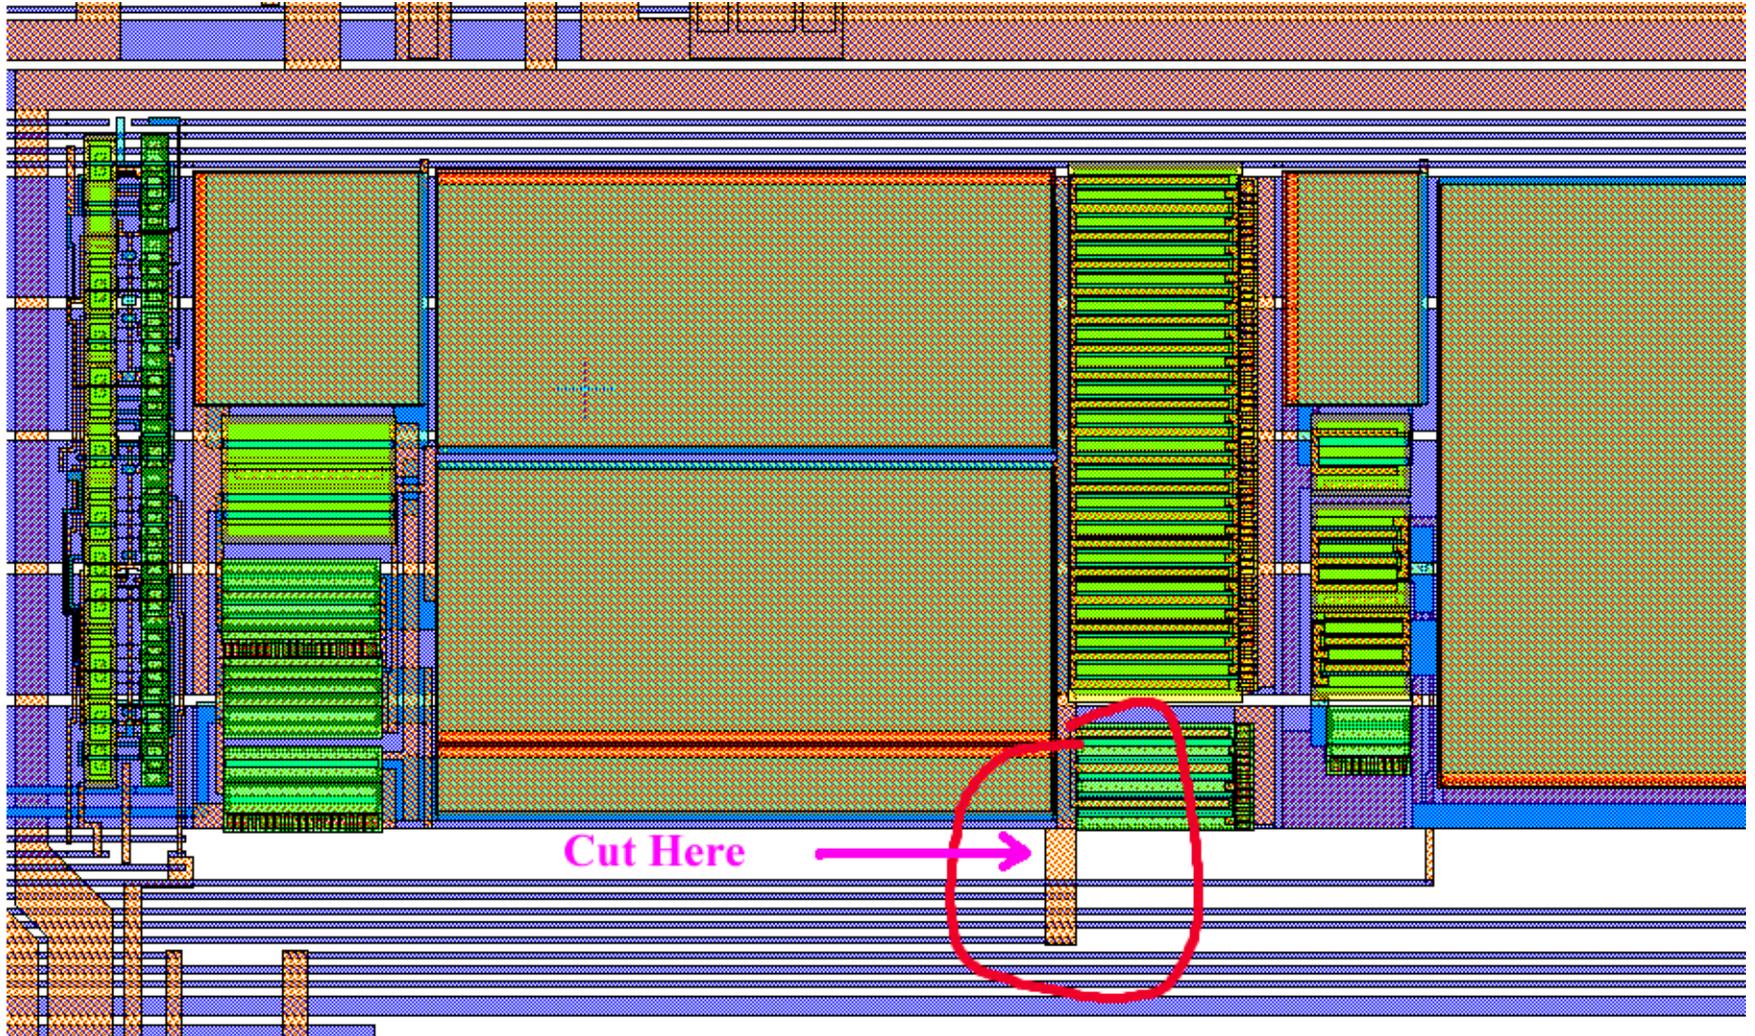
- Decided to completely dice the lower half of wafer #7, and to perform FIB modification on 15 die with 9 good column pairs in Pixel Register test in order to allow external supply of VTH for front-ends.

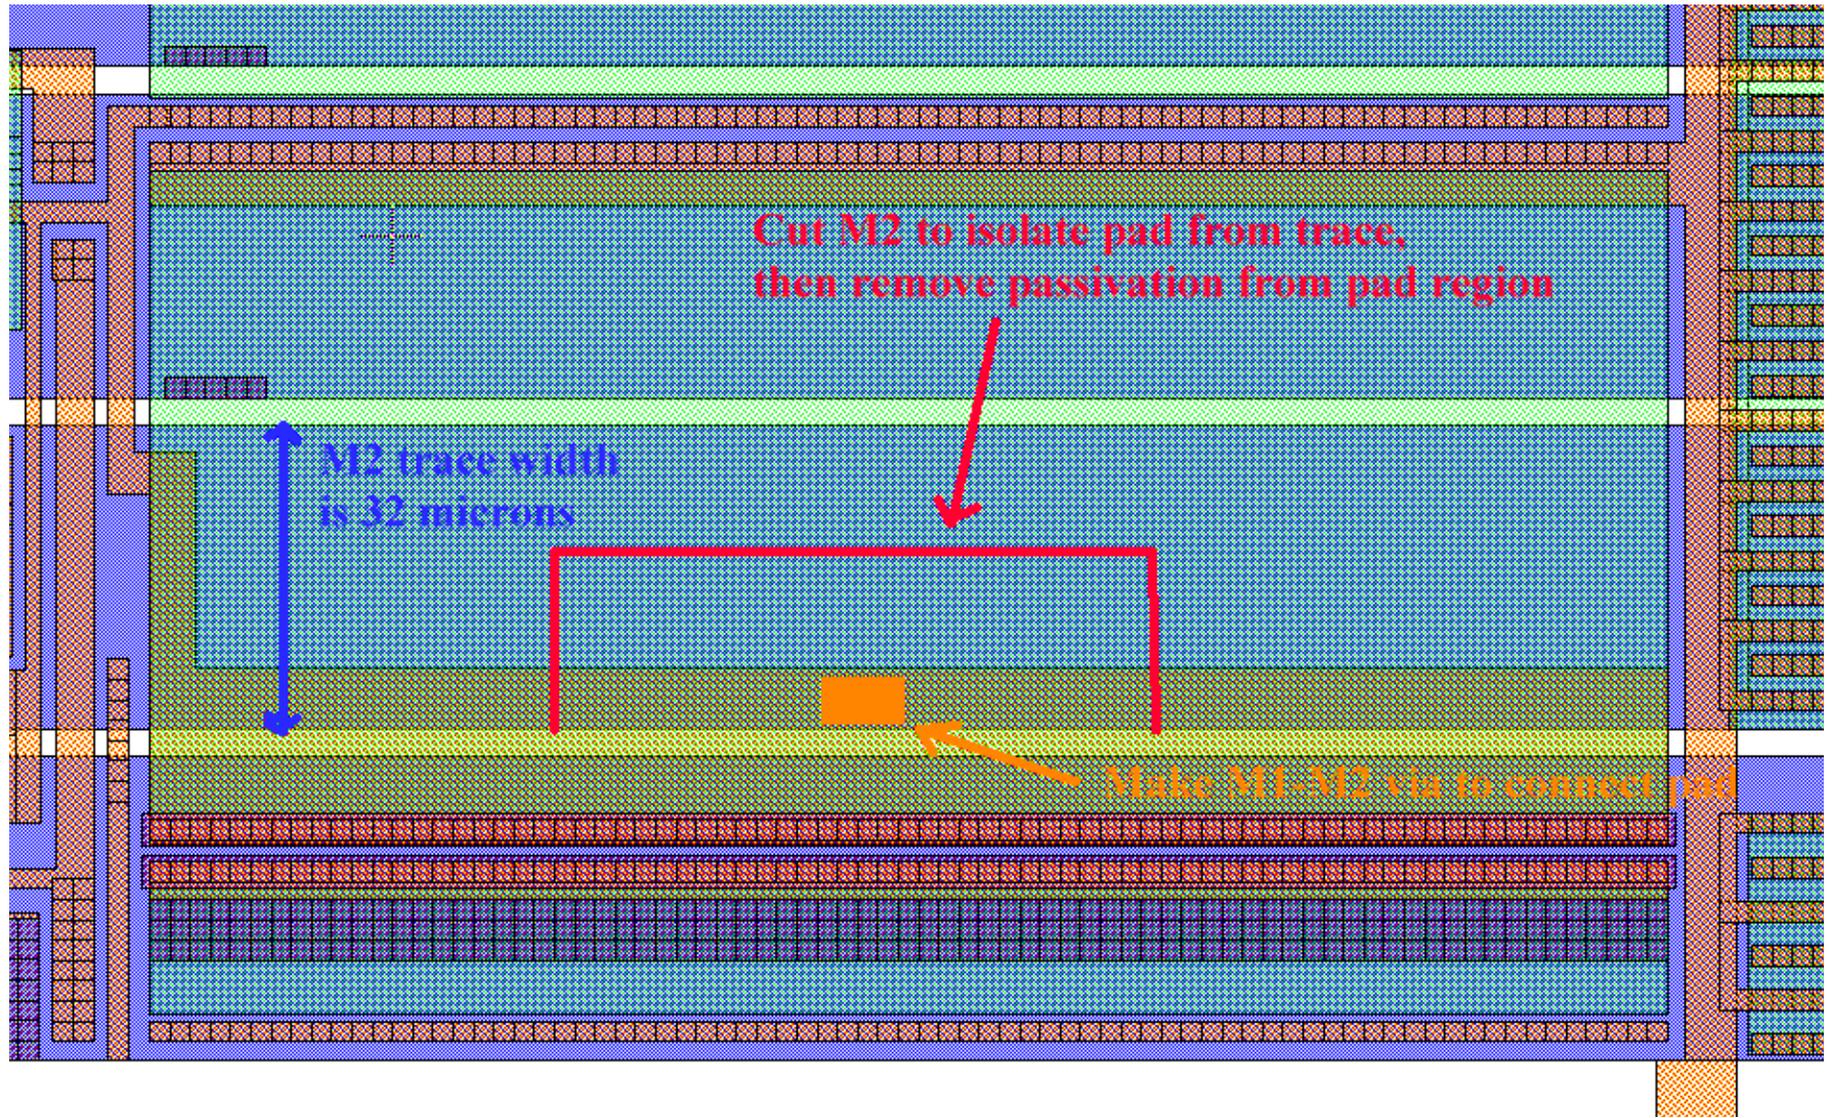
- In order to evaluate further the present hypothesis about the fabrication fault, one die was modified to create a small pad for probing the gate of the output transistor of the VTH amplifier:

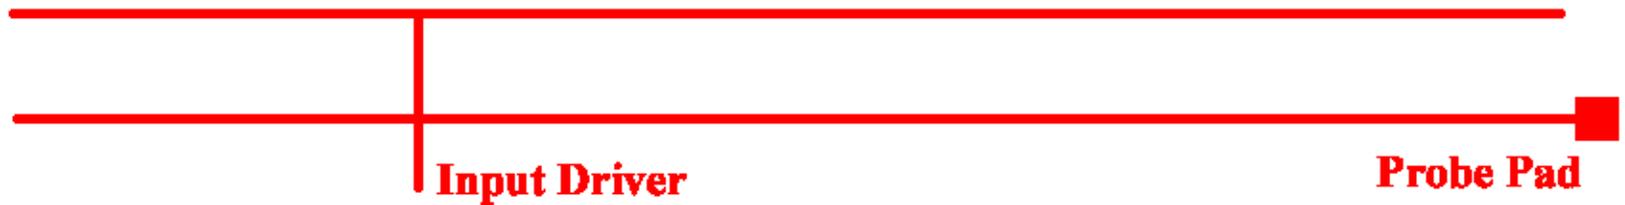
XCK Bus Topology:

- Beyond the VDD problem and the low yield, the next major issue is the XCK distribution problem. Clearly, the quality of the internal XCK signal is not great. However, it would be surprising if, even with the poor risetime observed on the probe pad, either the VDD problem or low yield could be explained by this.

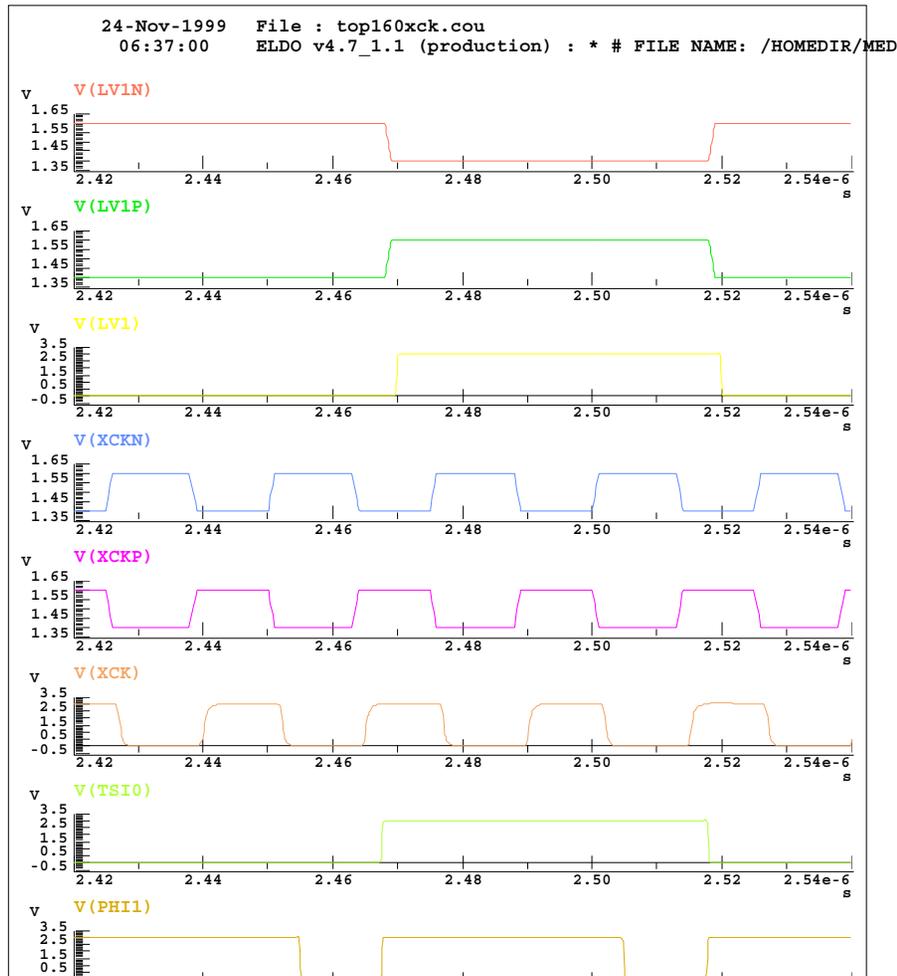
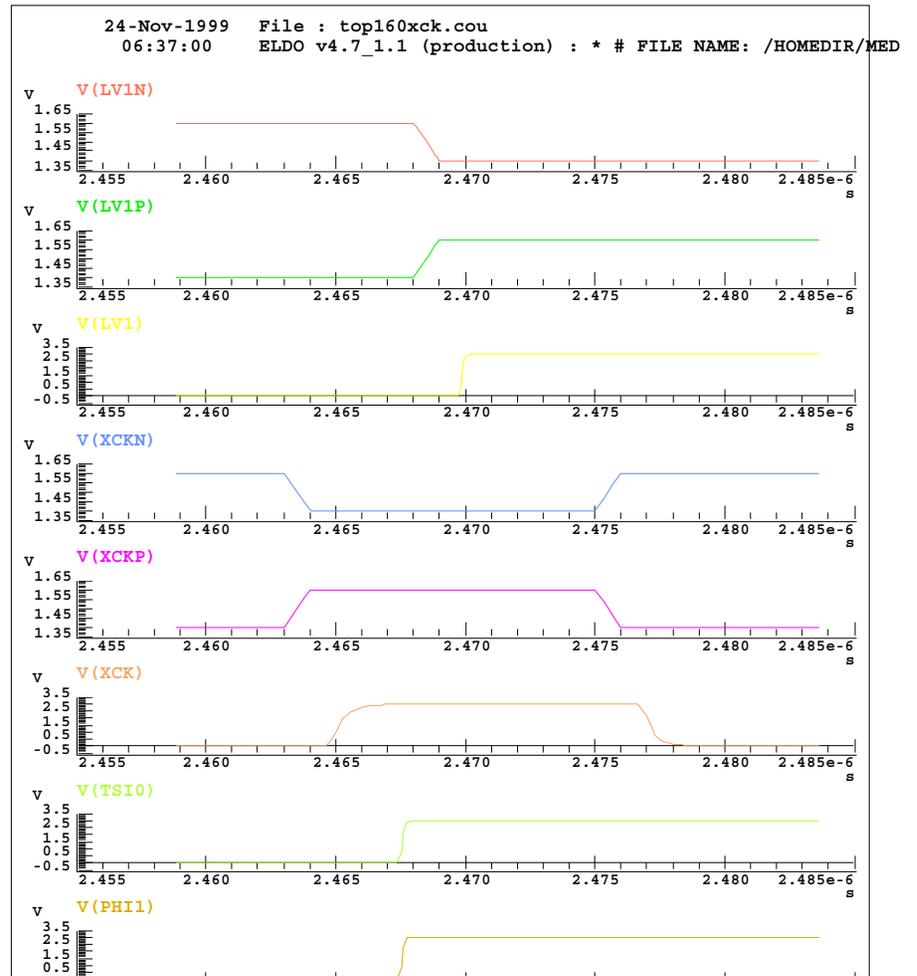
- Previous digital readout simulations were extracted from schematics and did not include pad frame or interconnect parasitics.
- First step towards improvement: include pads for XCK/LV1/SYNC in basic column-pair + bottom-digital simulation. No significant degradation seen:

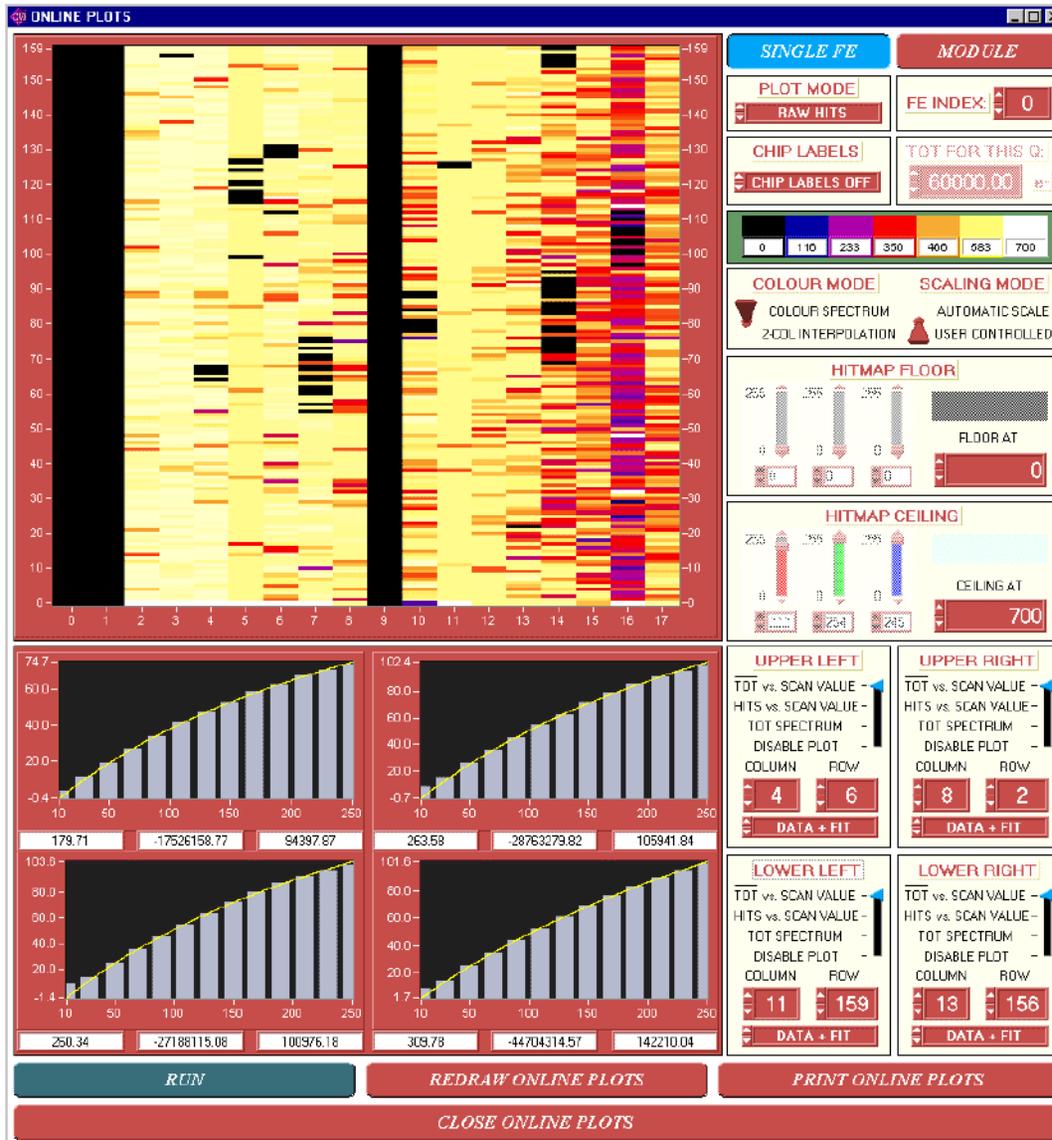
- TOT response curve is quite nice at high VCCD.
- Units are DAC counts for internal chopper DAC.

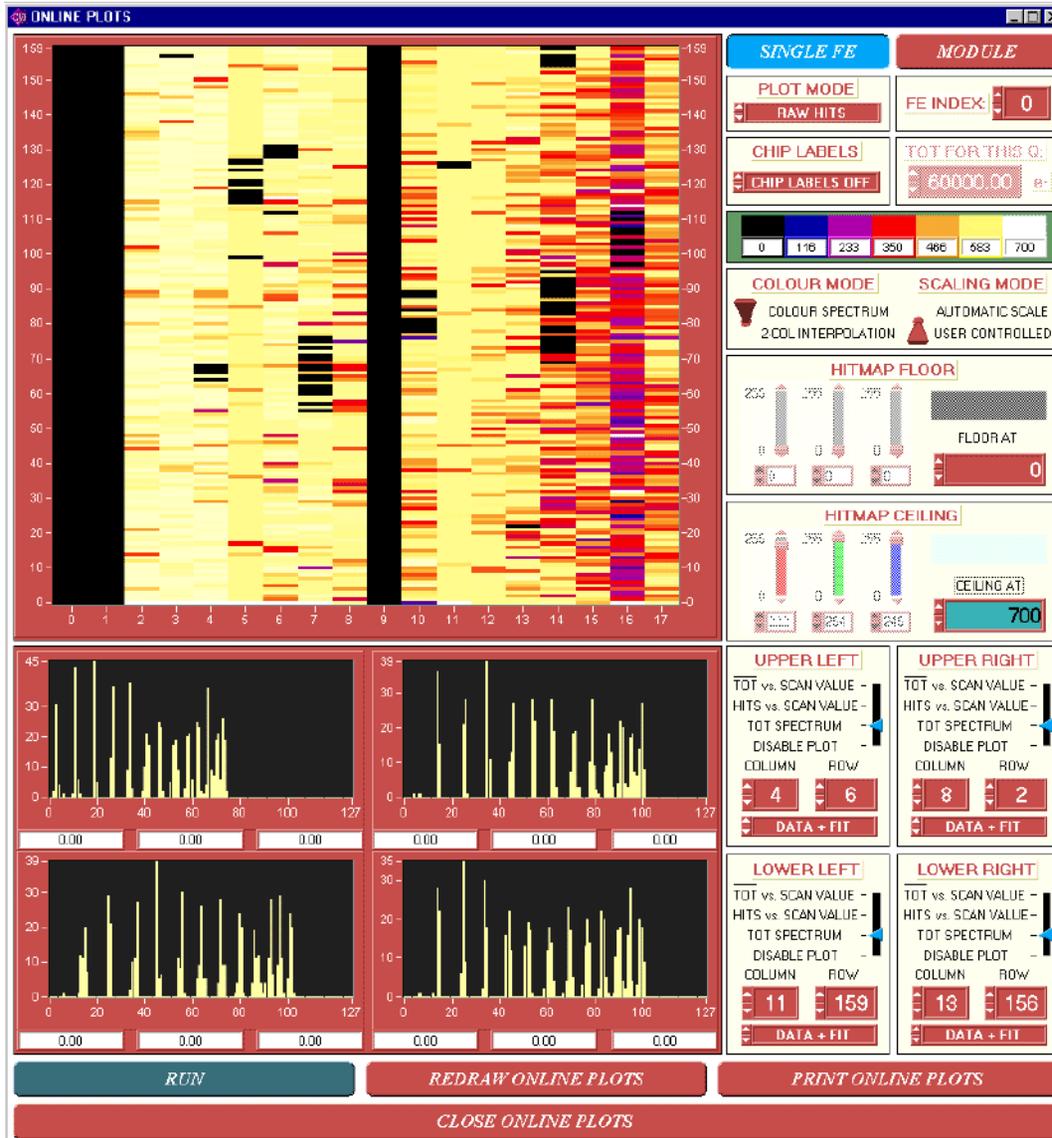
- Spectra for individual channels show a good charge measurement:

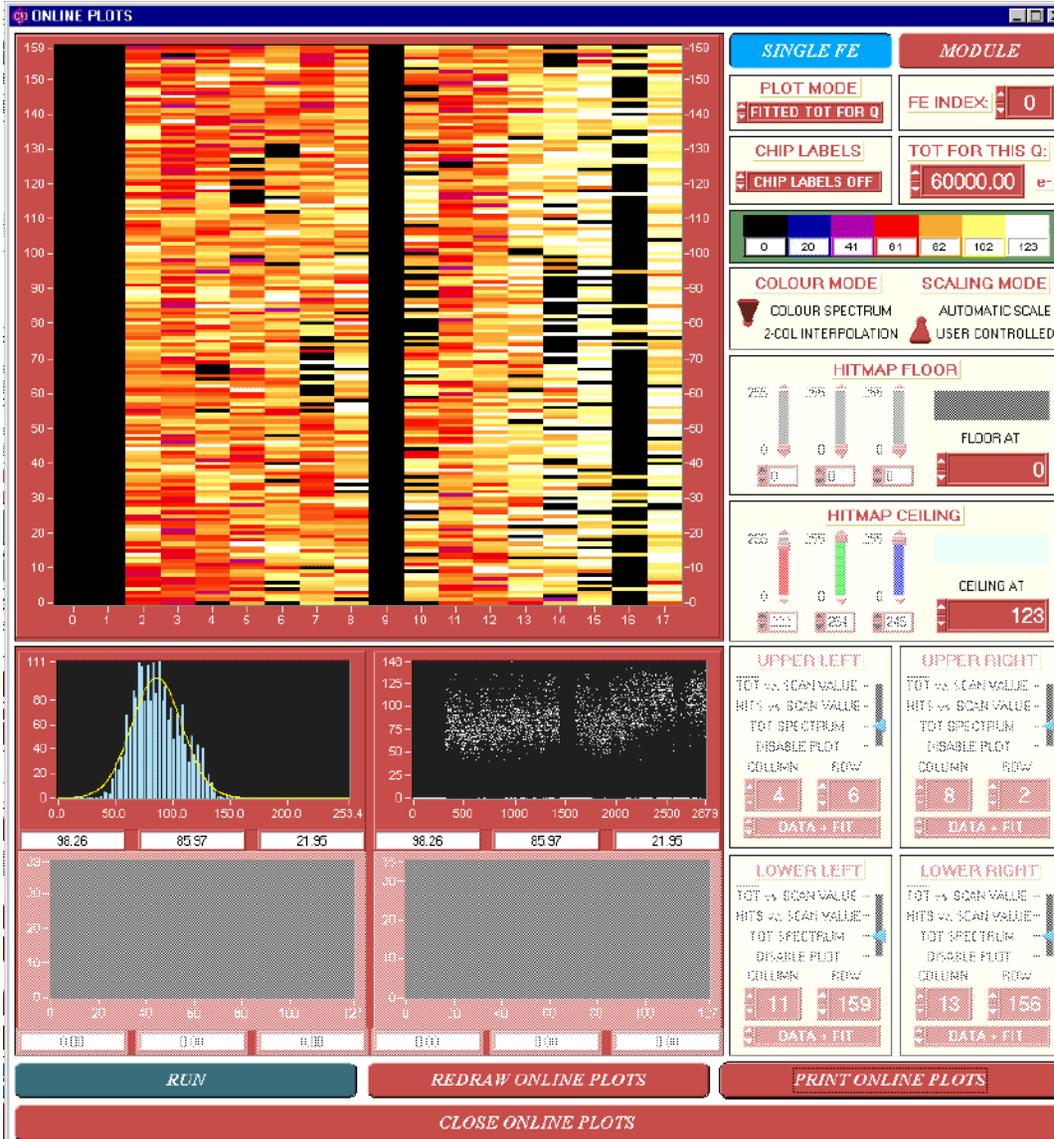
- TOT dispersion over the whole chip is also reasonable:

- Mean TOT for 60Ke (extracted from extrapolation of fit) is 86 counts.
- The dispersion on this value is 22 counts over the working parts of the chip.
- This value does not show any particular structure over the chip.
