Summary of FE-I2 Measurements

K. Einsweiler, LBNL

Fault Diagnosis for FE-I2

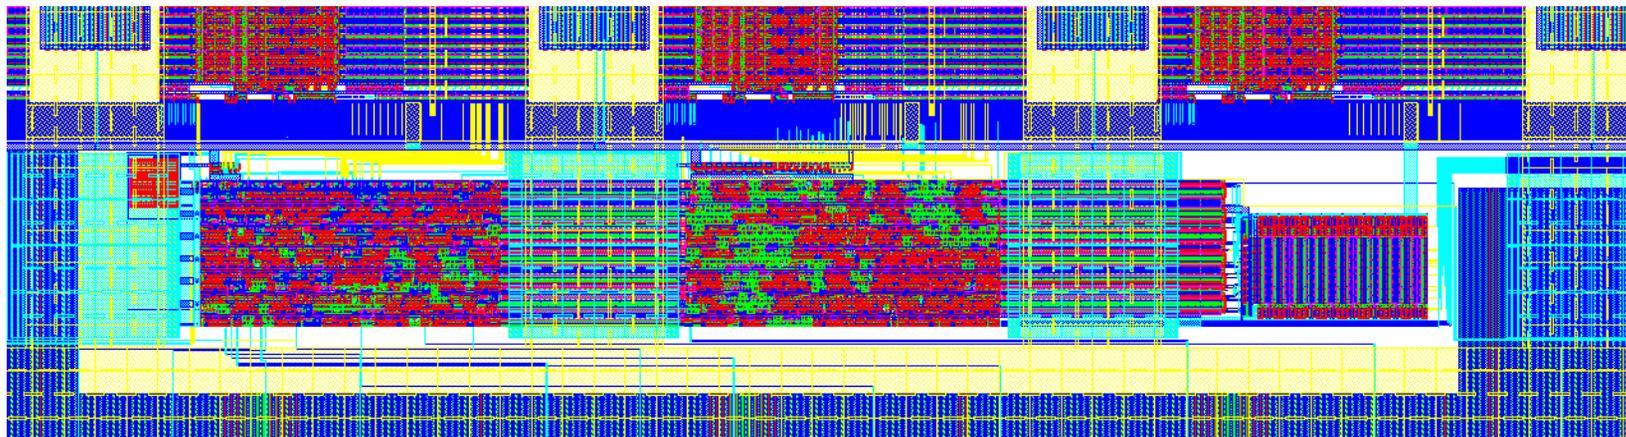
In FE-I1, there are two regions of place and route circuitry, and a third region containin the trigger FIFO and its control logic.

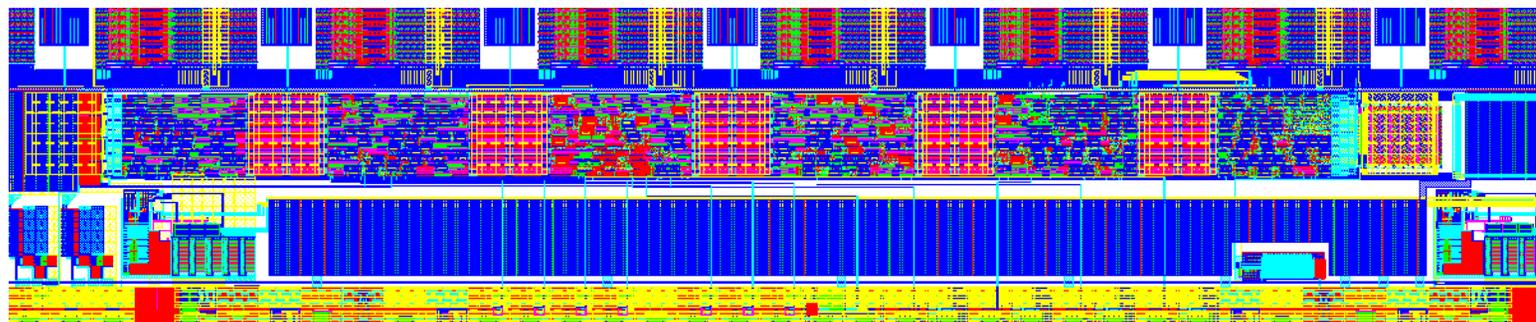
In FE-I2, there are six regions of place and route circuitry, plus the trigger FIFO. This results in spreading circuit blocks across the regions shown here.

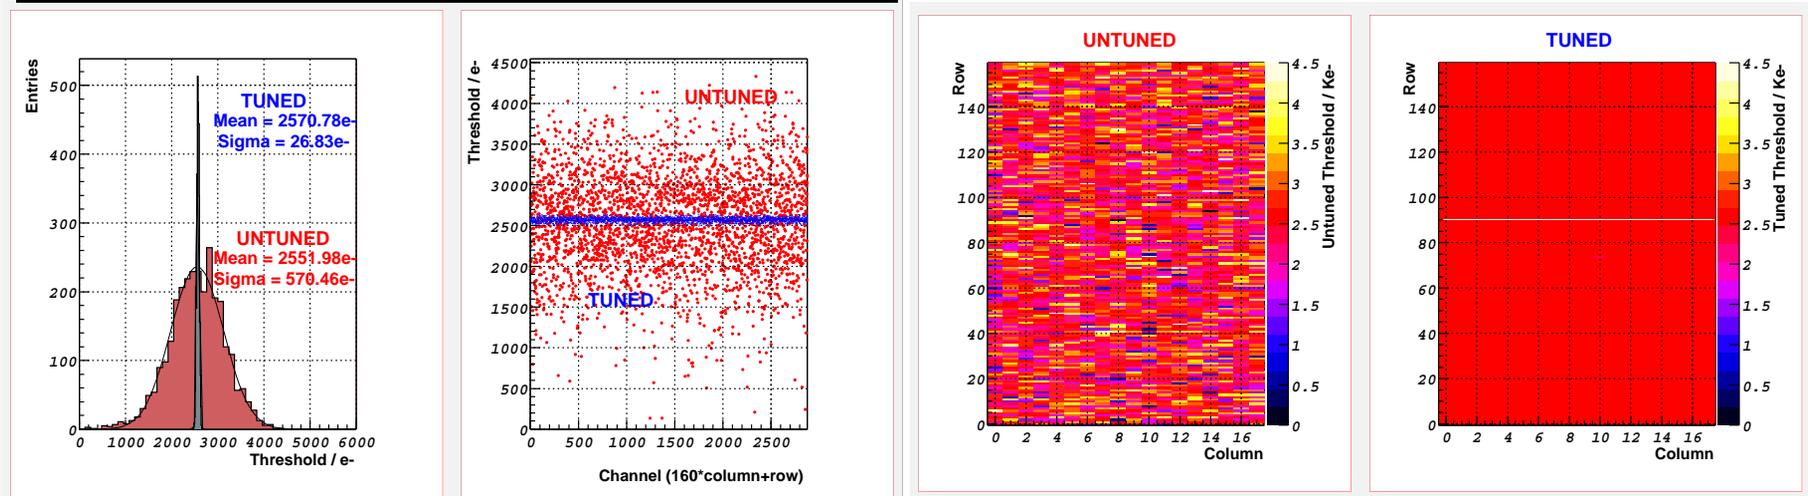
FE-I2 (probed on wafer). Draconian TDAC Tune (every point scanned)

- Initial dispersion is about 600e for TDAC=64 (compared to 900e for FE-I1B), which is roughly the expected improvement due to improved transistor matching.
- After tuning, it is possible to achieve 26e dispersion on threshold. Simpler scans with about 9 points and interpolation achieve 50e dispersions.
- Note that top pixels appear noisier without sensor due to their higher IP current which makes them faster for a given load.

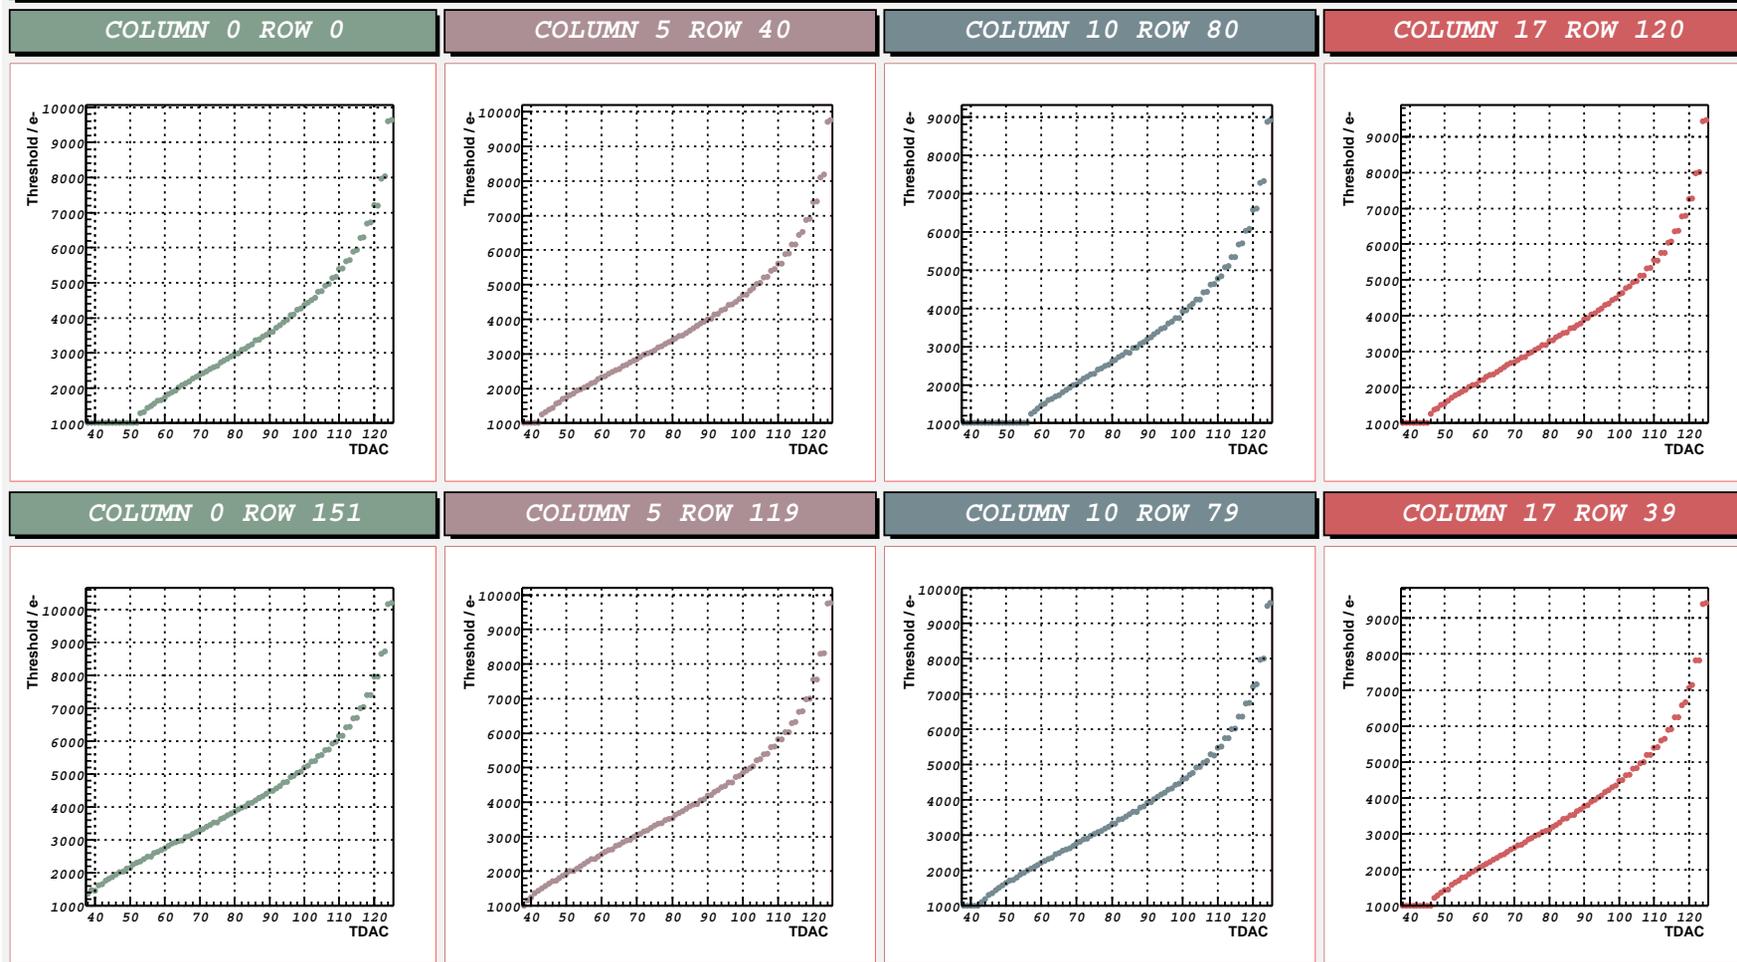
FE-I2 (probed on wafer). Examples of Threshold versus TDAC at GDAC=7

- It is clear that the new TDAC design is very linear over a large range close to the center of the scale.

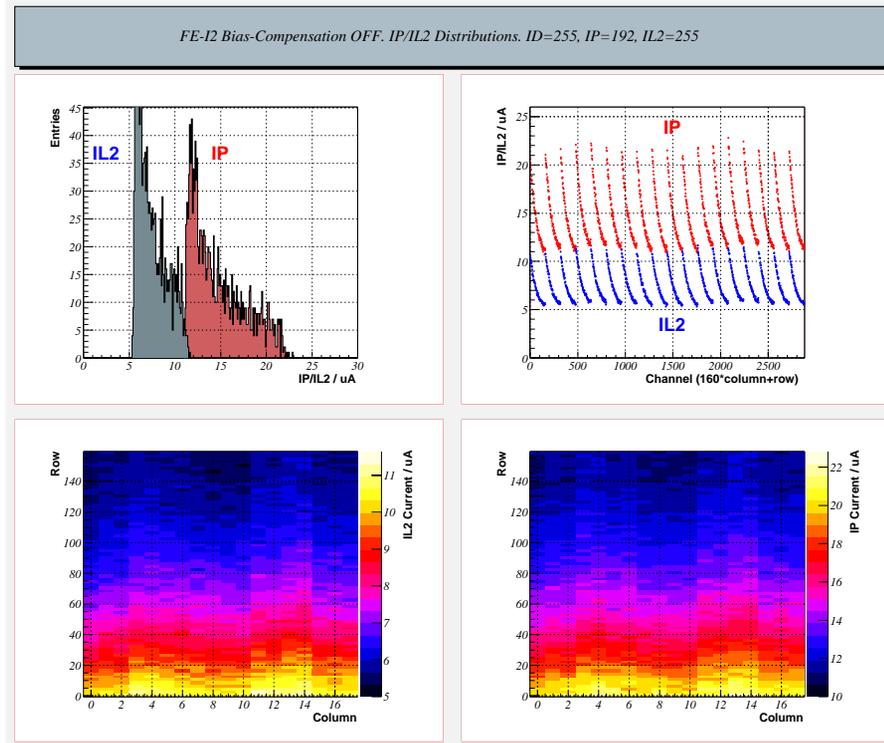
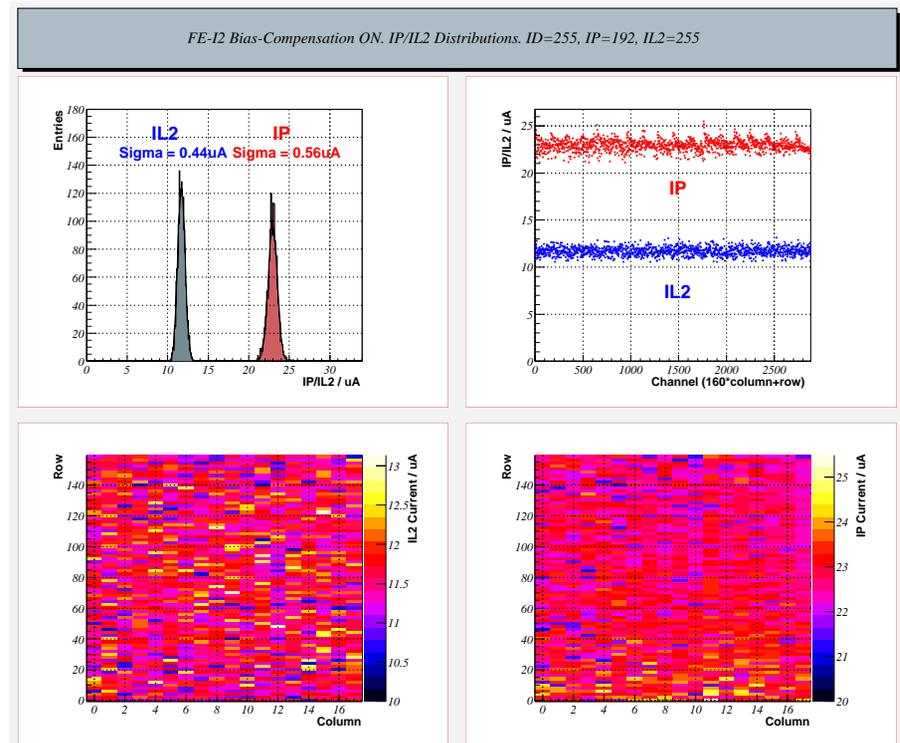
- In FE-I1, there were significant internal voltage drops on analog supply busses, particularly AGnd. This is turn caused row-dependence in the bias currents which were referenced to AGnd, principally IP and IL2.
- In FE_I2 there is one bias compensation circuit per pixel. Odd pixels compensate IP, even pixels compensate IL2. The local bias current is shared by two pixels.
- Left plots shows large systematic variations in IP and IL2 when circuit is turned off (note IP and IL2 currents set to very large values to enhance drops). Right plots show compensation eliminating systematic effects. IP = $24 \mu A$ and IL2 = $12 \mu A$.

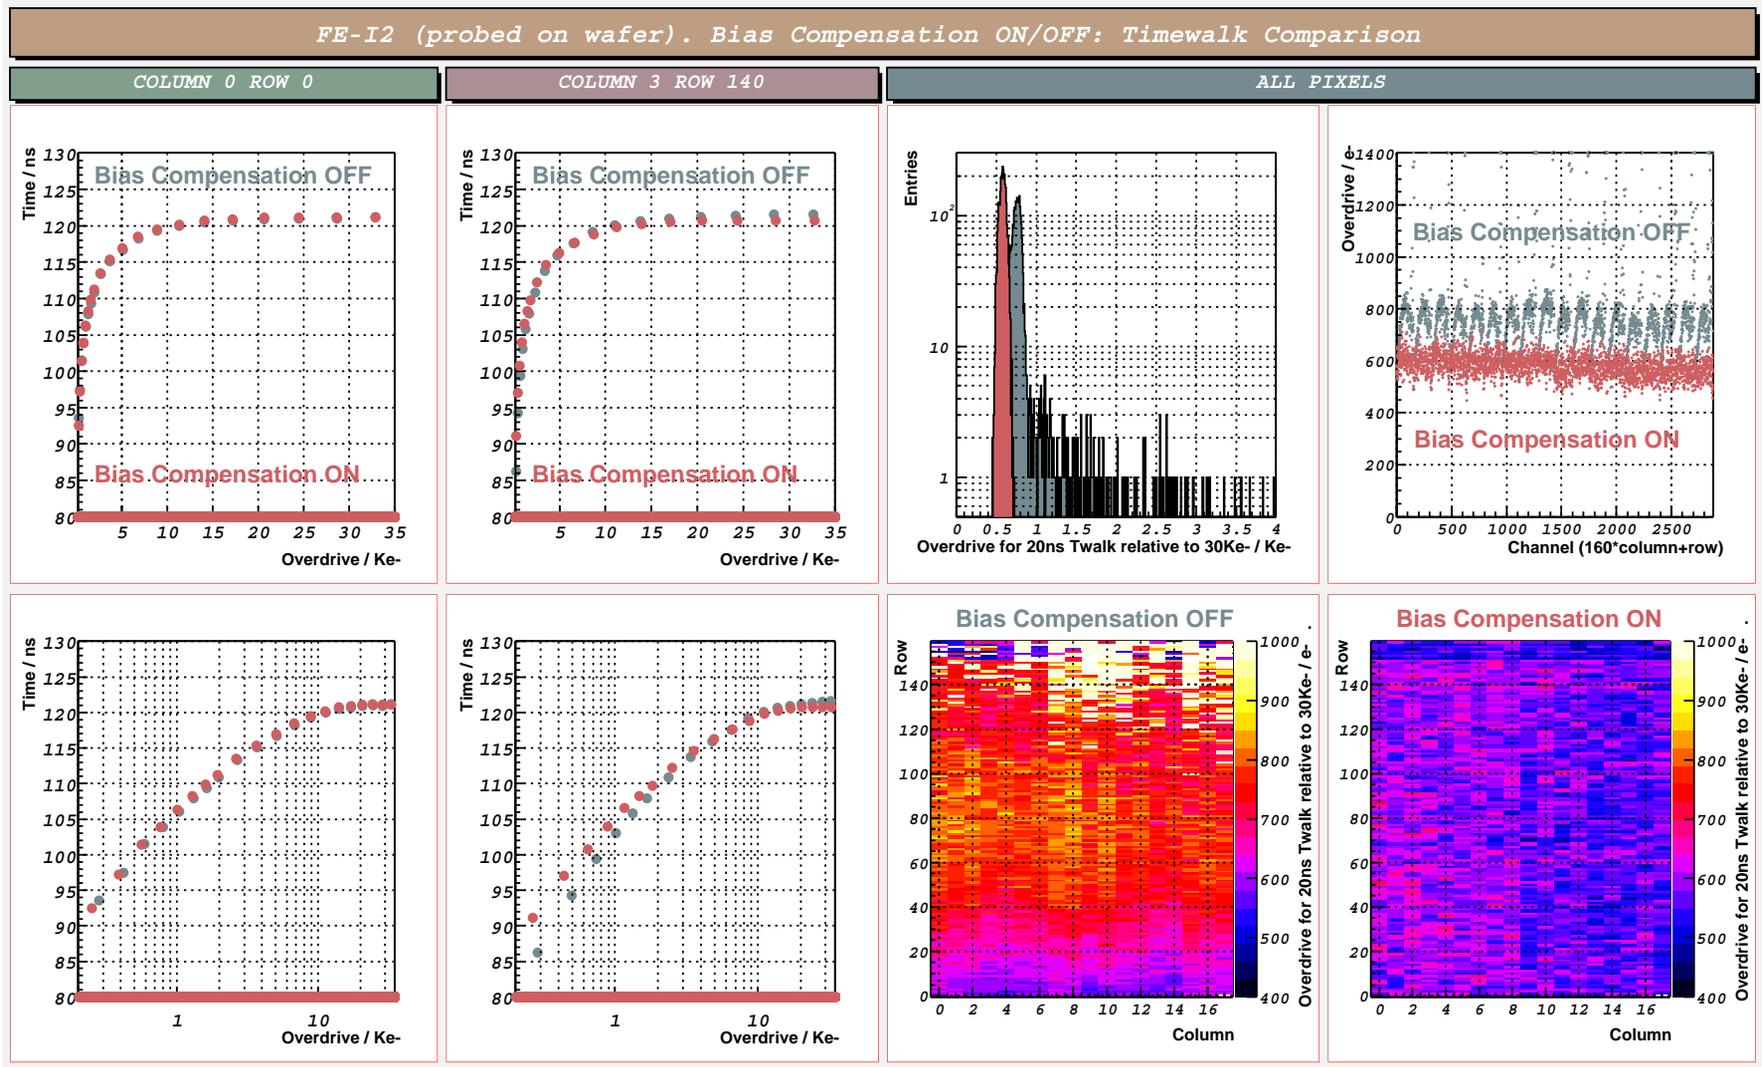
Timewalk measurements with/without biascomp:

- Timewalk variations without sensor are small. However, can see the degradation in timewalk performance visible for high row numbers without compensation disappears when compensation is on, making all channels behave identically.

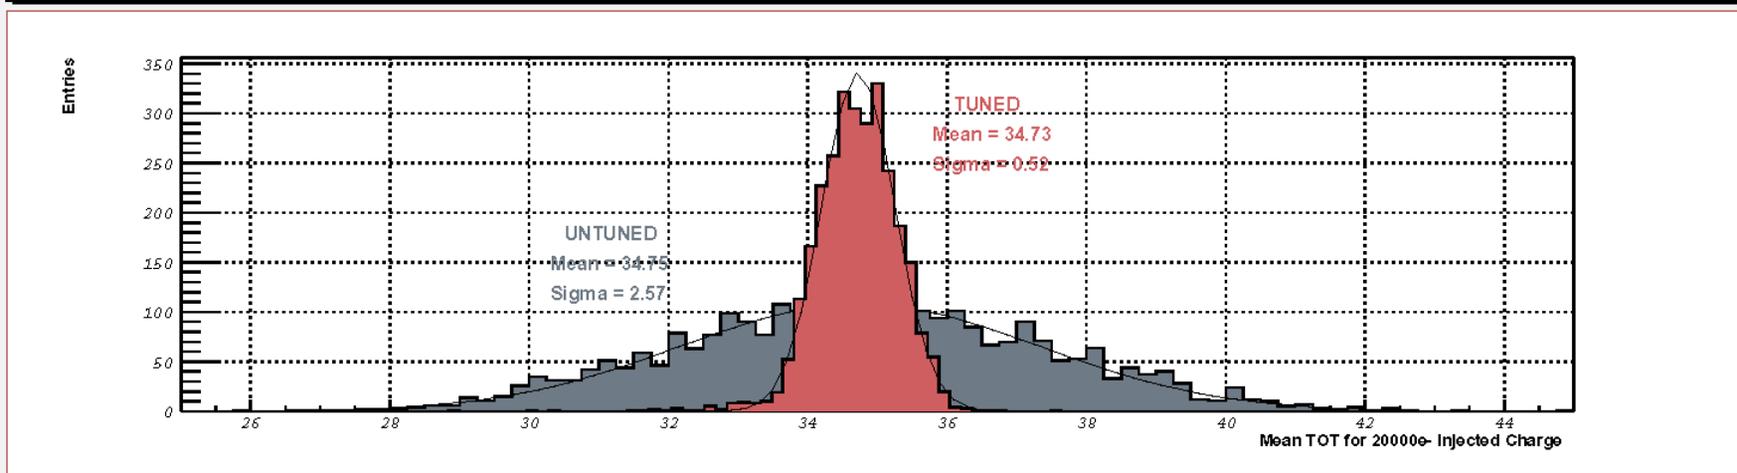
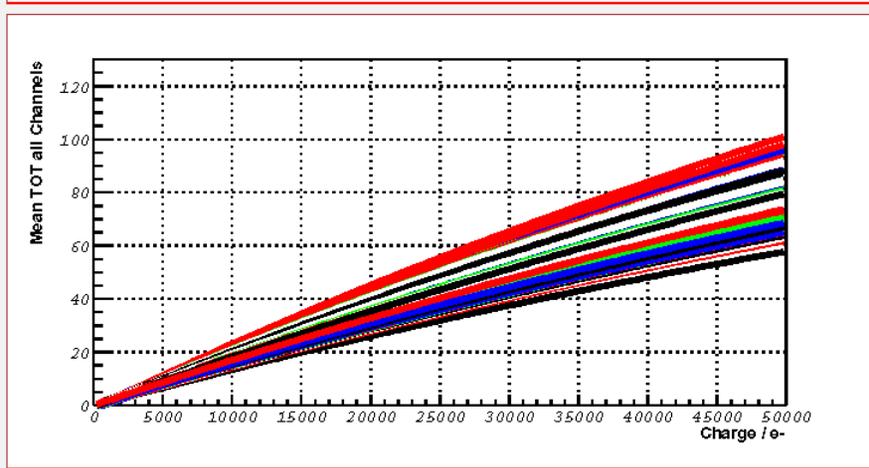
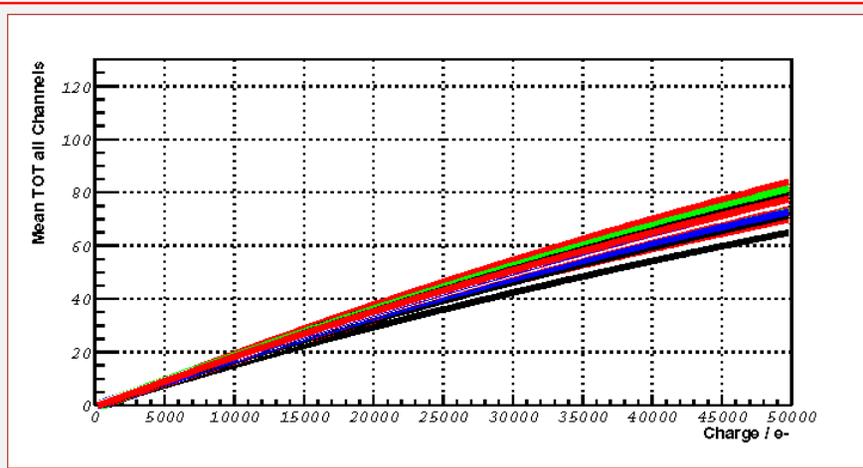
FE-I2 (probed on wafer). FDAC Tuning Performance

- Plots show that TOT response can be tuned to better than 2% using 3-bit FDAC. Although tuning is done for a particular charge (20Ke), tuning is valid over a larger range of TOT (compare left and right families of curves).

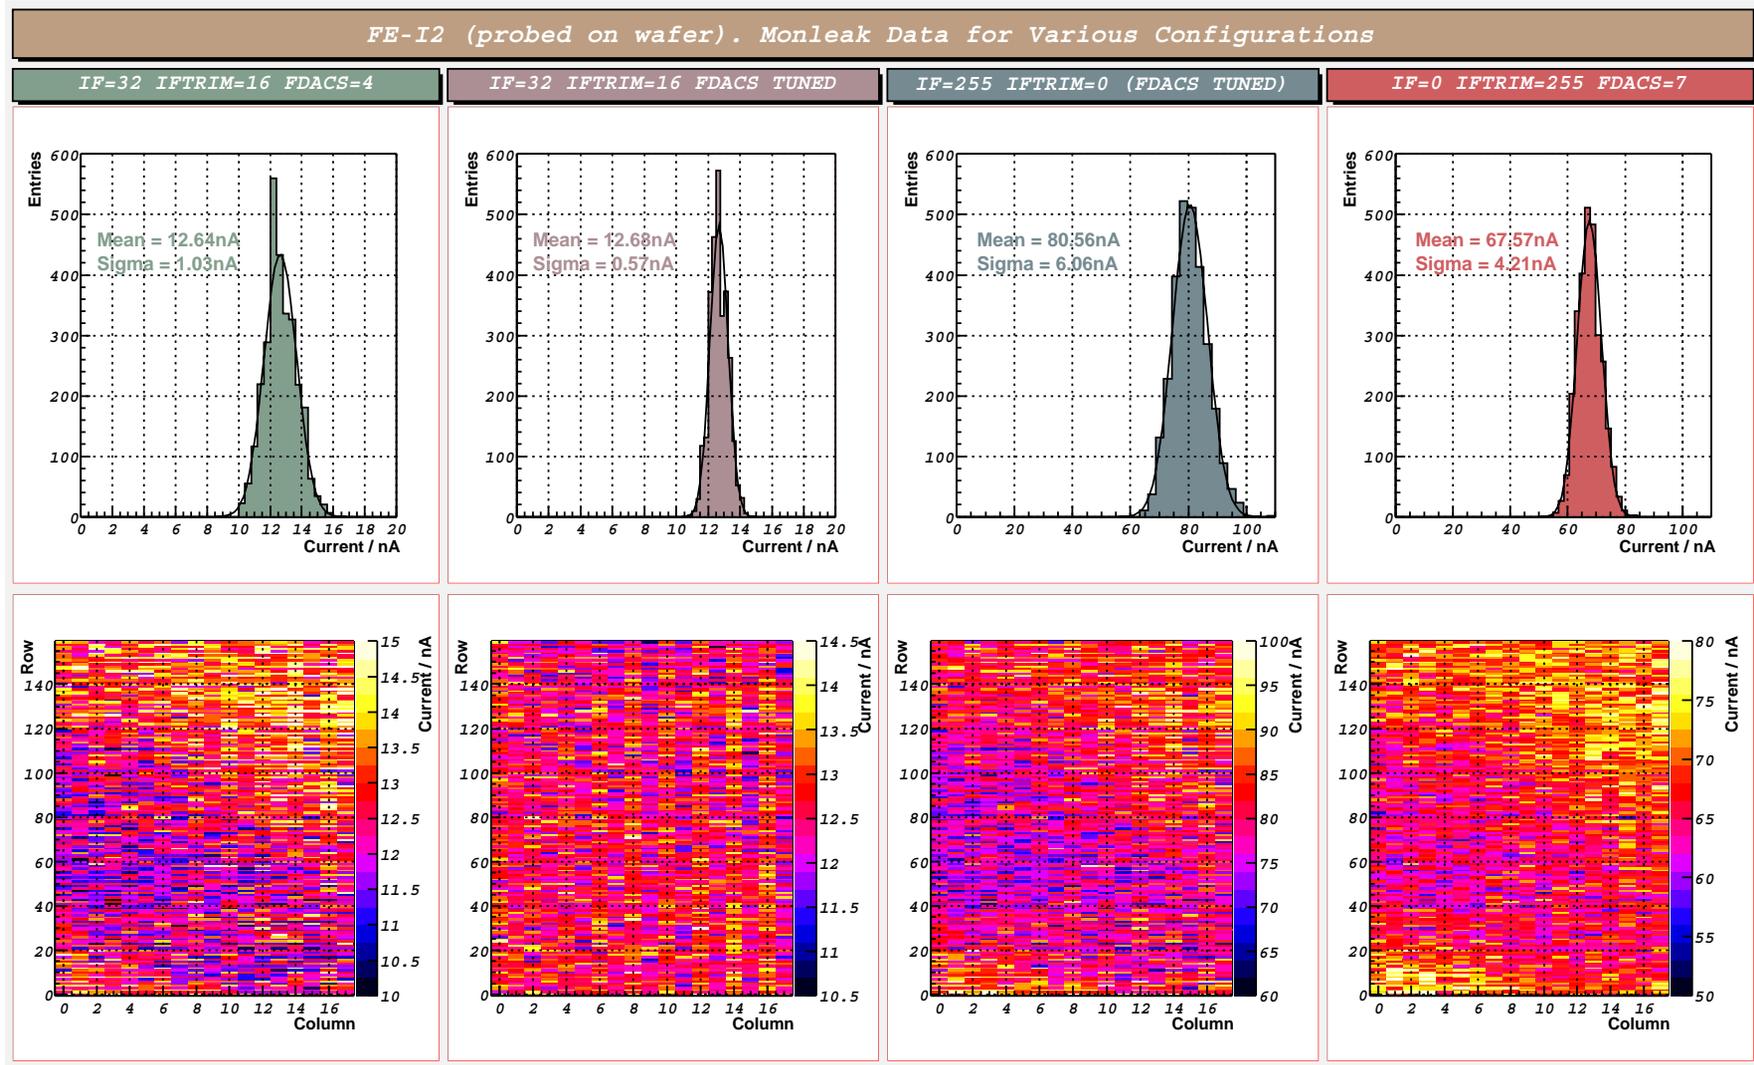
Monleak measurement and FDAC tuning:

- Leftmost plot shows raw Monleak with FDAC=4, next plot shows tuning FDACs also eliminates non-uniformity in Monleak. Finally, extreme cases with IF=255 or with ITrimIF = 255 show similar non-uniformity. Is three bits enough for the FDAC ?
