ATLAS Pixel Detector Mechanics and Services

The mechanical elements and services of the pixel detector are described in this section. We also describe the integration of the major components of the pixel detector and installation in ATLAS. The pixel detector, including the internal services, is located within the pixel support tube (PST) as already shown in Figure 2.1. A perspective view of the pixel detector elements within the PST is shown in Figure 1.

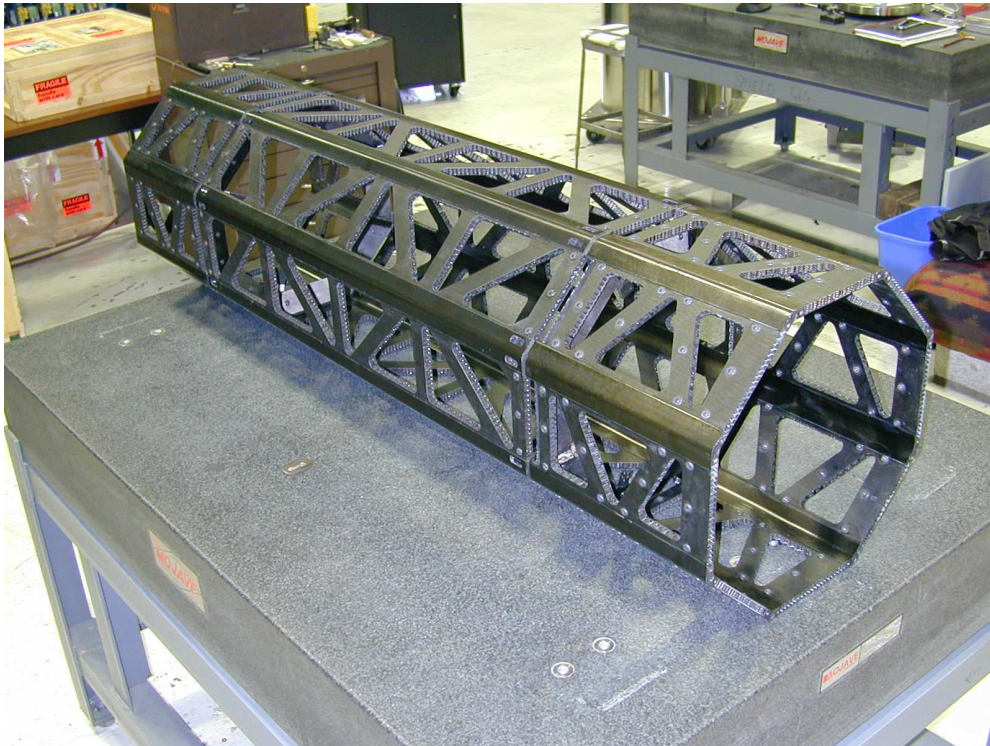
Figure 2. The support frame for the pixel detector.

The barrel shells and the disk rings are rigidly supported by a support frame constructed in three sections – a barrel section and two identical endcap sections. The support frame is constructed from carbon composites apart from small aluminum blocks in the regions where the barrel and endcap frame sections are bolted together. A picture of the support frame is shown in Figure 2. Four precision mounts are mounted on endplates attached to the support frame. These precision mounts engage mating supports in the PST when the support frame and the attached services slide through the PST during the installation procedure(section 7.7).

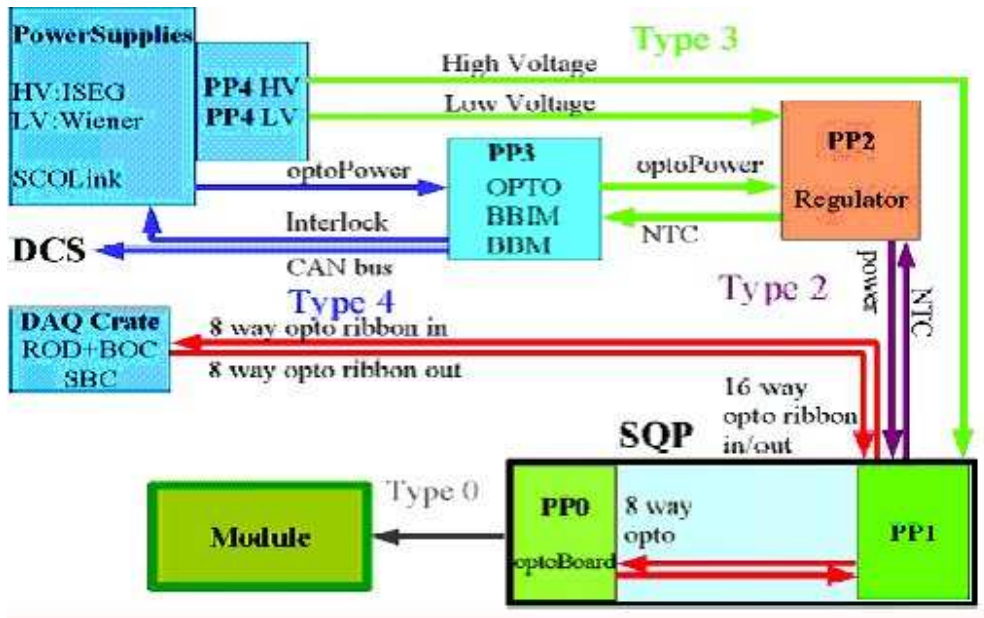
Figure 3. Schematic of the pixel electrical and optical services.

A schematic overview of the pixel electrical and optical services is given in Figure 3.

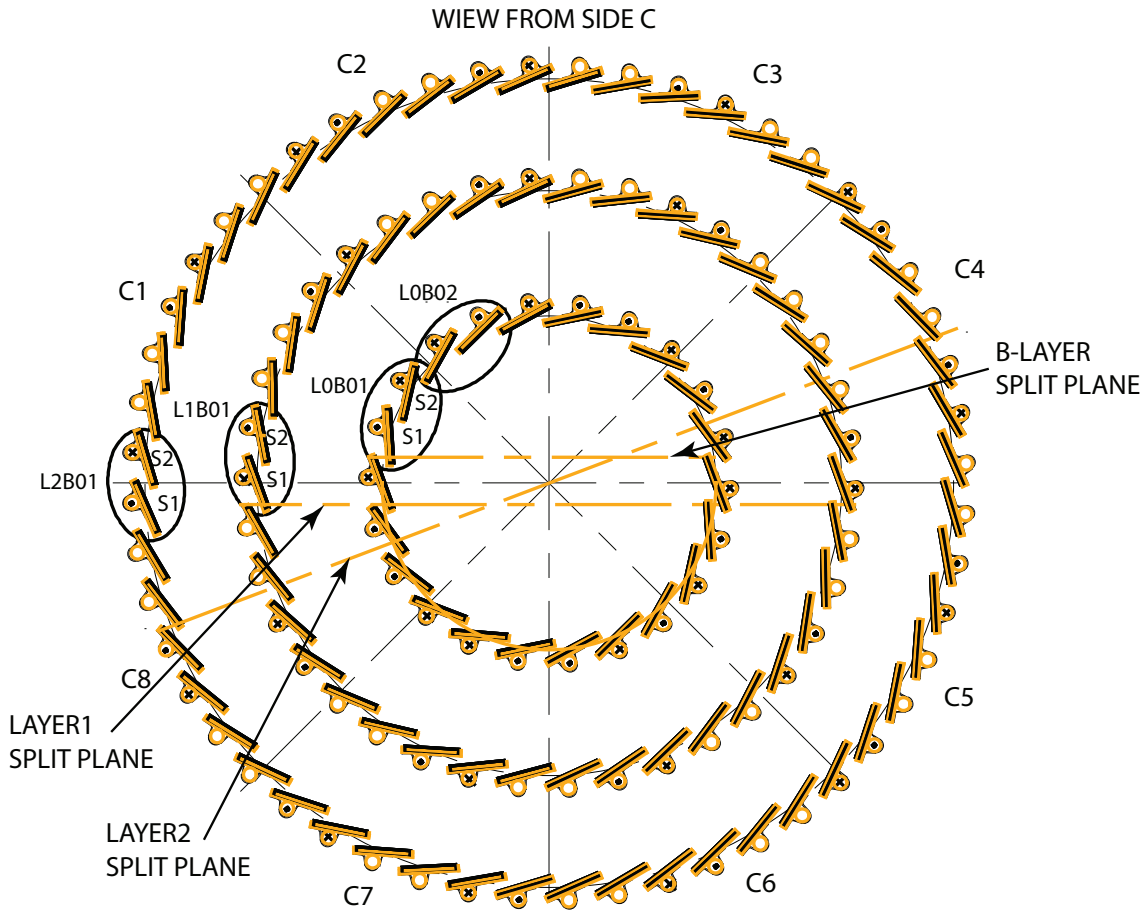
Figure 4. Layout of the Pixel barrel region. Support shells are not shown.

The pixel detector barrel region (see Figure 4) has three concentric layers with modules loaded on local supports (staves) supported by three shells. The global support described in section 1 surrounds the shells and supports them through four radial fingers at the ends of the barrel region. Each stave [?] is about 800 mm long and carries 13 pixel modules tilted in both the Z-R and R- Φ planes by 1.1° and 20° , respectively. There are in total 112 staves. Two staves share a single cooling loop generating an assembly called a bi-stave with 26 modules. The modules are distributed over the three layers as summarised in Table 1.

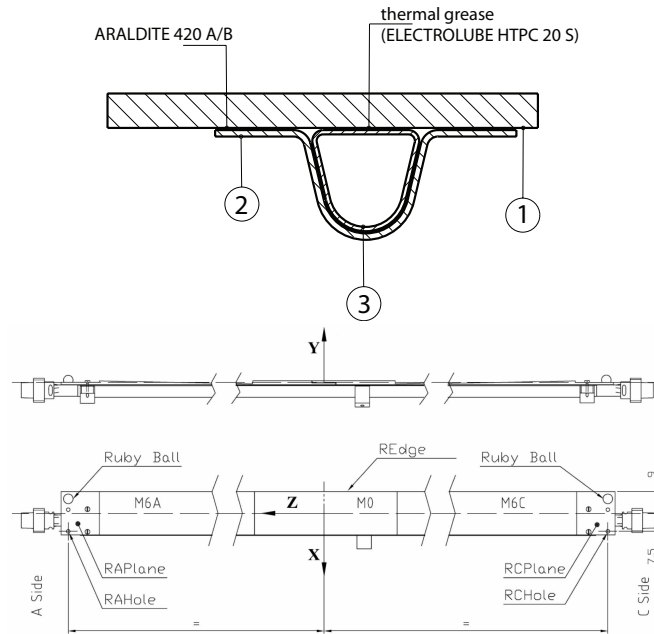
Figure 5. (a) top, cross section of a stave. Part 1 is the TMT, 2 is the omega piece and 3 the aluminum pipe. (b) bottom, longitudinal views of the stave with the reference system used for survey.

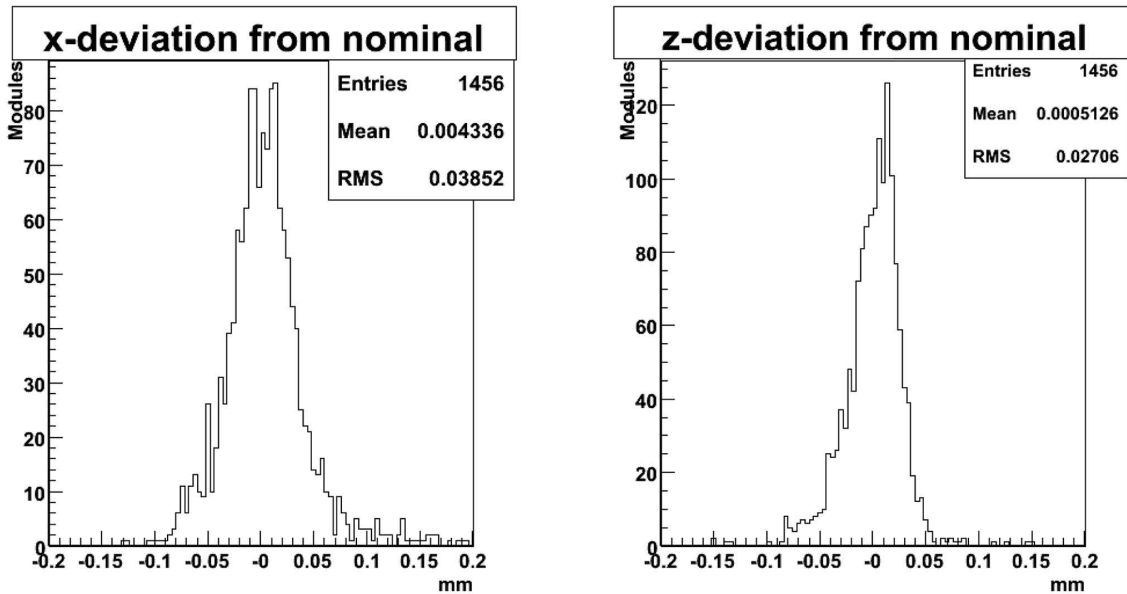
Figure 8. Deviation of module positions from nominal values for the barrel modules as described in the text.

160 A loaded stave was surveyed on a CMM. Deformation of pixel modules (bow) was measured using different methods. All measurements were taken with respect to the two ruby balls mounted on each stave. The deviation of modules position from nominal in X (transverse to the stave axis) and Z (along the stave axis) coordinates are shown in Figure 8 [?]. Only a few modules have deviations bigger than 50 μm .

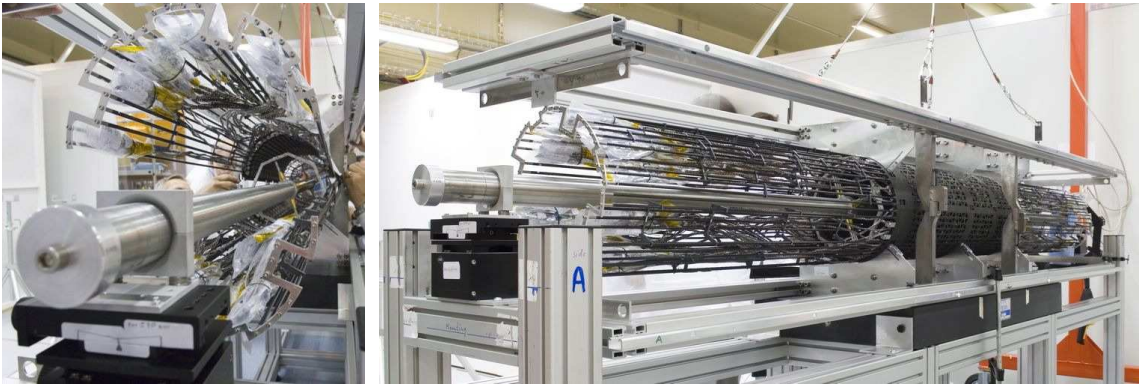
Figure 12. Clamping of the Layer 2 half-shells. The top half is craned onto the bottom one resting on the STT (see text). The picture shows the mechanism that guides the process. The stainless steel pipe, visible along the the axis of the shell, was used to guide the insertion into the global frame and was removed afterward.

Two half-shells of each layer were clamped together into a complete shell. A half-shell lacks torsional stiffness (around the axis of the cylinder). Half-shells were stiffened with an external structure and kept undeformed during the integration process. The shell transferring tool (STT) held each of the two half-shells by ten clamps that grabbed each half-ring in two places. The tool
210 was placed on the flat surface of a granite table that provided the reference plane. The bottom half-shell is kept on the STT and the top one was lowered until it engaged the clamping features (see Figure 12).

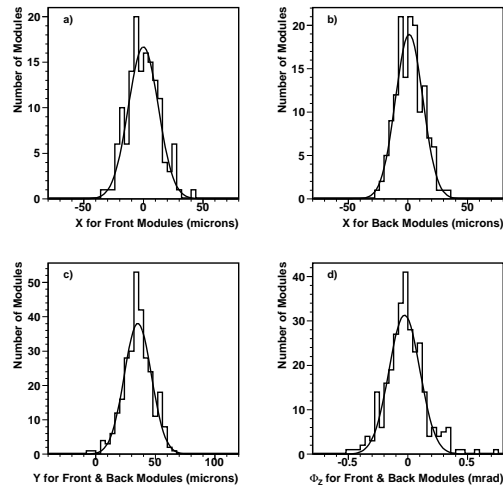
Figure 17. Final X,Y, Φ_2 alignment parameters calculated from the disk surveys.

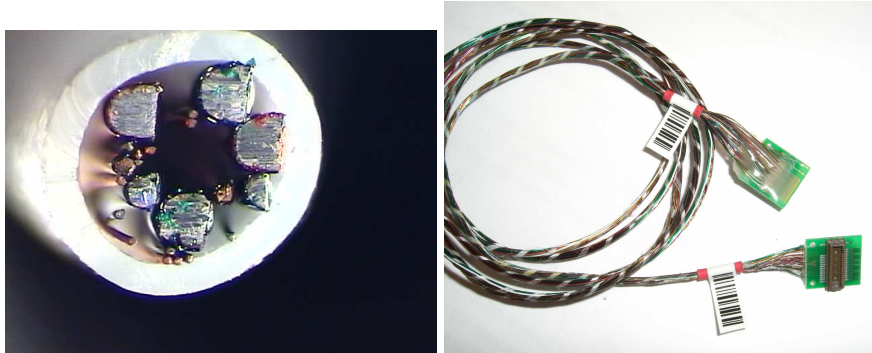
Figure 23. (a) Section through a disk T0 cable and (b) detail of a barrel T0 cable.

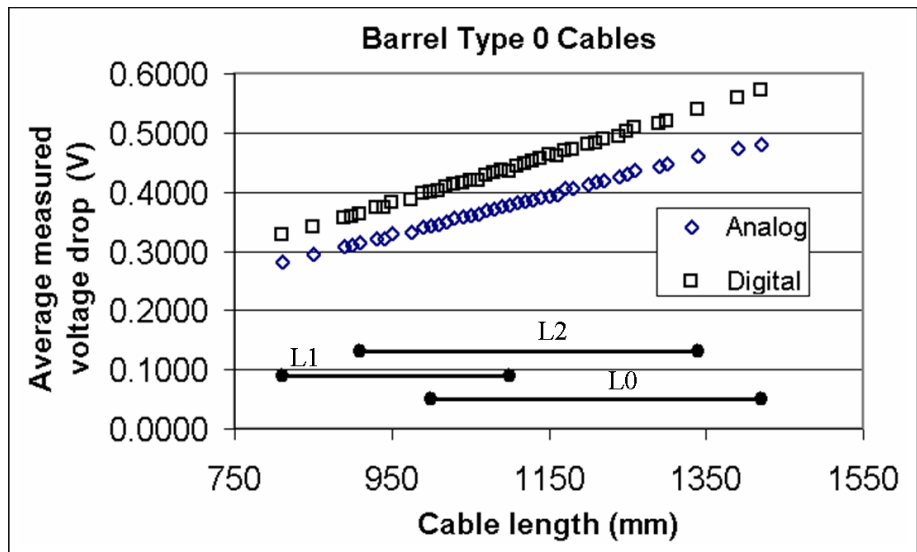
Figure 24. Average of measured voltage drops in barrel Type 0 cables vs. cable length, at the highest operating current. Values are round trip. The horizontal lines show the length range spanned by each layer. The 300-micron wire resistance derived from these measurements is $0.4 \Omega/m$.

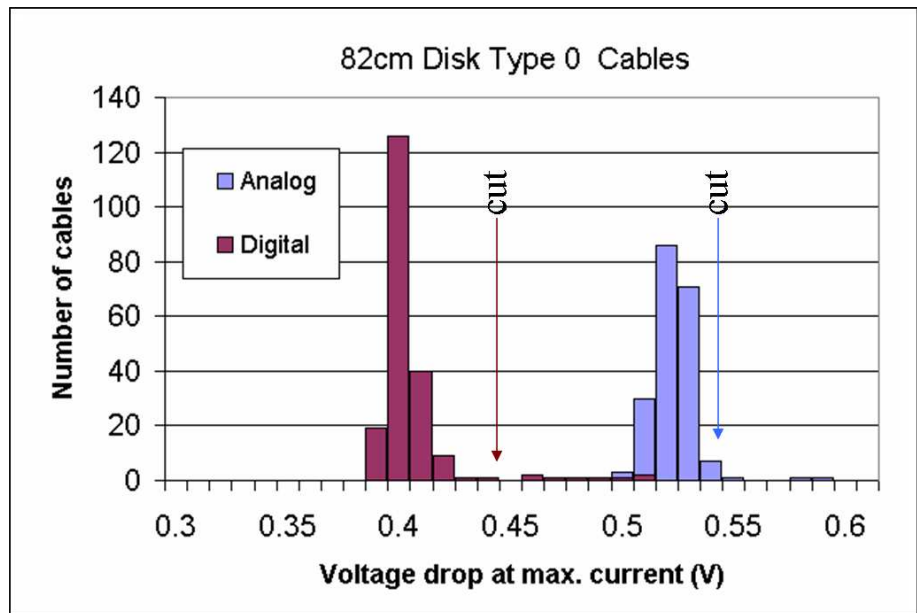
Figure 25. Measured voltage drop distributions for disk 1 and 3 type 0 cables, round-trip at highest operating current. The quality control acceptance cuts are indicated. The 400-micron copper-clad aluminum wire resistance derived from these measurements is $0.25 \Omega/m$.

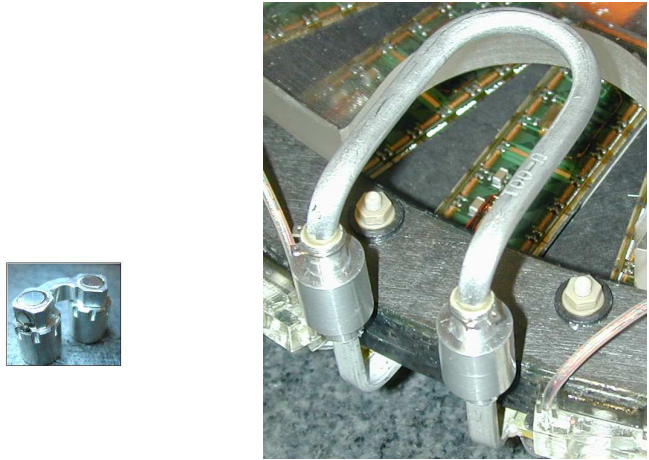
Figure 32. (a) U-link structure used to connect to staves to form a bi-stave unit and (b) U-tube for connecting disk sectors, during assembly of a disk.

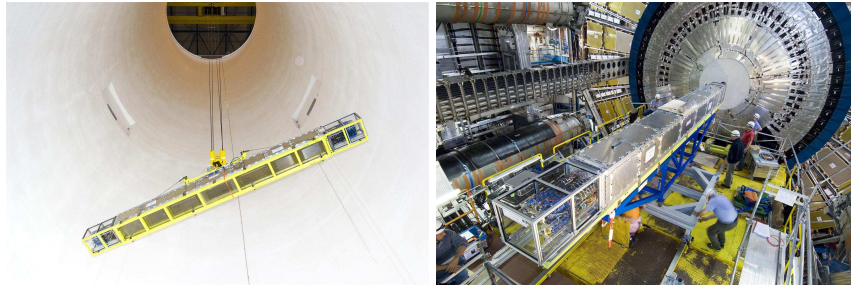
Figure 49. (a) the pixel detector in the Dummy Support Tube (see text) being lowered into the ATLAS underground hall and (b) the Dummy Support Tube and pixel detector on a platform between the Inner Detector area and the endcap calorimeter.
